SERVICE INFORMATION BULLETIN

APPLICABILITY: 2019-22MY Ascent
 2020-22MY Legacy & Outback 2.4L

NUMBER: 02-190-22R

SUBJECT: Proper Diagnosis of Oil Level Switch Leaks

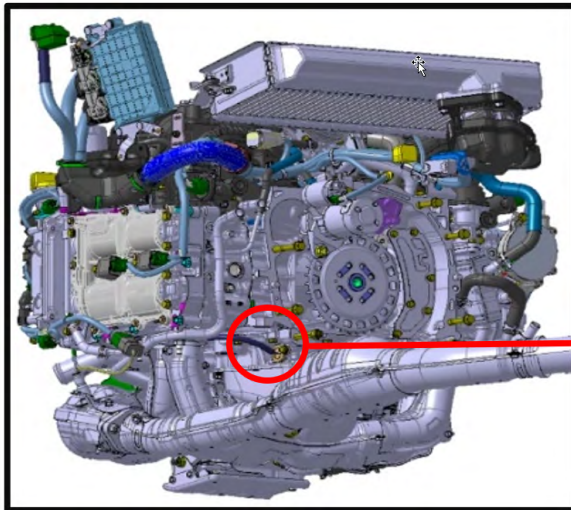
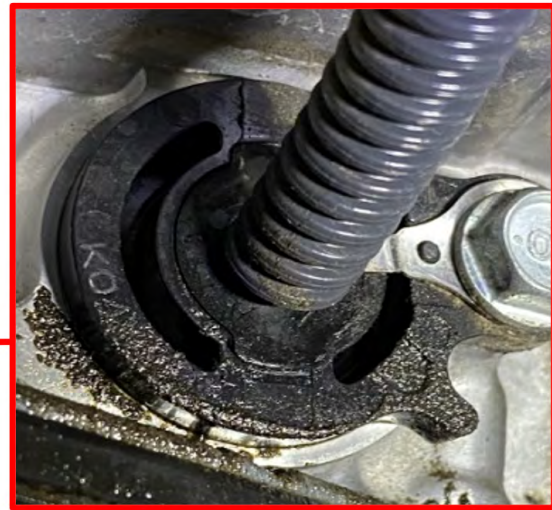
This Service Information Bulletin announces the proper diagnostic procedures regarding oil leakage from the oil level switch area. There is a slight clearance between the center epoxy portion of the oil level switch and its exterior. Engine oil flows through the switch and can cause the clearance to become saturated in oil. During engine operation, the switch temperature increases and the clearance between the epoxy and the exterior shrinks due to thermal expansion. As this clearance shrinks, the previously saturated oil is forced out and gives the appearance of a leaking oil level switch.

Pictured above is an example of an oil level switch **NOT** leaking oil but can be perceived to have a leak.
