Technical Service Bulletin

Subject: OIL LEAKAGE FROM DRIVE BELT AUTO TENSIONER AND RATTLE NOISE FROM ENGINE COMPARTMENT	Bulletin No.: 01-008/23
	Last Issued : 06/05/2023

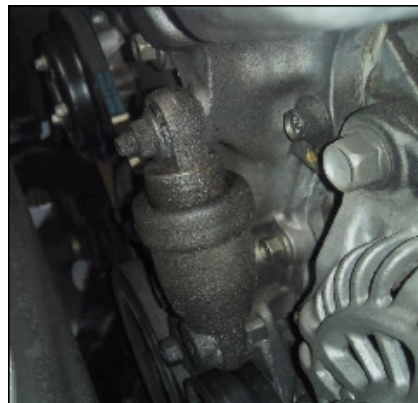
Some vehicles may exhibit oil leakage from the drive belt auto tensioner and rattling noises from the engine compartment. This may be caused by insufficient sealing at the drive belt auto tensioner damper when the auto tensioner fully operates under both high ambient temperature and high load conditions. To eliminate this concern, the shape of the drive belt auto tensioner damper has been changed.

1. Verify the customer concern.
2. Inspect the drive belt auto tensioner.

Is it part number **PE01-15-980**, or **PE03-15-980B** or earlier according to the GEPC?

- **NO:** This service bulletin is not applicable to the subject vehicle.
- **YES:** Replace the drive belt auto tensioner with a modified part according to the instructions on MGSS online:
