Subject: CREAK OR SQUEAK NOISE FROM FRONT OF VEHICLE WHEN TRAVELING OVER A BUMP WHILE TURNING AT LOW-SPEED	Bulletin No.: 02-002/23
	Last Issued : 06/14/2023

2024 CX-90

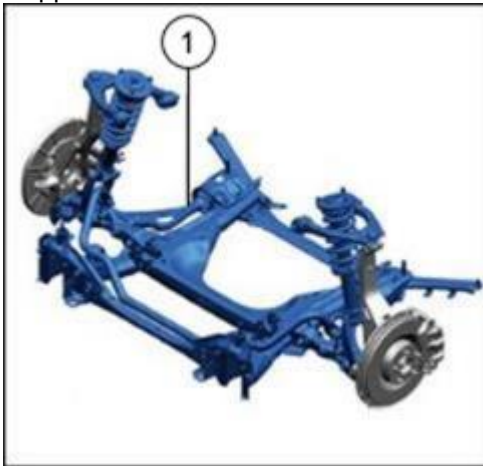
Some vehicles may exhibit a creaking or squeaking noise from the front of the vehicle when traveling over a bump while turning at low-speed. This is caused by a stick-slip phenomenon occurring between the rubber bushing and the stopper on the rear of the front lower arm (1). A mass production change is under study.
