**Subject:****CLICKING NOISE WHEN TURNING THE STEERING WHEEL****Bulletin No.: 08-004/23****Last Issued : 06/14/2023****BULLETIN NOTES****APPLICABLE MODEL(S)/VINS**

2019-2020 Mazda3 vehicles (Japan built) with VINs lower than JM1 BP\*\*\*\* \*\* 150801 (Produced before Aug. 5, 2019)

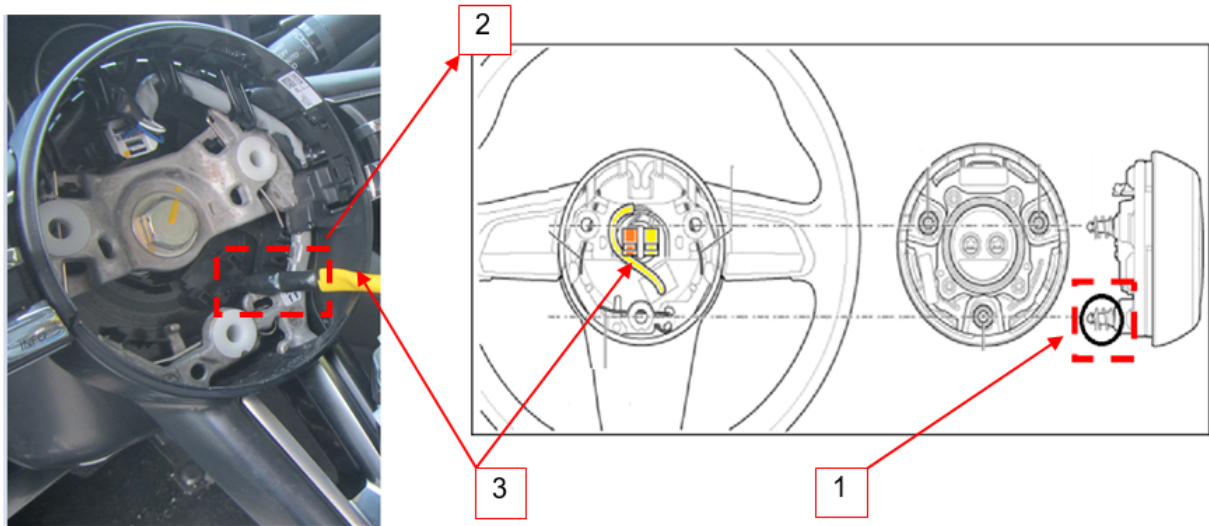
Some vehicles with the two-step deployment control air bag module may exhibit a clicking sound when turning the steering wheel. This is caused by the horn spring (1) of the airbag module interfering with the black color tape (2) of the clock spring harness (3), resulting in a stick-slip noise (click on attached sound file below).

To eliminate this concern, a material change of the harness tape is planned.

Customers having this concern should have their vehicle repaired using the following repair procedure.
