Subject: FRONT DOOR INTERFERES WITH REAR DOOR GARNISH	Bulletin No.: 09-027/23
	Last Issued : 06/28/2023

2020-2023 CX-30 (Mexico built) vehicles with VINs lower than 3MV DM**** ** 528452 (Produced before Jan. 23, 2023)

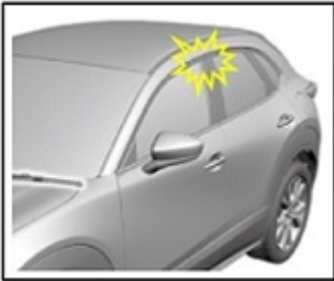
On some vehicles, the front door glass run channel may interfere with the rear door garnish. Since the front door glass run channel is not fixed strongly enough to the door, repetition of door operation may result in interference and damage to the rear door rubber seal.

To eliminate this concern, the fixing force and durability of the glass run channel against thermal expansion and vibration has been improved. The shapes of the front and rear glass run channels and the rear garnish lip have been changed to prevent interference.

1. Verify the customer concern.
2. Replace the front and rear door glass run channels and rear garnish with modified parts according to the instructions on MGSS online: (FRONT DOOR GLASS RUN-CHANNEL REMOVAL/INSTALLATION), (REAR DOOR GLASS RUN-CHANNEL REMOVAL/INSTALLATION)
