# Service Alert

<b>Subject:</b>  <b>CONNECTED VEHICLE SYMPTOM TROUBLESHOOTING</b>	<b>Service Alert No.:</b> SA-009/23
	<b>Last Issued :</b> 06/12/2023

2019-2023 Mazda3  
2020-2023 CX-30  
2021-2023 CX-5  
2021-2023 CX-9  
2022-2023 MX-30  
2023 CX-50  
2024 CX-90

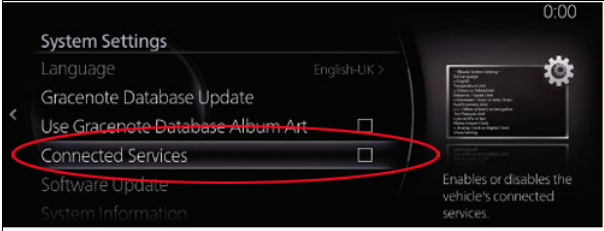
<p>Connected Services disabled (box unchecked)</p>

<p>Enable Connected Services (box checked) to prevent message appearing at engine start up.</p>

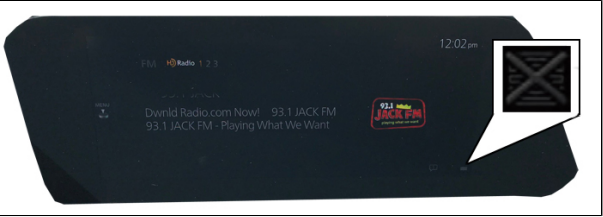
<p>Infotainment Center Display</p>	<ul style="list-style-type: none"> <li>• <b>TCU in Deactivation Mode</b></li> <li>• <b>One Time Passcode (OTP) is processing</b></li> </ul>	<p><b>Reception Icon Shows "X"</b></p>

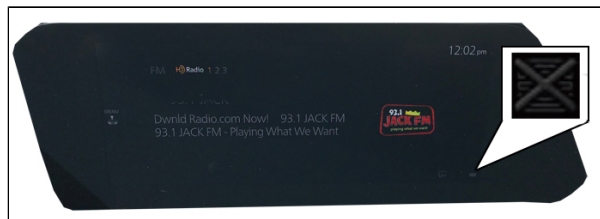
- If the reception icon shows "X", the vehicle is possibly in Deactivation Mode.

- Customer/Dealer can activate CV services anytime via MyMazda app (there just might be a slight delay in making the backend connection since it was temporarily deactivated).
- If the reception is weak, move the vehicle to a location where the reception is good to strong as shown in the table, then try to get the Authorization Code and/or operate the remote functions before proceeding to the Repair Procedure if there is still an issue.
- If the reception is good to strong, proceed to Connected Vehicle Troubleshooting below.

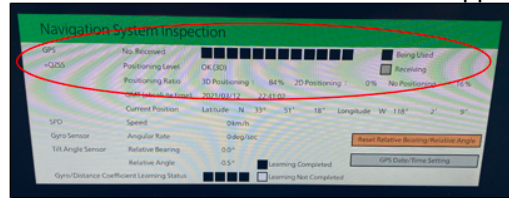
**Good** - Contact Hotline for technical support

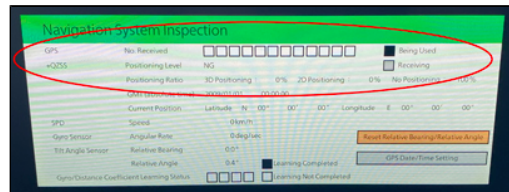
**No Good** - Swap Tel antenna No. 1 with known good vehicle

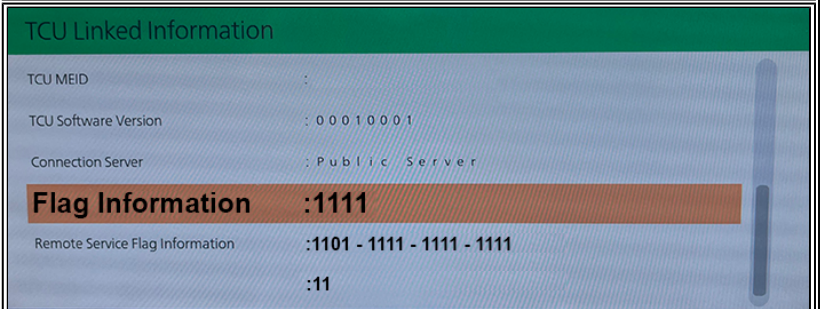
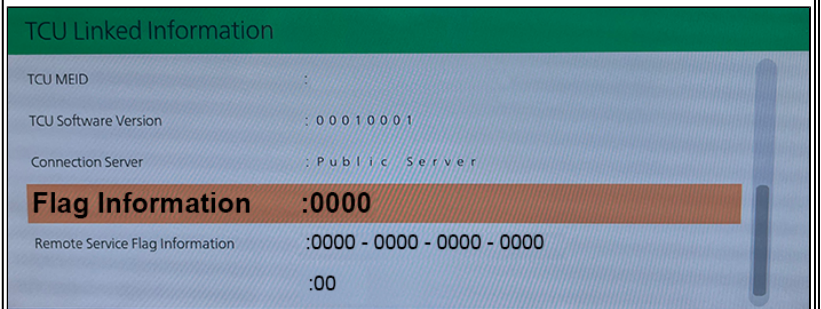
**Is the Flag Information 1111 or 0000?**

- **1111** - Disconnect 12V battery for 1 hour, then retry connected vehicle enrollment.
- **0000** - Contact Hotline for technical support.
