Service Alert

**LACK OF POWER UNDER HEAVY LOAD WITH NO WARNING
LIGHTS OR DTCS**

Service Alert No.: SA-035/23

2016-2021 CX-3	2016-2020 MX-5
2013-2023 CX-5	2013-2018 Mazda3
2016-2023 CX-9	2014-2021 Mazda6

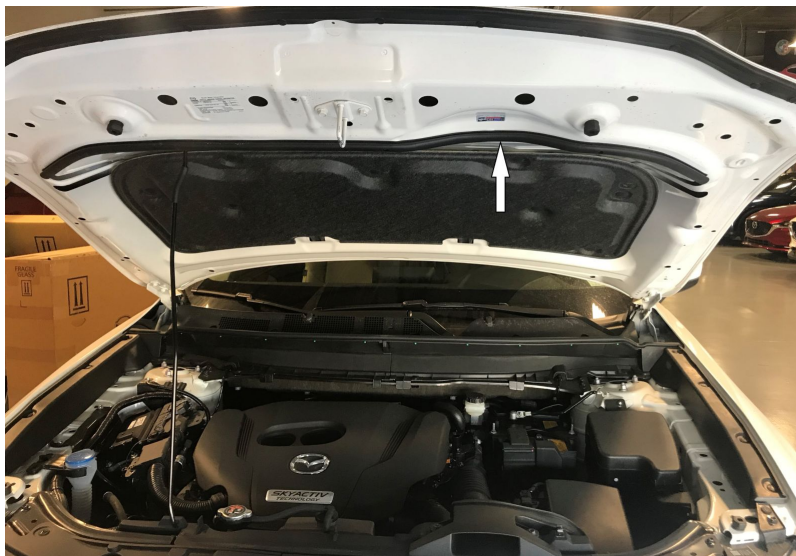
(Hood Weatherstrip Location Shown Below, Correctly installed)

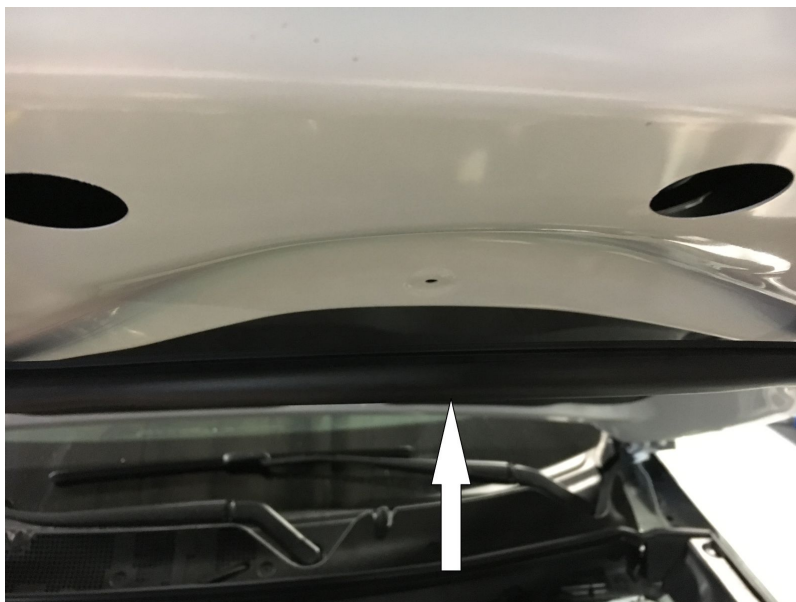
Some customers may complain of a lack of power under heavy load without any warning lights or DTCs. This concern may be due to a loose or detached hood weatherstrip, which can cause a blockage or restriction in the air intake system.

(Hood Weatherstrip Shown Below, Loose / Detached From Hood)

To correct this concern, reattach the weatherstrip or replace it with a new one if it is damaged.
