# Battery Electric Vehicle (BEV) Model VNR-E Insufficient Cab Cooling

## Air Conditioning Compressor Inspection/Replacement

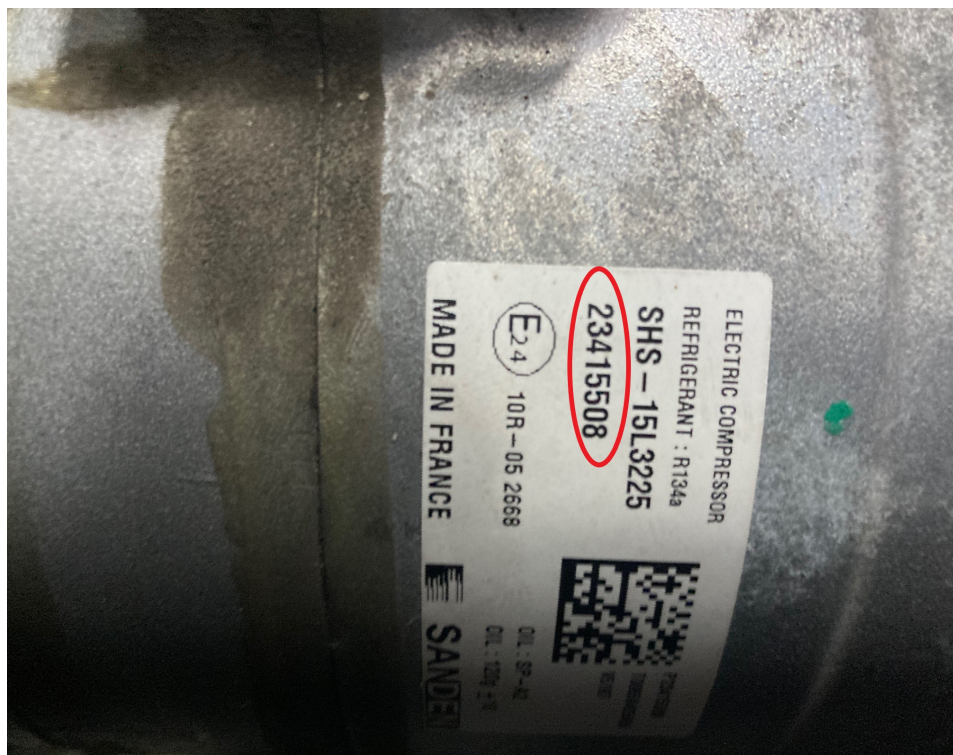
Volvo Trucks has determined that certain VNRe model vehicles may have an issue with the electric air conditioning system that could cause only one of the two electric air conditioning compressors to operate correctly. This is caused by incorrect A/C compressor CAN ID.

If the HVAC system is not sufficiently cooling the cab verify both A/C compressors are p/n 23415508.

In the event both A/C compressors are not p/n 23415508 please replace the non - 23415508 compressor.

**NOTE:** Both A/C compressors must be p/n 23415508.
