**Spray Pattern of Windshield Washer System Uneven (SY 56/23)**

Model Line: **Macan (95B)**

Model Year: **As of 2019 up to 2023**

Concerns: **Spray nozzles for windshield washer system**

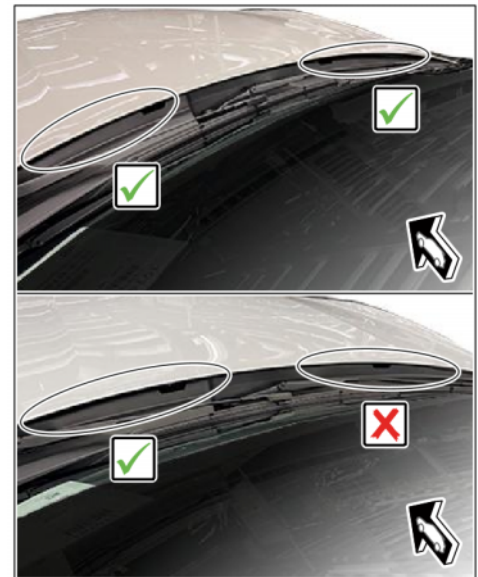
Cause: There is a possibility that the plenum panel cover is not installed correctly. As a result, one of the three spray nozzles may be covered by the cover so that the water jet from this nozzle does not hit the windshield, but instead hits the cover from the inside.

An incorrectly mounted plenum panel cover can be recognized from partial (one-sided) or continuous (both sides) at a very short distance from the bonnet.

*Correct and incorrect assembly of plenum panel cover*

Remedial Action: If there is a complaint, install plenum panel cover correctly.

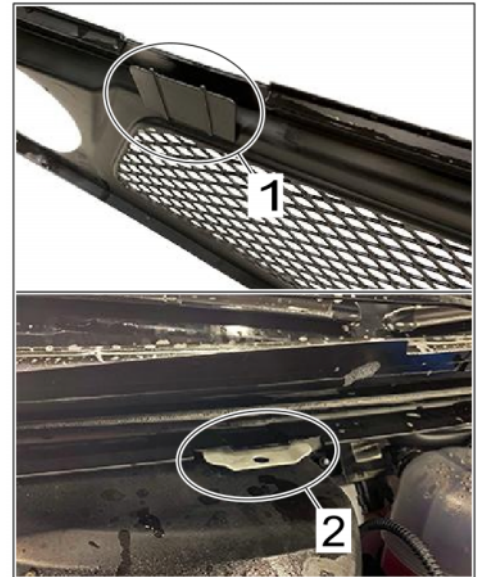
*Tab on plenum panel cover / tab on body*

Work Procedure: 1 Remove plenum panel cover and then install it correctly.  
Make sure that the tab ⇒ *Tab on plenum panel cover / tab on body-1* on the cover engages under the tab ⇒ *Tab on plenum panel cover / tab on body-2* on the body.

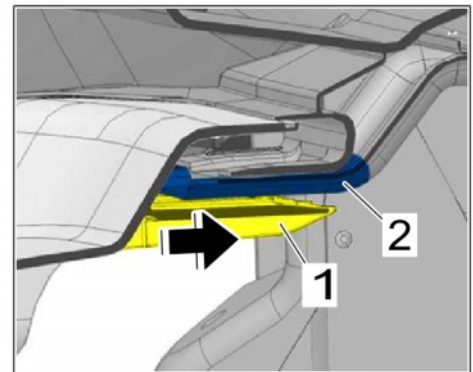
*Correct positioning of tabs  
(plenum panel cover)*
