MAZDA DEALER EMAIL

Subject: Dealer Rework (DRW) 54 – Suspension of Delivery 2024MY CX-90 Tightening Torque Concern

CX-90 DRW54 REPAIR PROCEDURE
SUSPENSION AND STEERING
TIGHTENING TORQUE CONCERN

Subject: DRW54 - SUSPENSION OF DELIVERY - 2024 CX-90 TORQUE TIGHTENING CONCERN	Campaign No.: DRW54
	Last Issued : 06/09/2023

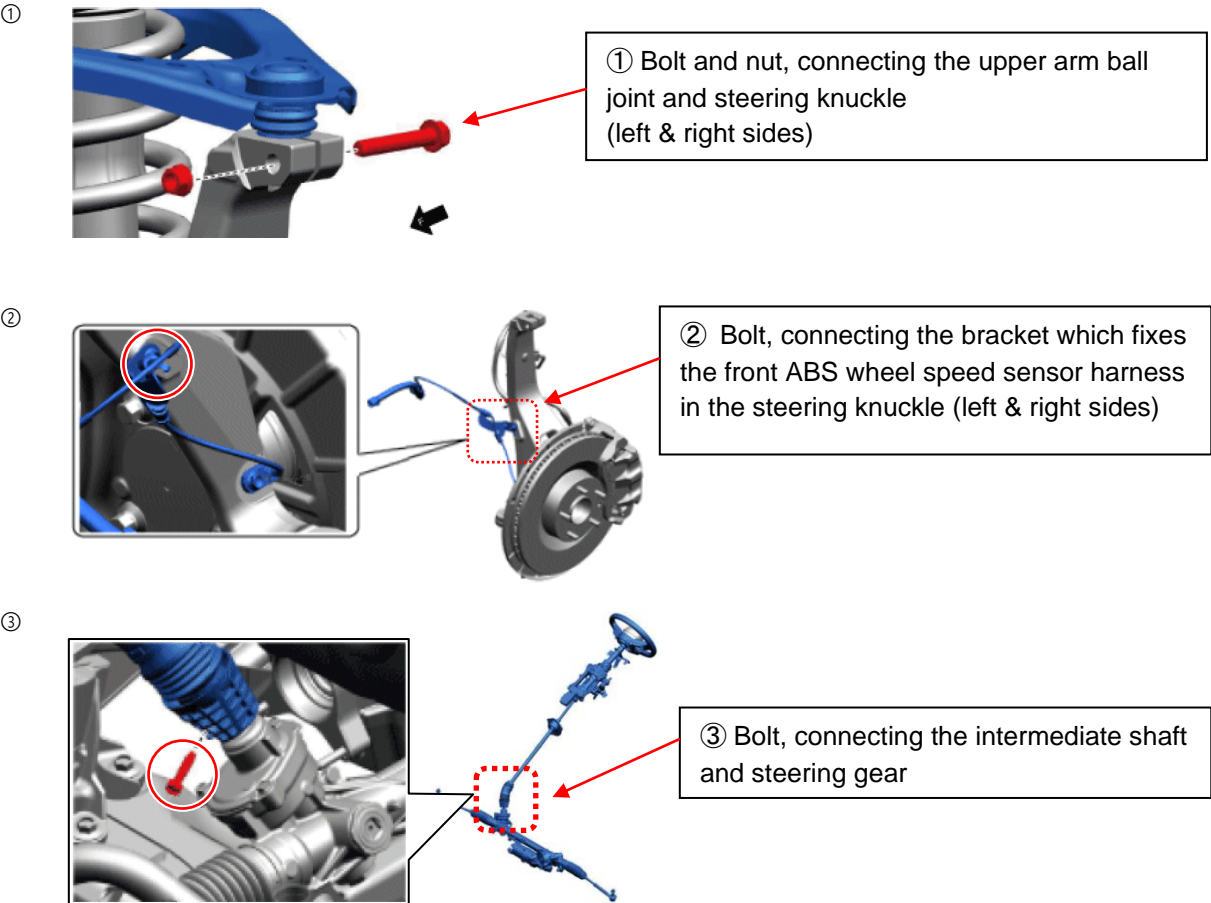
Potentially affected bolts:

On the subject CX-9 vehicles, there is a possibility that certain bolts may not be tightened completely, allowing the bolts to become loose and come off during driving.

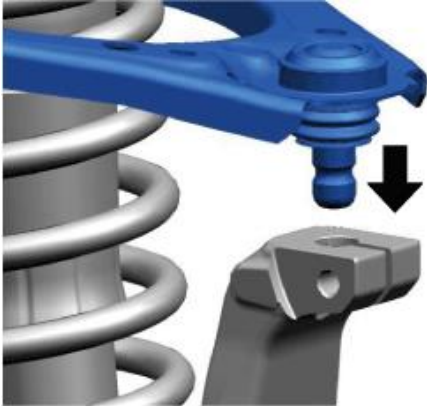
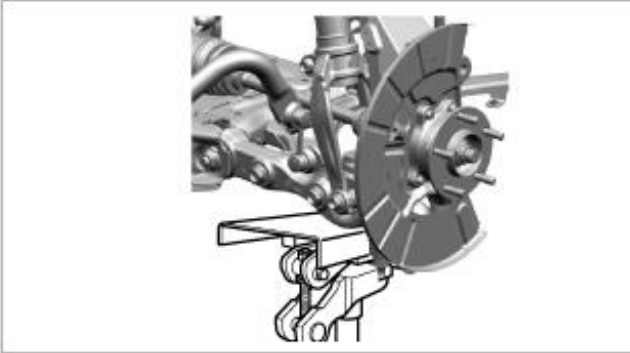
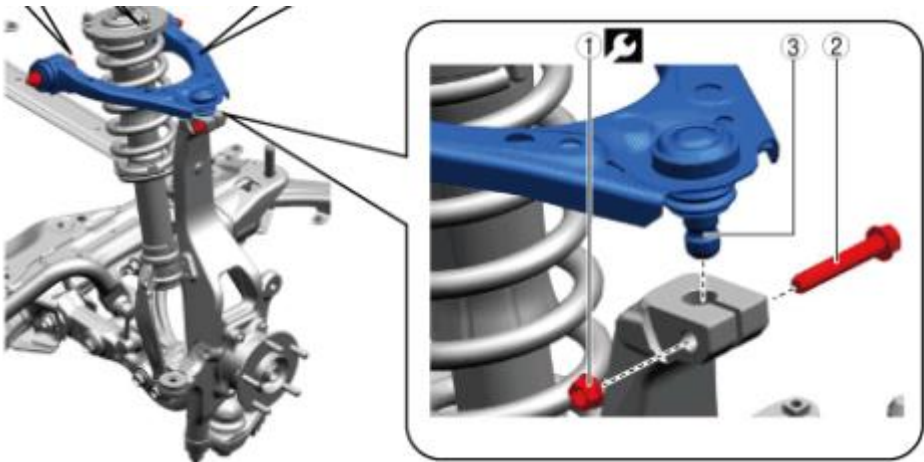
The figure shows the driver's side (same as passenger's side)

• The figure shows the driver's side (same as passenger's side).

- A) Lift the vehicle
- B) Inspect and Tighten the LH and RH Front Upper Control Arm Ball Joint Bolt to Steering Knuckle and ensure the ball joint is fully inserted into the Steering Knuckle
 - a. Torque the Bolt to 42.5 N·m {4.3 kgf·m, 31.15 ft·lbf}

Procedure	Part name	Applicable condition	
1	Nut	Continuous	42.5 N·m {4.3 kgf·m, 31.15 ft·lbf}
2	Bolt	Continuous	—
3	Front upper arm ball joint	Continuous	—

Replace the bolt and nut if they are missing.

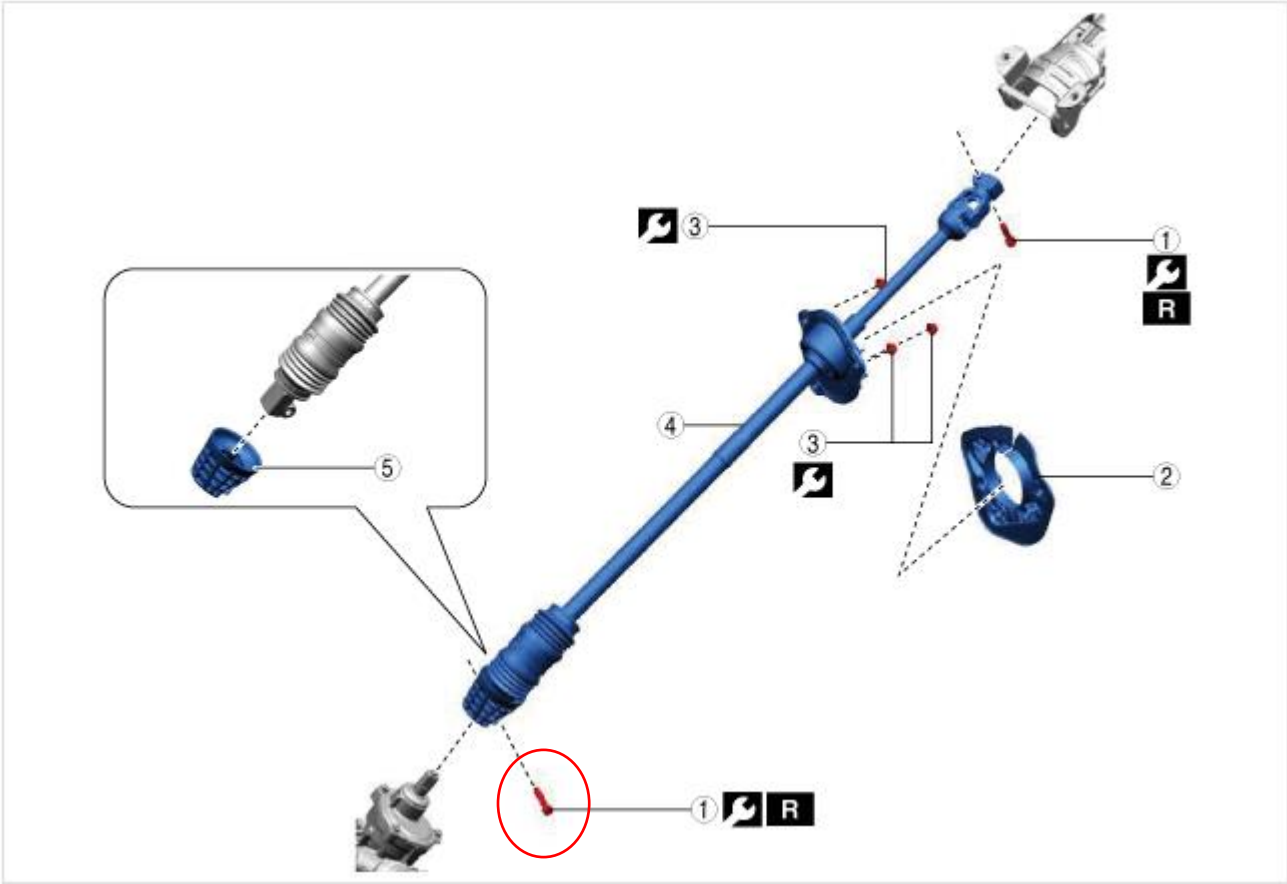
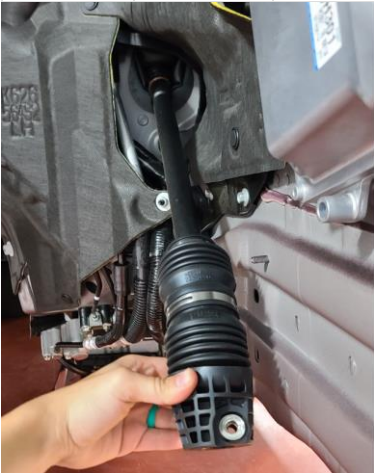
NOTE: Rotate the steering wheel until the joint bolt on the steering column side and steering gear side reaches the removal position. See photo and diagram below.

- D) Inspect and Tighten the Intermediate Steering Shaft Bolt to Steering Gear to 29 N·m {2.95 kgf·m, 21.4 ft·lbf}. Note this bolt is a "R" part but can be tightened if not torqued to spec. Access to this bolt is located in the engine bay.

Procedure	Part name	Applicable condition		
1	Joint bolt	Continuous	Replacement part	29 N·m {2.95 kgf·m, 21.4 ft·lbf}
