Technical Bulletin

Bulletin No: TCH-27-005 Rev 000

Subject: **Bendix® EC-80™ Antilock Braking System (ABS) Electronic Control Unit (ECU) Standalone Update Tool - ID 13351**

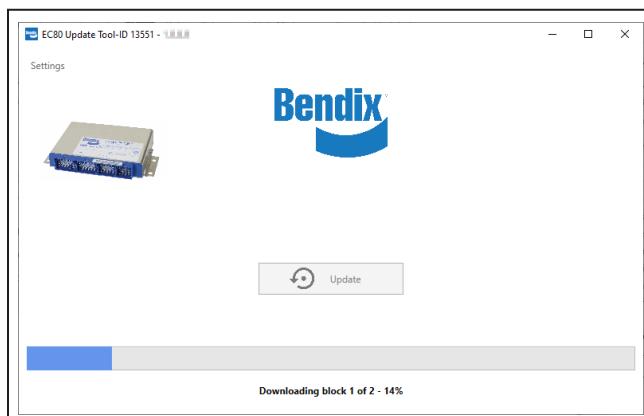
Figure 3 – Update in Process

4. *Figure 3* shows the update is in process. The update time is approximately two (2) minutes.

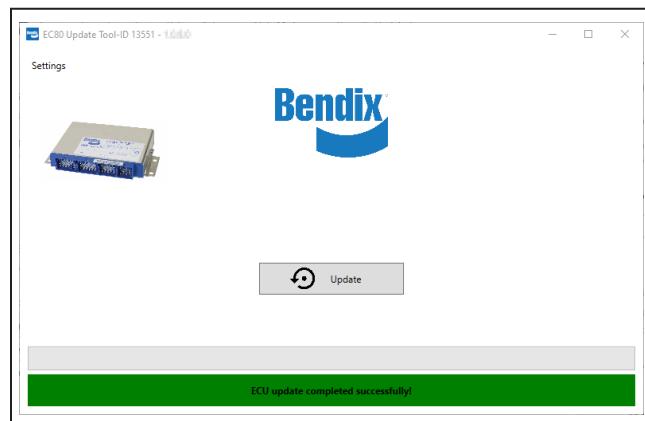
Figure 4 – Update Completed Successfully

5. *Figure 4* shows the update completed successfully.

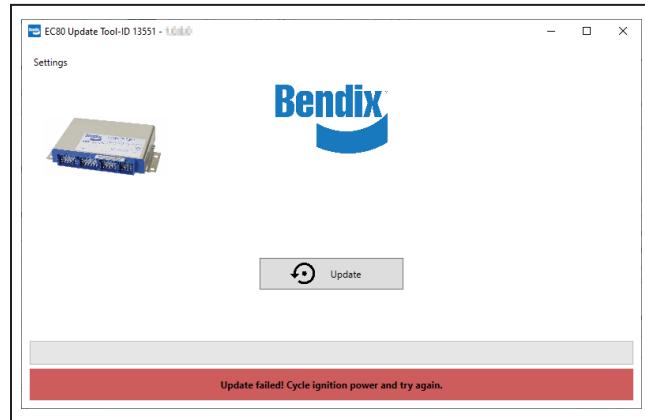
Figure 5 – Download Failed

6. *Figure 5* shows the update failed. Power cycle and restart the update procedure from Step 1.

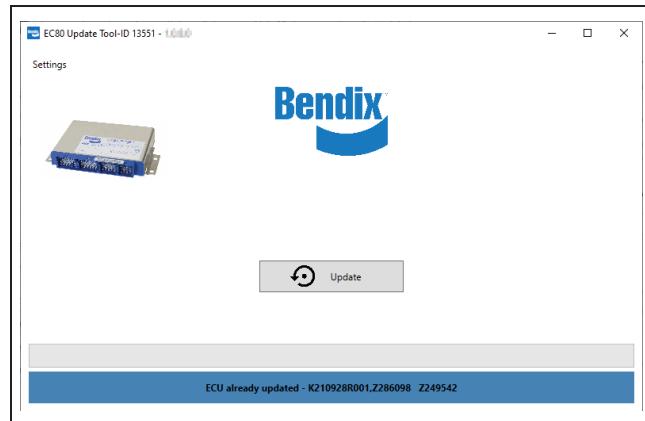
Figure 6 – Update Already Performed

7. *Figure 6* shows the update has already been performed. No further action is required.

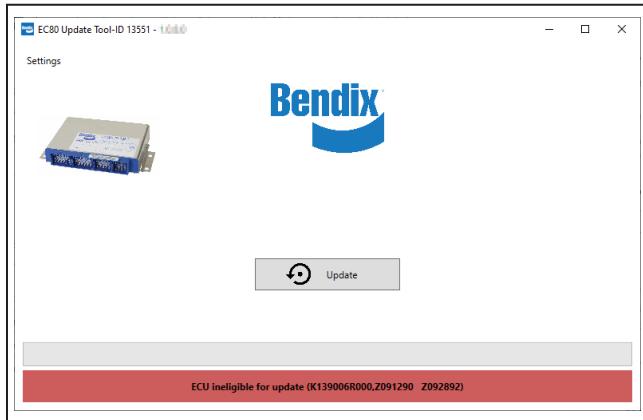
Figure 7 – ECU Ineligible for Update

8. *Figure 7* shows the Electronic Control Unit (ECU) is not eligible for the update. No further action is required.

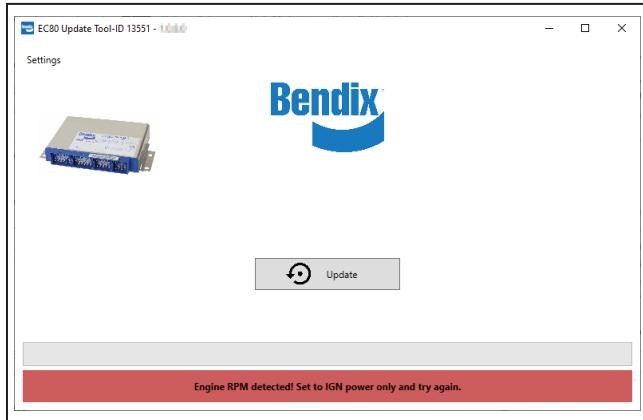
Figure 8 – Engine RPM Detected

9. *Figure 8* shows the engine RPM has been detected. Power cycle to ignition only and restart the update procedure from Step 1.

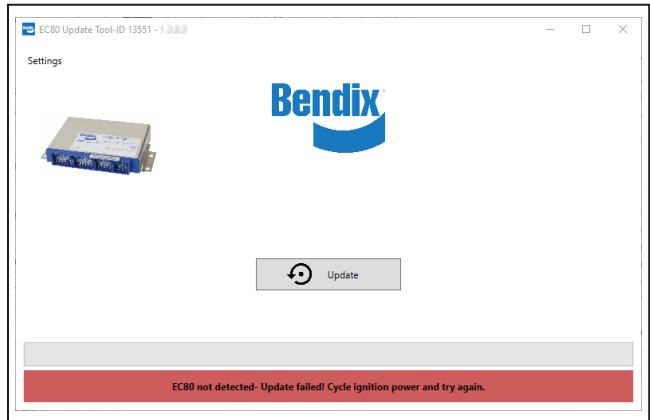
Figure 9 – ECU Not Detected

10. *Figure 9* shows the ECU is not detected. Verify the ignition power is ON and/or ensure the correct RP1210C channel is selected. Restart the update procedure from Step 1.
