RSB-56-23-002-1: R1S Upper Liftgate Body Fit and/or Water Leakage

Document Type	Technical Service Bulletin
Date	June 14, 2023
Affected Region(s)	USA
Affected Model(s)	R1S
Model Year(s)	2022
Approximate Build Dates	November 2021 - July 2022

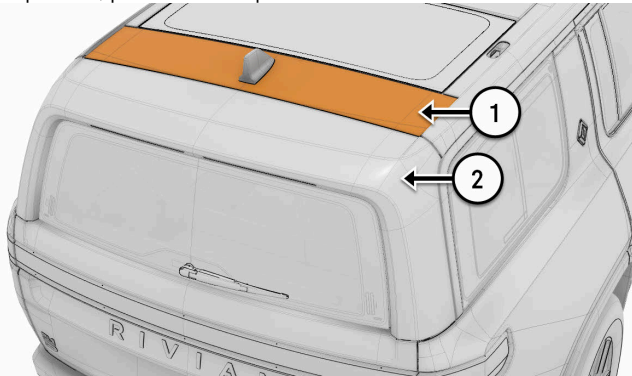
1	Rear roof applique
2	Upper liftgate

- Perform this procedure when the upper liftgate is replaced.
- Upper liftgates were adjusted at the factory to prevent water leakage. This could result in sub-optimal body gaps around the liftgates.
 - If a customer complains of water leakage near the liftgate, perform this procedure.
 - If a customer complains that the upper liftgate contacts the rear roof applique when the liftgate is opened, perform this procedure.

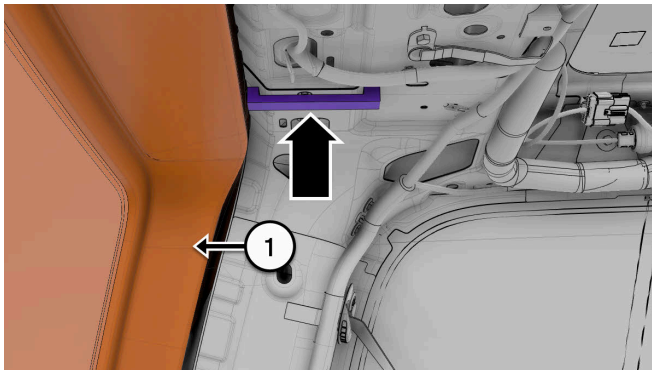
c. The upper liftgate is aligned within specification if the narrow side slides freely in the gap and the wide side does not fit in the gap.

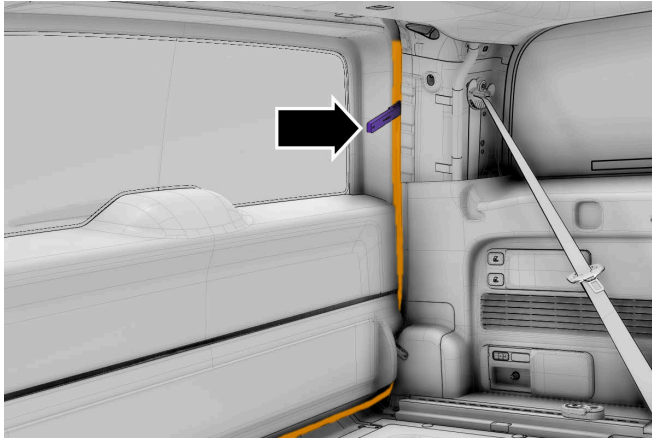
3. On both sides: Use the tool to check the gaps in the highlighted areas.
 - a. Insert the narrow side of the tool in the gap.
 - b. Insert the wide side of the tool in the gap.
 - c. The liftgates are aligned within specification if the narrow side slides freely in the gap and the wide side does not fit in the gap.

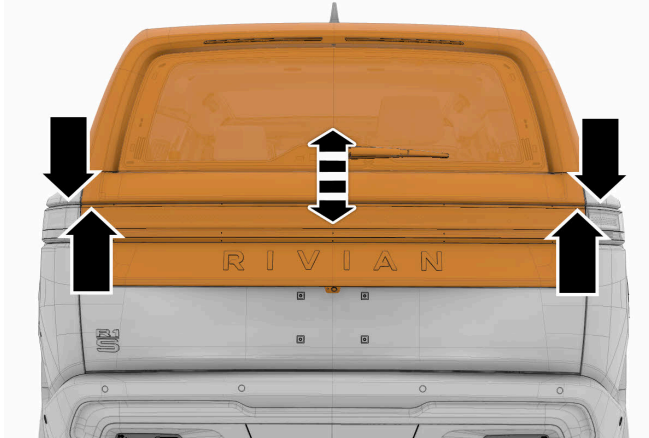
a. Check the gaps shown.

- 2-6 mm with upper liftgate assist struts installed
- 3.5-7.5 mm with upper liftgate assist struts removed

b. If adjustment is necessary: Loosen the highlighted fasteners to adjust the component.

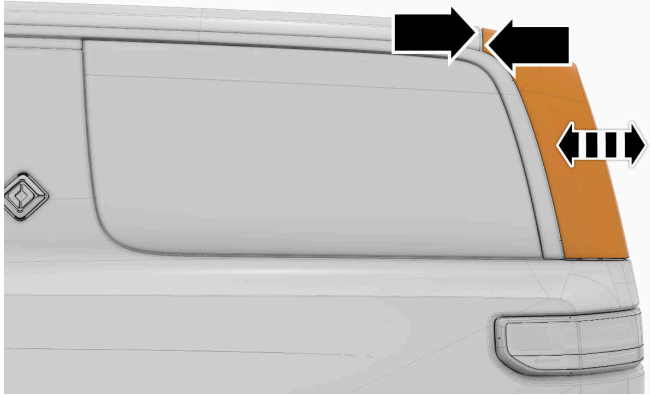
a. On both sides: Check the gaps shown.

Target gap: Defined by the special tools in the [Inspection](#) section.

b. If adjustment is necessary: Loosen the highlighted fasteners to adjust the component.

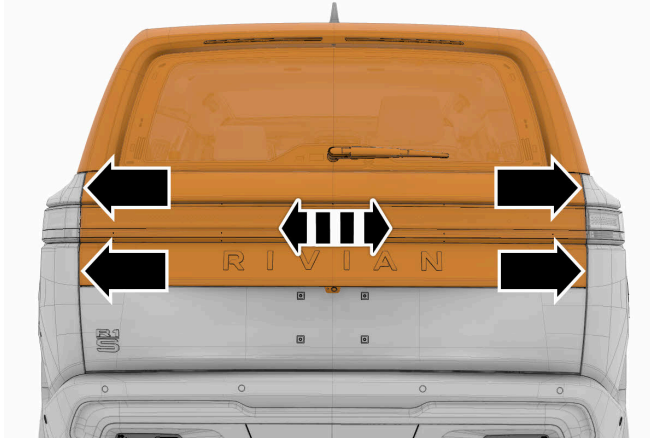
a. Check the gaps shown.

Target gap: Equal values (the component should be centered).

b. If adjustment is necessary: Loosen the highlighted fasteners to adjust the component.

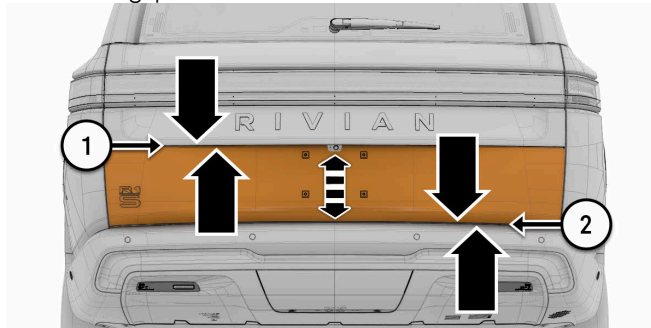
a. Check the gaps shown.

1	2.3-5.7 mm
2	3.1-8.9 mm

b. If adjustment is necessary: Loosen the highlighted fasteners to adjust the component.

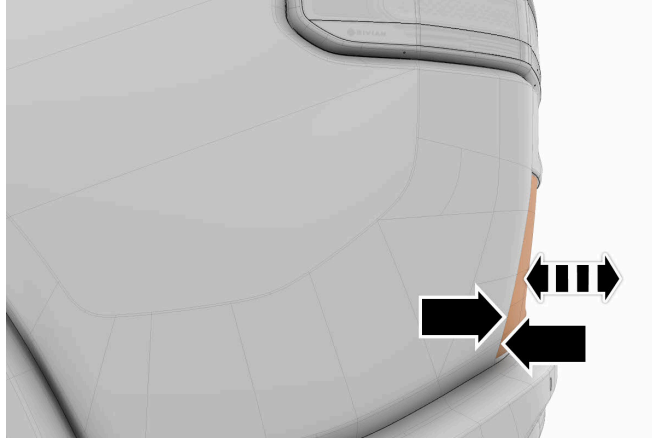
- a. On both sides: Check the flushness between the components.

Target flushness: Lower liftgate 0.5-3.5 mm underflush to the bodyside.

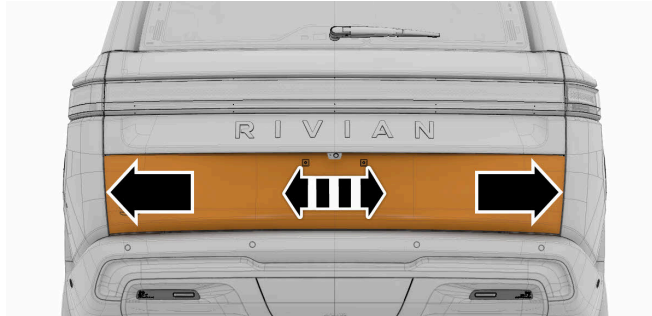
- b. Check the gaps shown.

Target gap: Equal values (the component should be centered).

- c. If adjustment is necessary: Loosen the highlighted fasteners to adjust the component.

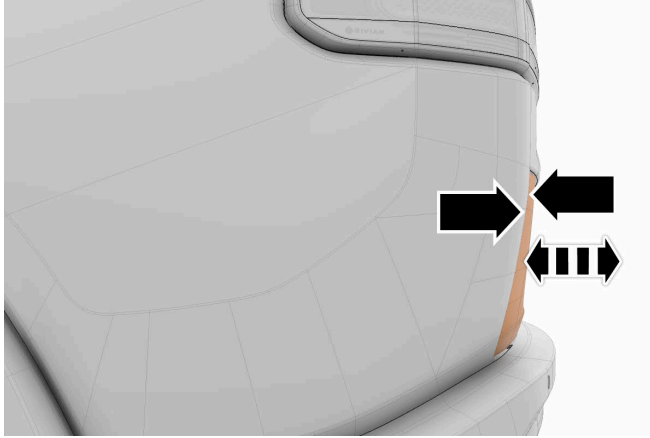
- a. On both sides: Check the flushness between the components.

Target flushness: Lower liftgate 0.5-3.5 mm underflush to the body side.

- b. If adjustment is necessary: On both sides: Use a trim tool to pry near the highlighted clip(s).

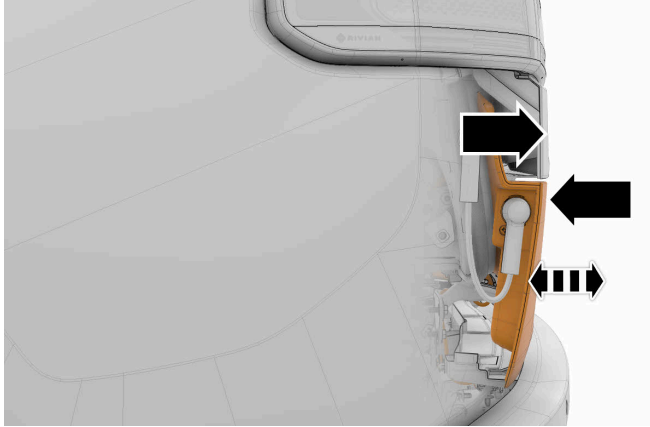
- a. On both sides: Check the flushness between the components.

Target flushness: Lower liftgate 1 mm underflush-1 mm overflush to the upper liftgate.

- b. If adjustment is necessary: Remove: Trim Panel, Lower Liftgate, Upper (refer to service manual procedure 641956010).

- c. Loosen the highlighted fasteners to adjust the component.
