**Outer Body Symptom - The Vehicle Unlocks Again Immediately After Locking (SY 64/23)**

Model Line: **Taycan (Y1A/Y1B/Y1C)**

Model Year: **As of 2022 up to 2023**

Concerns: **Outside door handles**

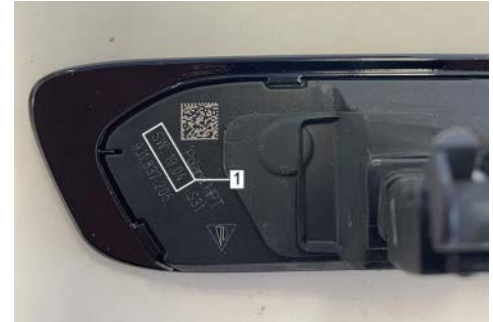
*Door handle software version*

The part number has not yet been changed due to the changed version of the door handles. However, an assessment of the software version of the door handle can be made using the software version specified on the inside of the door handle.

Only **door handles with software version SW 19.08** can show the described fault pattern and upon complaint, must be **replaced by door handles with a changed version** (currently software version **SW 19.04**, ⇒ *Door handle software version -1-*).
