# TECHNICAL SERVICE BULLETIN

Technical Service Bulletin: 51-1651

# BASECAMP MOTORIZED LEVELING CONTROLLER REPLACEMENT

| TSB Number: | 85-001-2023 | | | |

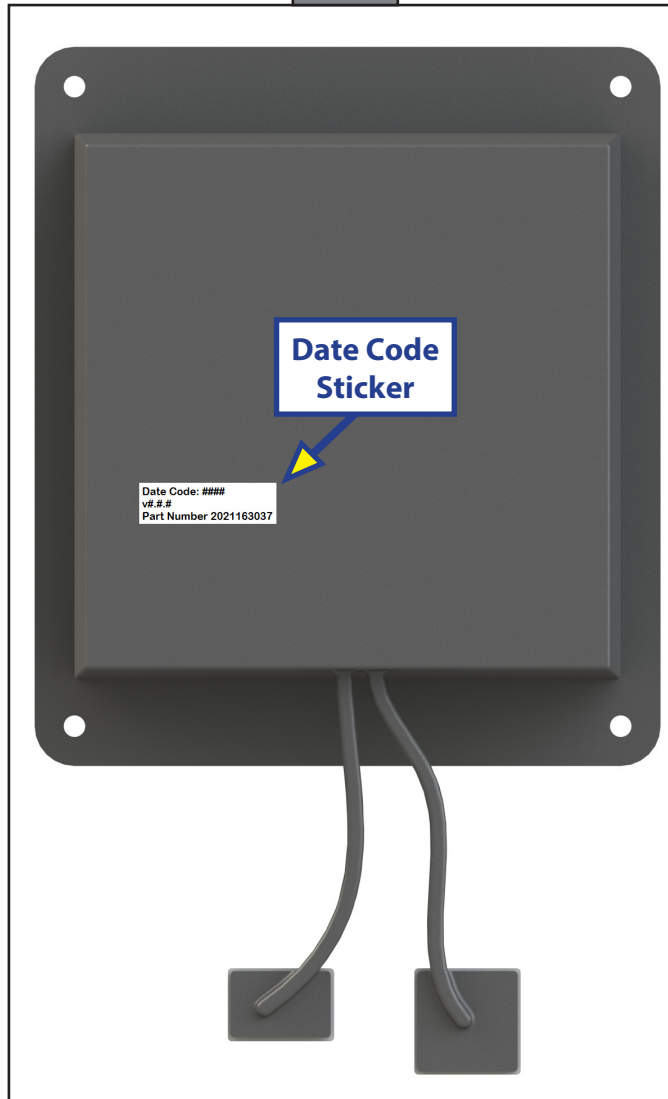
Fig. 3

3. Verify controller replacement is necessary.
  - A. Check the date code sticker on the back of the controller (Fig. 3).
    - I. Rev D, Date Code 1823 and under: replace with new controller.
      - a. Return old control to:

Lippert Warranty  
Attn: Warranty Lab  
2020 Blakesley Parkway  
Bristol IN 46507
    - II. Rev E, Date Code 1923 and greater: controller replacement not necessary.

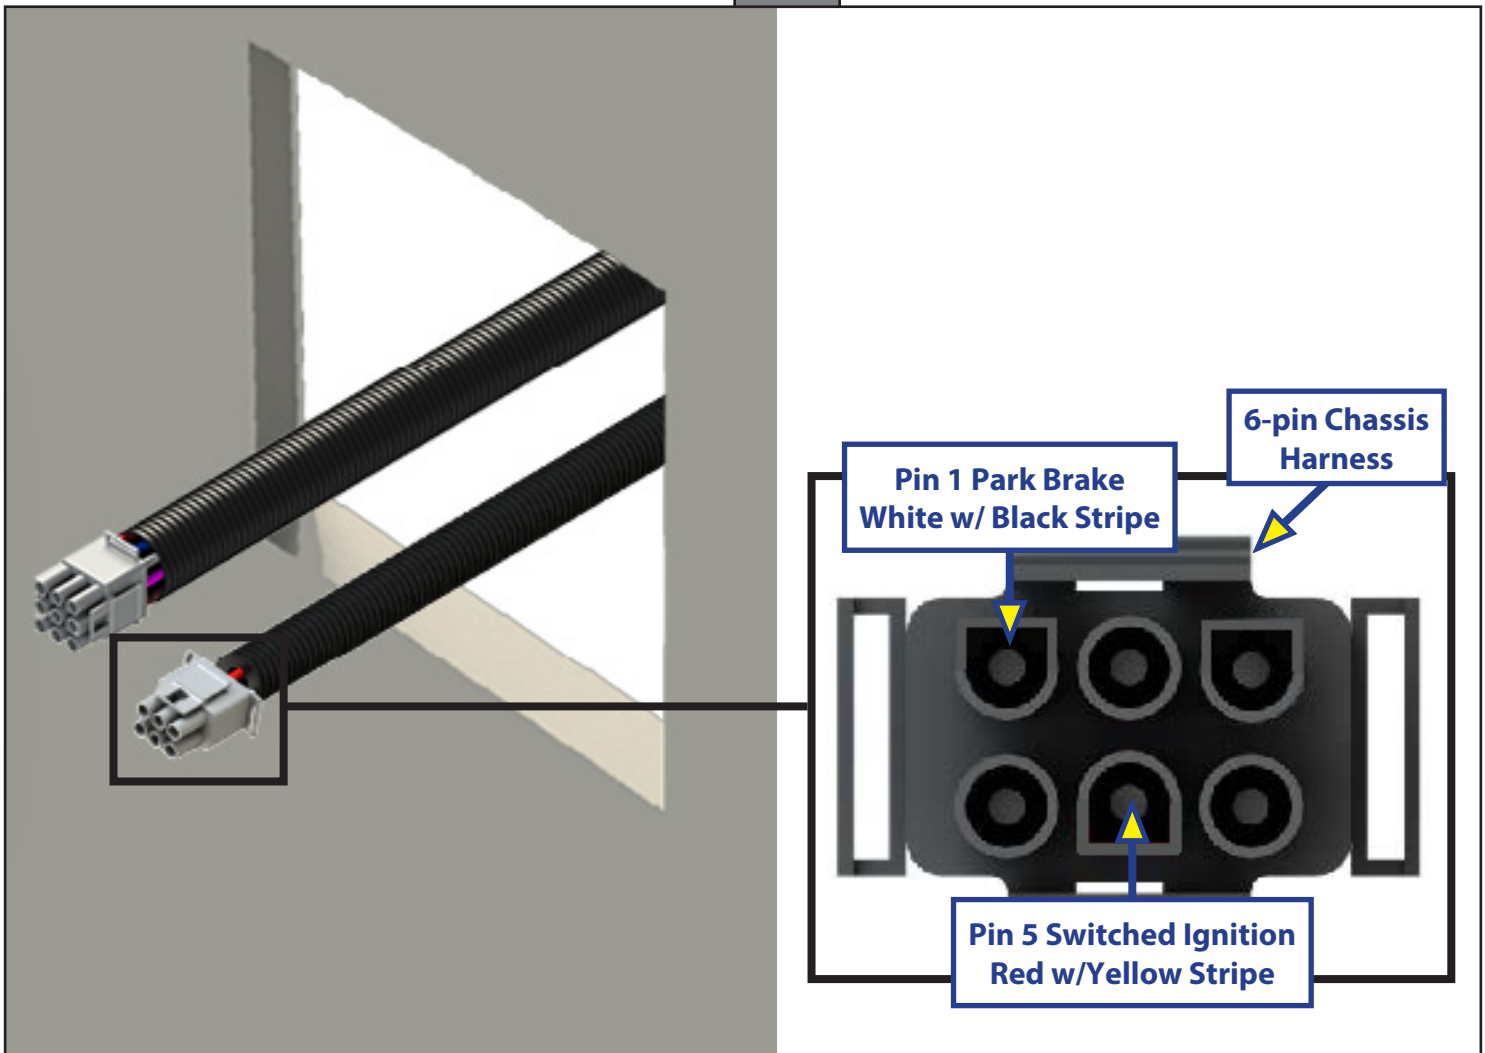
Fig. 4

4. Verify 6-pin chassis wire harness is wired correctly (Fig. 4):
  - A. Pin 1 (Fig. 4) of the 6-pin chassis harness must be wired to the parking brake to ensure a ground connection is made when the parking brake is applied.

**NOTE:** If pin 1 (Fig. 4) is wired to +12V the controller will be permanently damaged and non-responsive.

- B. Pin 5 (Fig. 4) of the 6-pin chassis harness must be wired to a switched +12V ignition source.
