Stacy L. Balzer  
Operating Director  
Service Engineering Operations  
Ford Customer Service Division

June 15, 2023

**SUBJECT: Optional Product Improvement Program 22G07**  
Certain 2020-2022 Model Year Police Interceptor Utility Vehicles Equipped with a Low Band Frequency Noise Suppression Kit - Electromagnetic Compatibility Upgrade

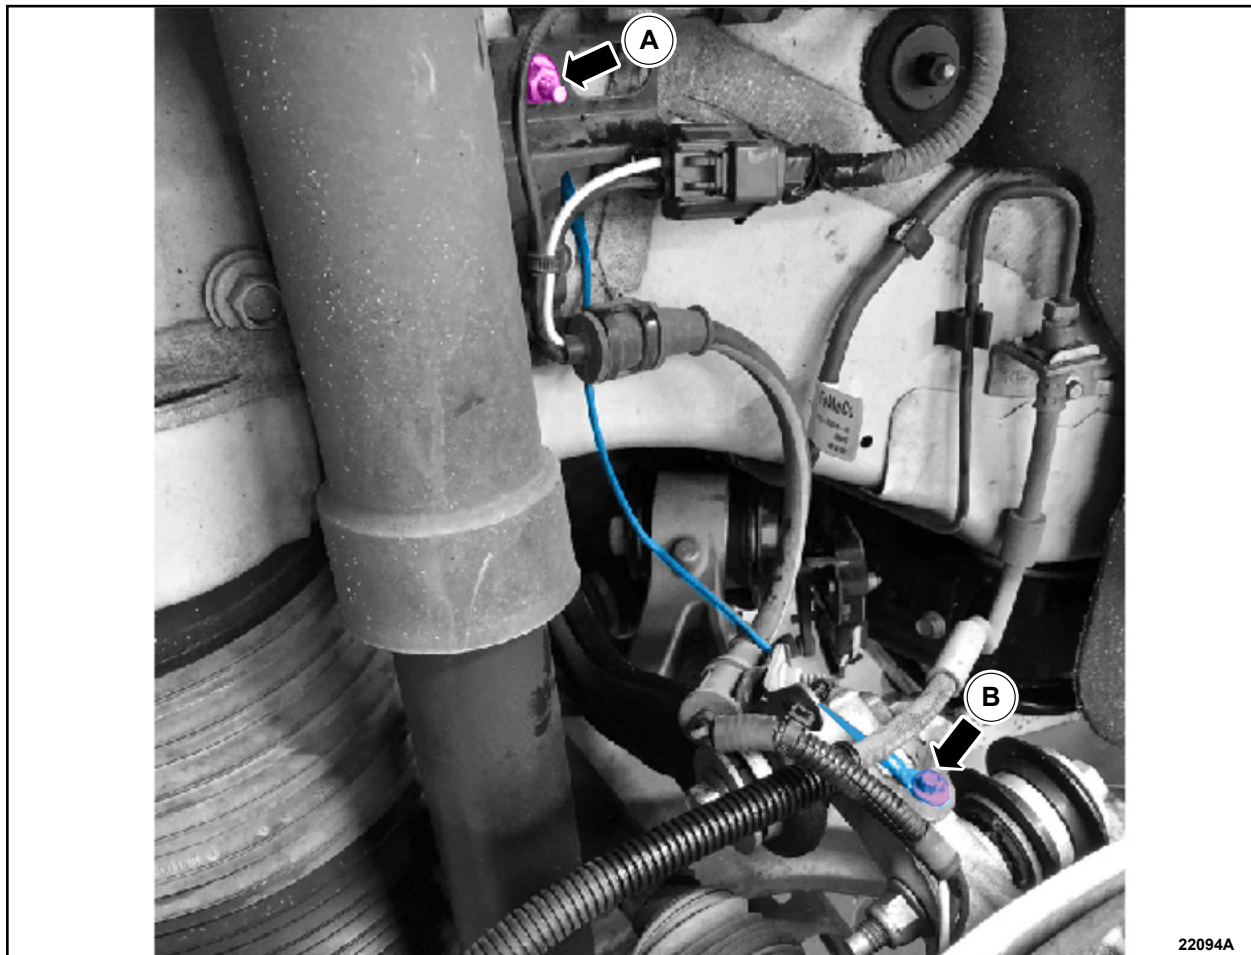
**FIGURE 1**

1. Position the vehicle on a hoist.
2. Remove both rear wheels. Follow the Workshop Manual (WSM) procedures in Section 204-04A.
3. On both sides, check the rear ground strap upper and lower fasteners (2 fasteners per side) located at the rear brake caliper for proper torque. See Figure 1.

- Torque A: 62 lb-in (7 Nm)
- Torque B: 133 lb-in (15 Nm)

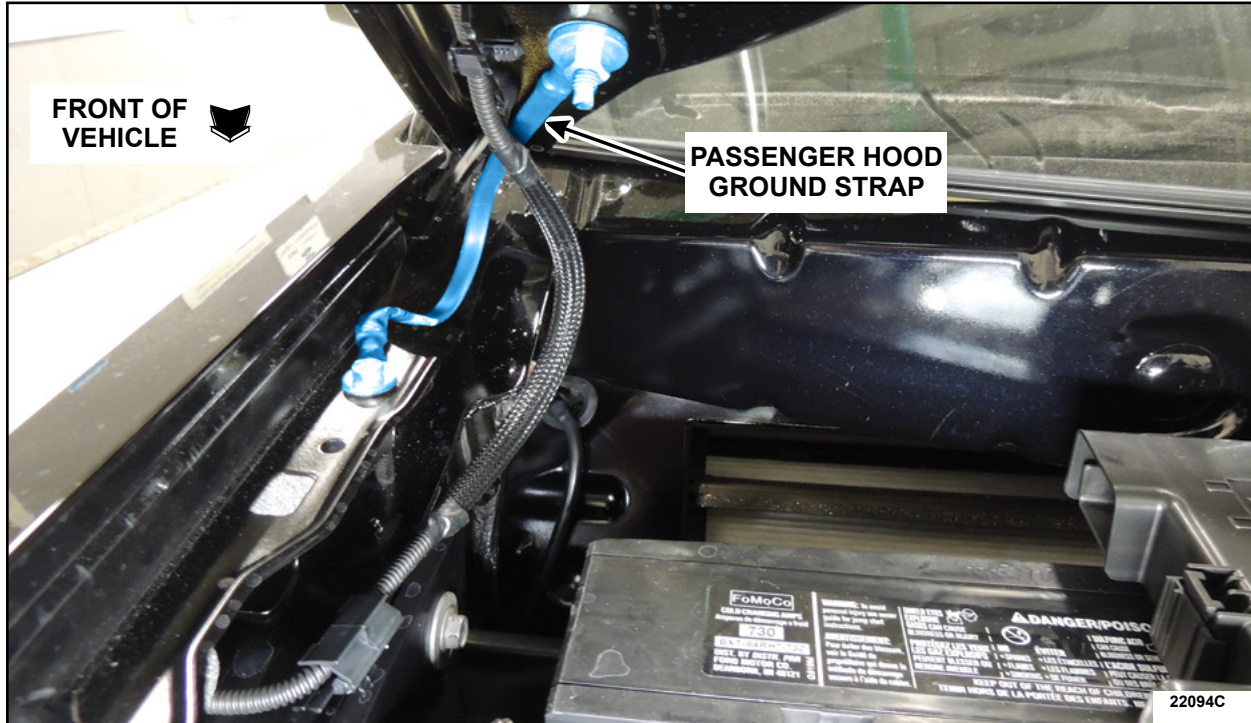
**FIGURE 3**

9. Inspect for a ground strap located at the passenger side hood. See Figure 3. Was a ground strap found on the passenger side of the vehicle under the hood?

**YES** - Proceed to Step 11.  
**NO** - Proceed to Step 10.

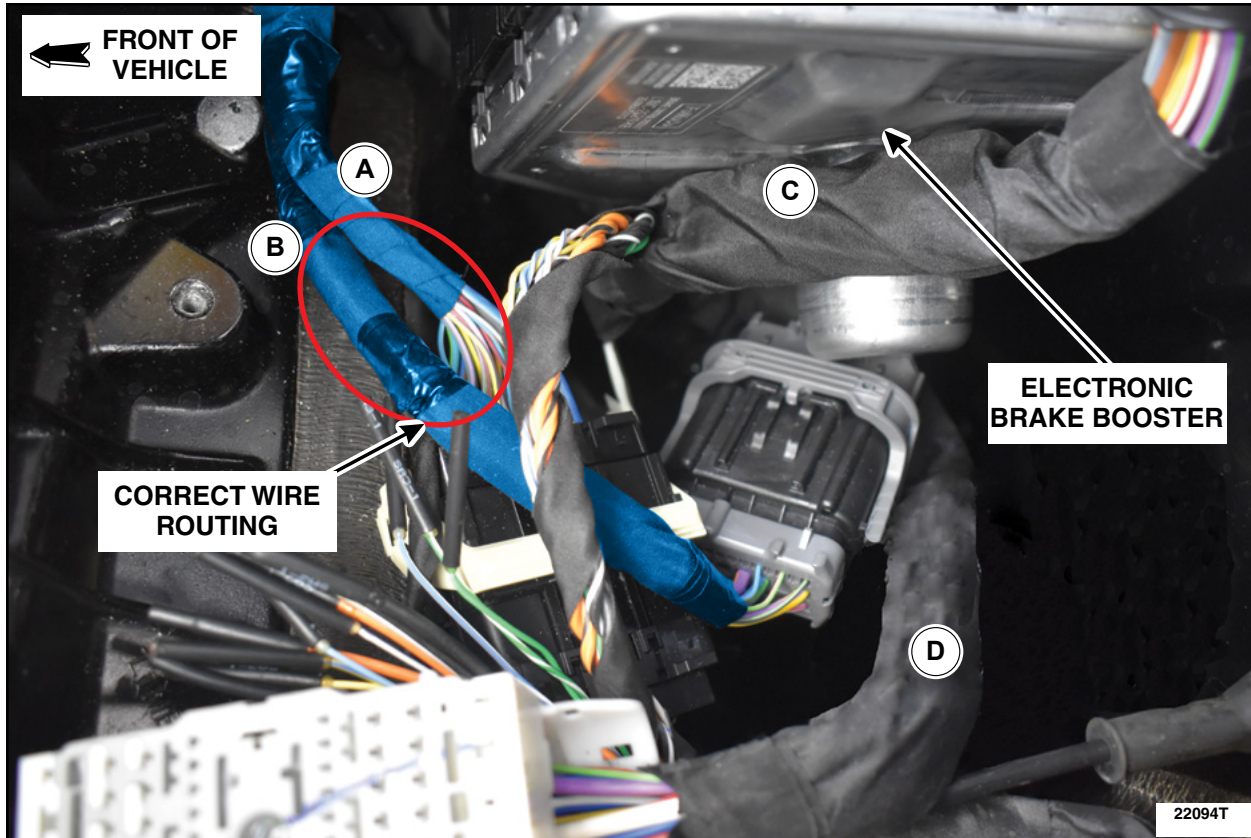
FIGURE 12

- Wires A and B need to be routed in front of wire bundles C and D.

18. Make sure the wire routing is as shown below in Figure 12 and adjust as necessary.

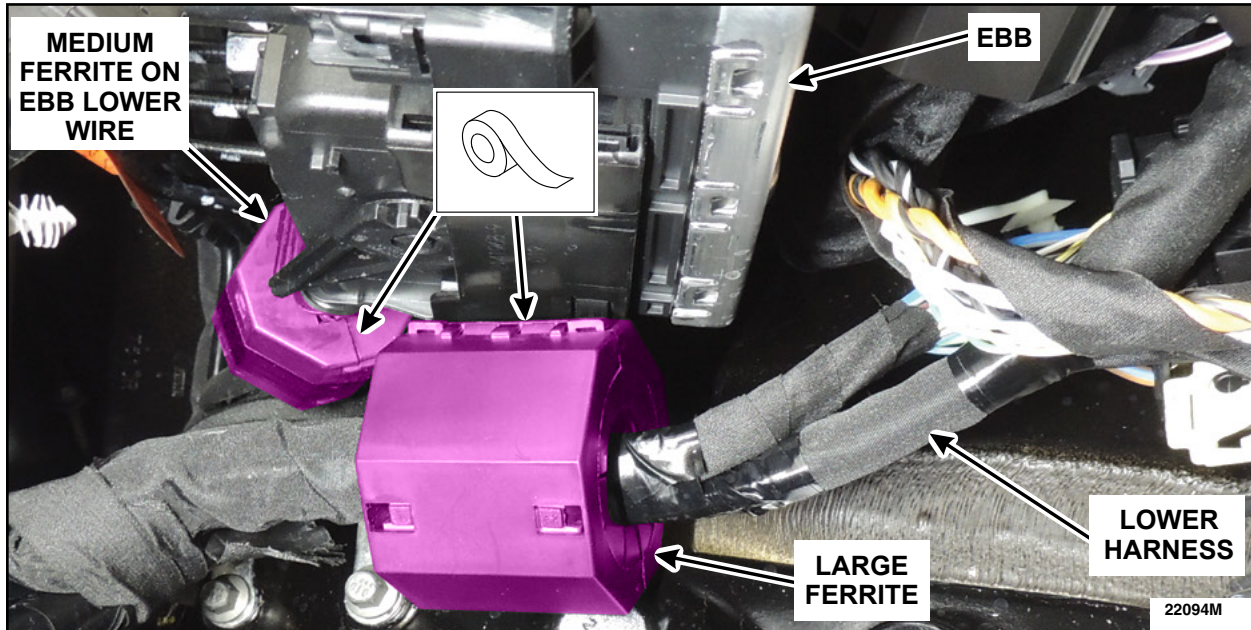
FIGURE 14

**NOTE:** If a ferrite is already present, confirm it is the correct size, position, and is properly secured.

20. Install a **MEDIUM** ferrite (item B) onto the lower EBB wire and a **LARGE** ferrite (item A) to the lower wiring harness. See Figure 14. Apply 3 wraps of Coroplast® tape around the ferrites to secure it closed.
