Technical product information

Topic	Bentayga V8 Kovomo - DTC P304300 with symptom code (10061) - Fuel Pump Mechanical Malfunction - MIL lamp
Market area	Australia E04 Bentley rest Asia and Australia (6E04),China 796 VW Import Comp. Ltd (Vico), Beijing (6796),Germany E02 Bentley rest Europe (6E02),Japan E03 Bentley Japan (6E03),Korea, (South) E08 Bentley South Korea (6E08),United Arab Emirates E06 Bentley Middle East and Africa (6E06),United Kingdom E01 Bentley UK (6E01),United States E05 Bentley USA and rest America (6E05)
Brand	Bentley
Transaction No.	2062092/3
Level	EH
Status	Approval
Release date

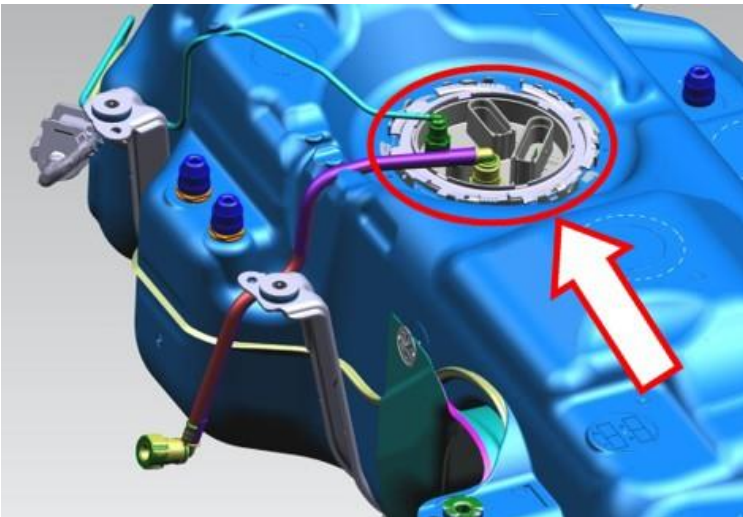
Figure 1

4) Conduct a visual inspection of the fuel pump delivery module (Top) for any obvious signs of damage (Figure 1)

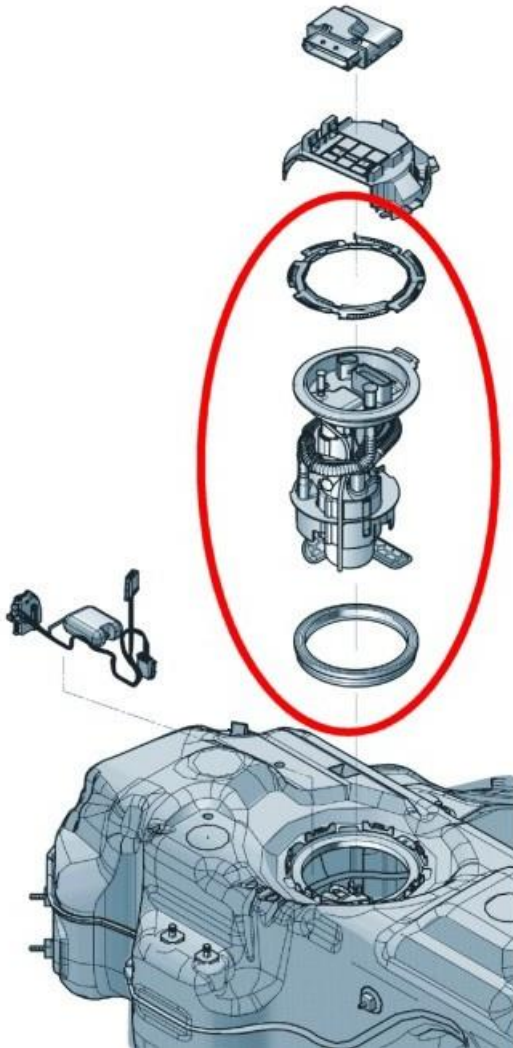
Figure 2

DTC P304300 – with symptom code (10061) - Fuel Pump Mechanical Malfunction evident

5) Should all the advised checks detailed in steps 1 to 4 be to specification – Replace the Fuel Delivery Module within the fuel tank (Figure 2) - Refer to Repair Group 20 Fuel supply, gas operation / 4.0L V8 TSI / Fuel pump, fuel level sensors, and jet pump (RH) – To remove and fit
