<b>Topic</b>	Bentayga W12 - DTC 310B00 - Low fuel pressure regulation
<b>Market area</b>	Australia E04 Bentley rest Asia and Australia (6E04),China 796 VW Import Comp. Ltd (Vico), Beijing (6796),Germany E02 Bentley rest Europe (6E02),Japan E03 Bentley Japan (6E03),Korea, (South) E08 Bentley South Korea (6E08),United Arab Emirates E06 Bentley Middle East and Africa (6E06),United Kingdom E01 Bentley UK (6E01),United States E05 Bentley USA and rest America (6E05)
<b>Brand</b>	Bentley
<b>Transaction No.</b>	2055321/4
<b>Level</b>	EH
<b>Status</b>	Approval
<b>Release date</b>

## Bentayga W12

These issues can trigger DTC 310B00: Low Fuel Pressure regulation, Fuel pressure outside specification

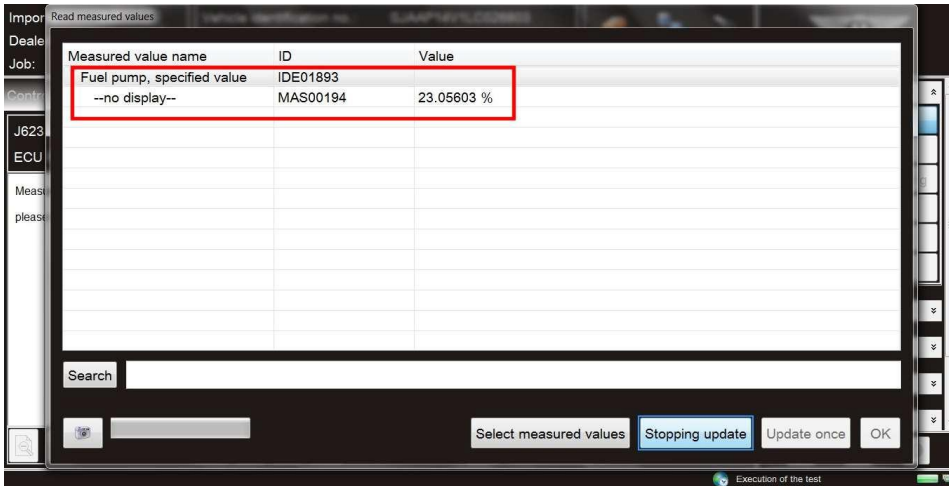
- Ensure the engine is idling at operating temperature - Ensure a suitable battery charger is also connected as per Rep.Gr 27
- Select Engine control module 1
- Select Guided functions – Read measured values
- Referring to Figure 1 - Navigate to Measured value IDE01893
- Select Starting update and monitor the Value – The value should be below 25%

**NOTE:** If the fuel pumps run faster at idle (above 25%) this is a sign of either a significant leakage or that the wrong fuel pump control modules are fitted - Carry out an inspection of the vehicles repair history, should the fuel pump control modules have been previously replaced you must ensure the correct specification were fitted, however if there is no replacement history of the control modules continue to step 2 – Fuel low pressure check

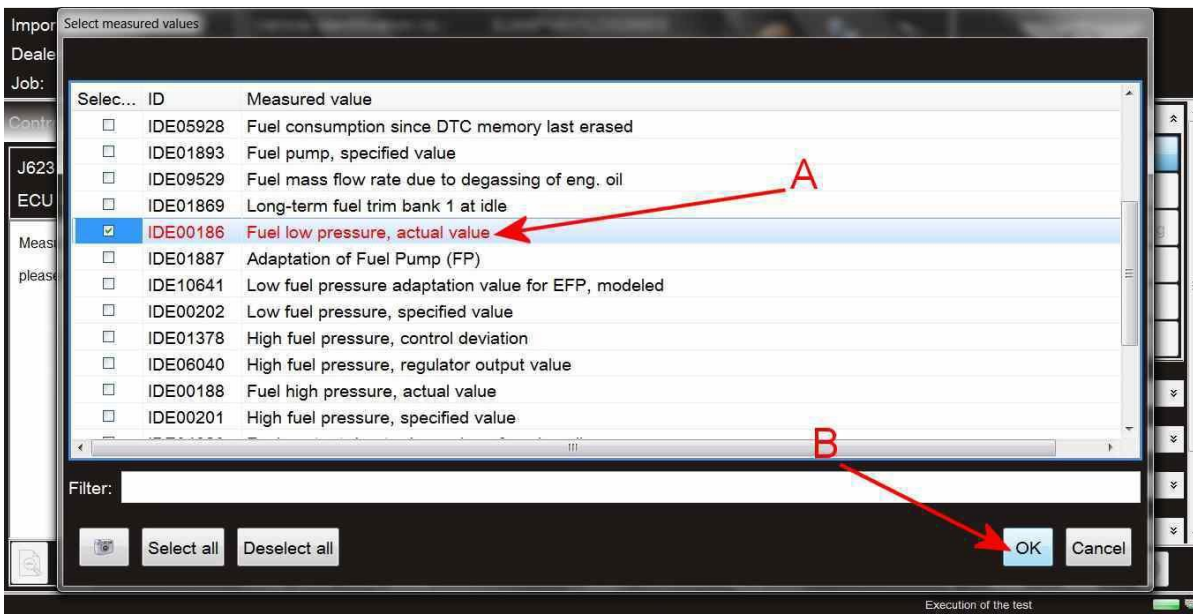
2) Fuel low pressure check - Referring to Figure 2 (Point A) navigate to Measured value IDE00186 Fuel low pressure, actual value

- Select OK (Point B)

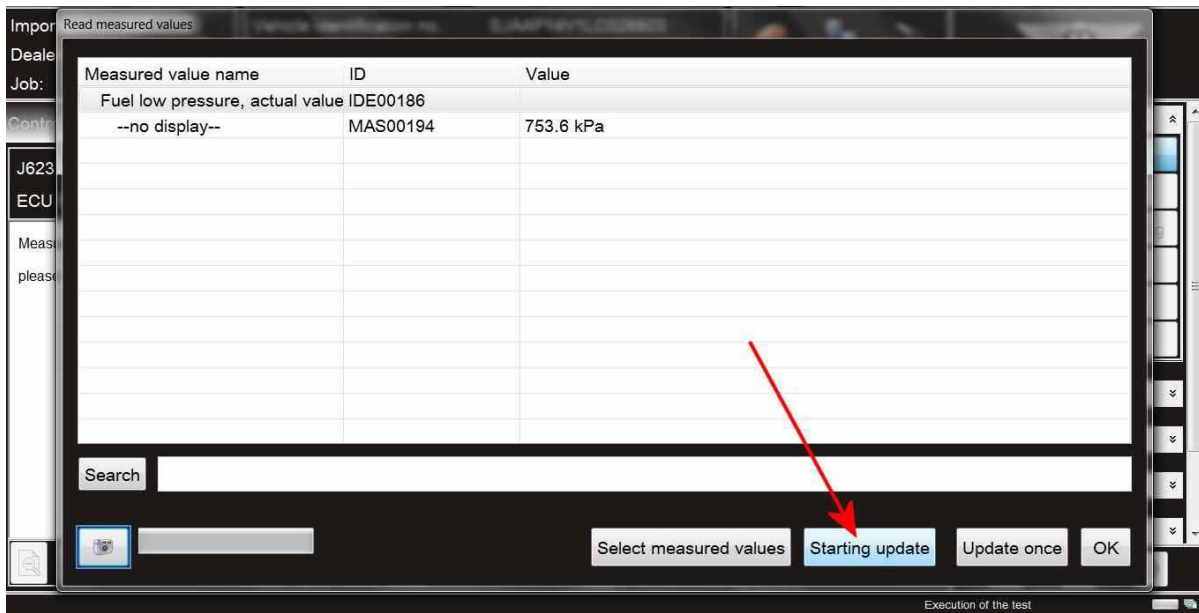
- Referring to Figure 3 – Select Starting update
- Switch off the engine and leave the ignition on
- Monitor the pressure decay of the low pressure fuel system for 10 minutes

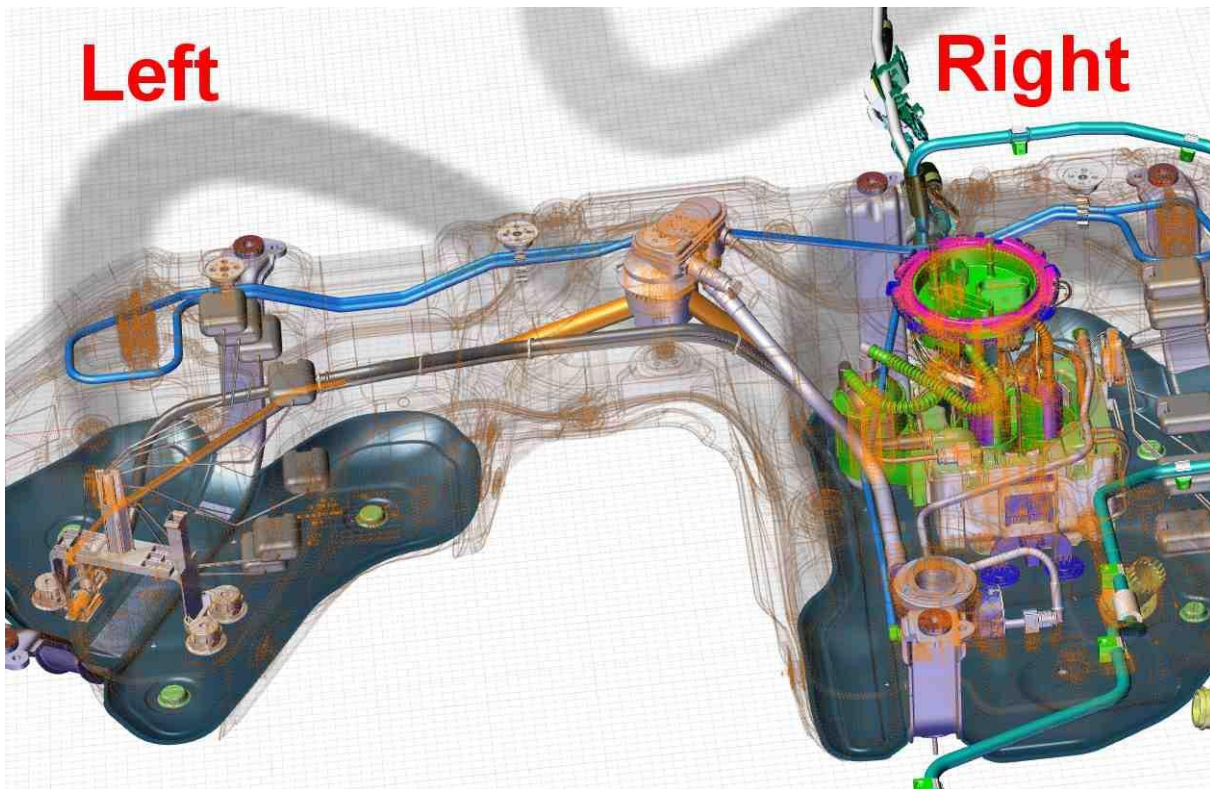
3) Should the pressure drop below 300 kPa after 10 minutes - Referring to Figure 4 - Gain access to the fuel pump assembly and fuel filter within the right hand side of the fuel tank - Rep.Gr 20

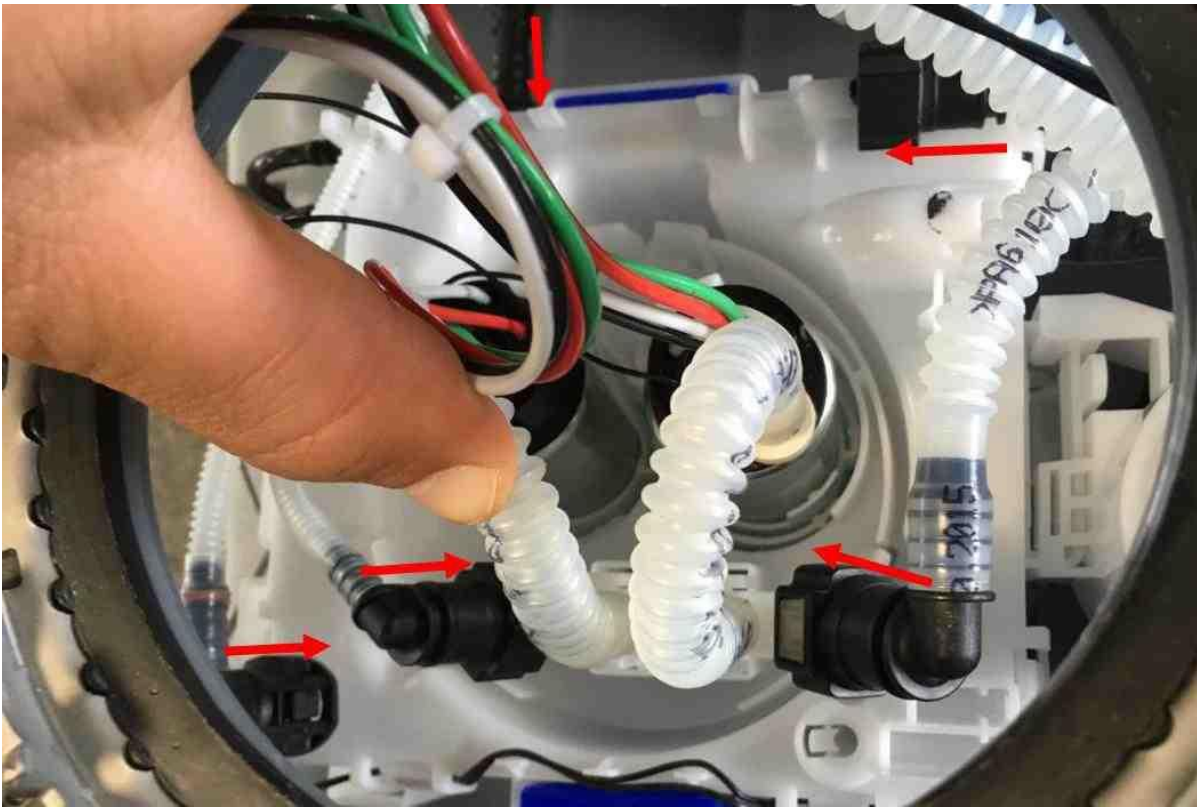
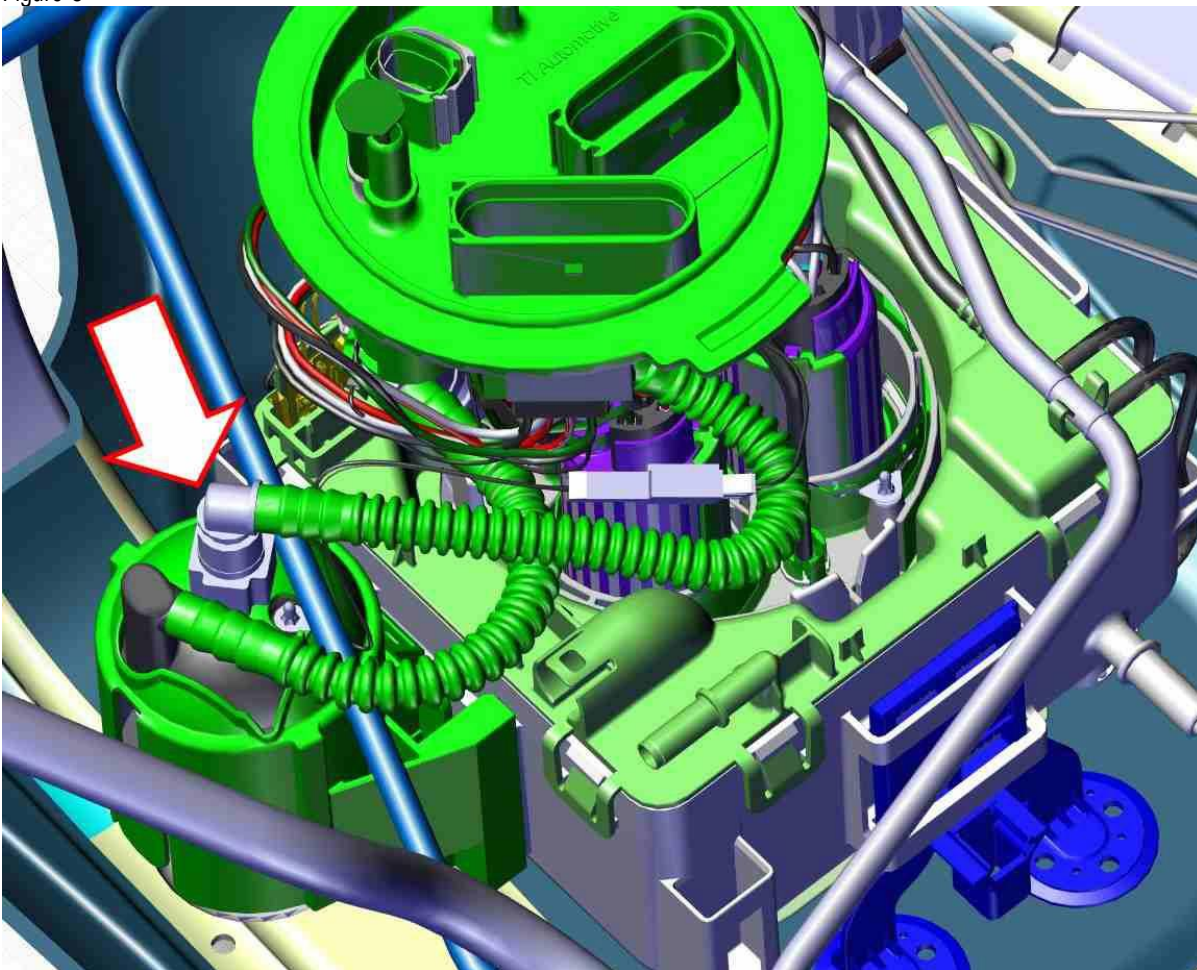
- Carry out an inspection of ALL accessible hoses and connections which connect to the fuel pump assembly/fuel filter assembly as shown in Figures 5 and 6
- Check for punctured/split hoses
- Check for broken and loose connections

- Should any issues be found with the fuel pump assembly or fuel filter replace the fuel pump assembly and fuel filter as per the applicable Rep.Gr

- Should any issues be found with the fuel pump assembly or fuel filter after the checks from Steps 1 through to 4 have been conducted - The operative **MUST** raise a DISS query and await feedback before conducting any further work

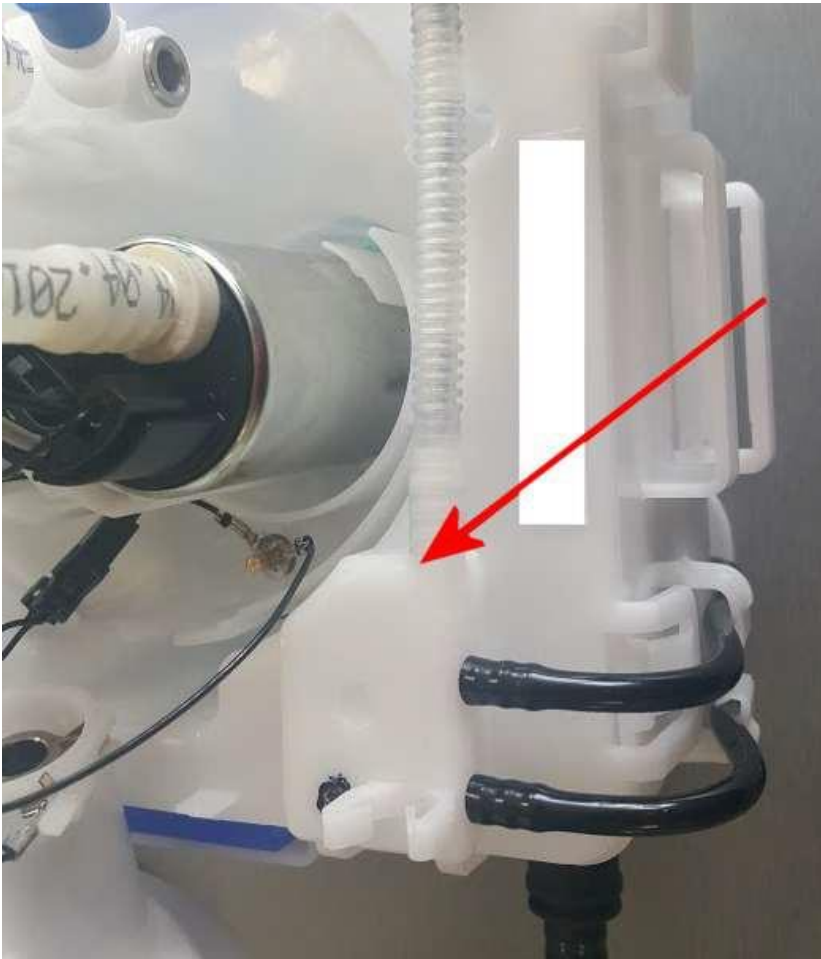
4) Referring to Figure 7 (For photographic purposes Figure 7, was taken with the fuel pump assembly removed from the fuel tank) Check the connection shown is not broken **NOTE:** Care should be taken when checking this part as damage can be caused when manipulating the fuel pump assembly

**IMPORTANT:** Only the components on the right hand side of the fuel tank are interchangeable, if there is a fault with any components on the left hand side or with any components which are not listed within the ETKA parts catalogue a new fuel tank is required
