# Technical product information

| Topic | Fuel tank internal fuel pump replacement - W12 TSI |
| Brand | Bentley |

*This TPI is applicable for W12 Bentayga TSI engine variants only*

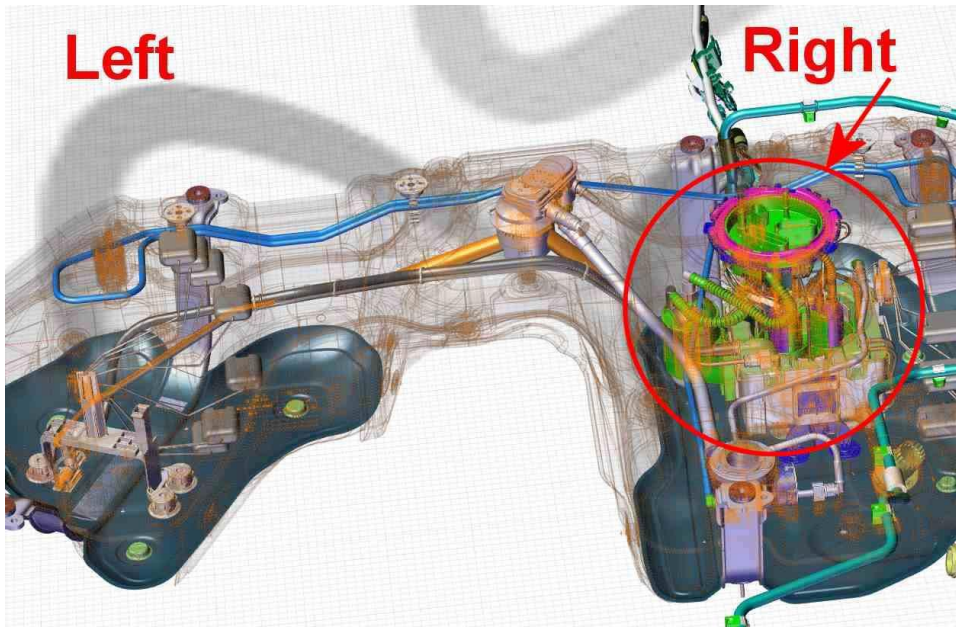
Figure 1

The twin fuel pumps which are part of the fuel delivery module (located on the right hand side of the fuel tank as Figure 1) have changed to an improved Diamond Like Coated (DLC) fuel pump

In the event the incorrect configuration of the fuel delivery module and control units are fitted the retailer/customer can experience a low fuel pressure too low DTC

low fuel pressure too high DTC depending on the incorrect configuration.

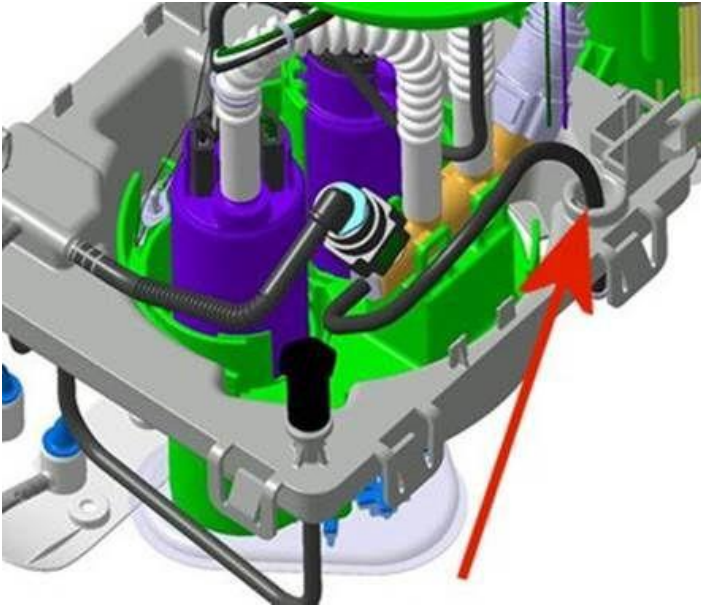
Figure 2

### Fuel delivery module with bypass tube (Figure 2)

36A 919 087F - Fuel pump assembly without auxiliary heater

36A 919 087G – Fuel pump assembly with auxiliary heater

Should the vehicle require a fuel delivery module the DLC type pump assembly will be supplied 36A 919 087H or 36A 919 087J. Both fuel pump control units 4M0 906 093K should also be replaced to ensure correct configuration/compatibility

Should a fuel pump control unit require replacing the DLC fuel pump will also require replacement as control units with the part number 4M0 906 093K will only be available, In this scenario (due to potential mismatch) both control units should be replaced
