GLOBAL SAFETY FIELD INVESTIGATIONS
DCS6618
URGENT - DISTRIBUTE IMMEDIATELY

Subject: REVISION: N222375790-05 - Customer Satisfaction Program
Park Assist Retrofit
Population Update

Models: 2022 – 2023 Cadillac CT4
2022 – 2023 Cadillac CT5
2022 Cadillac Escalade/Escalade ESV
2022 – 2023 Chevrolet Corvette
2022 Chevrolet Silverado 1500 New
2022 Chevrolet Suburban
2022 Chevrolet Tahoe
2022 GMC Sierra 1500 New
2022 GMC Yukon/Yukon XL

N222375790 Park Assist Retrofit

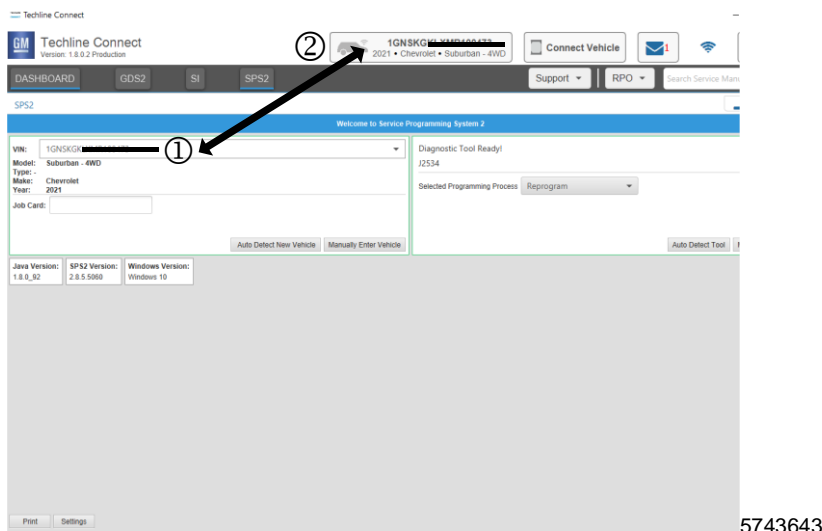
Caution: Be sure the VIN selected in the drop down menu (1) is the same as the vehicle connected (2) before beginning programming.

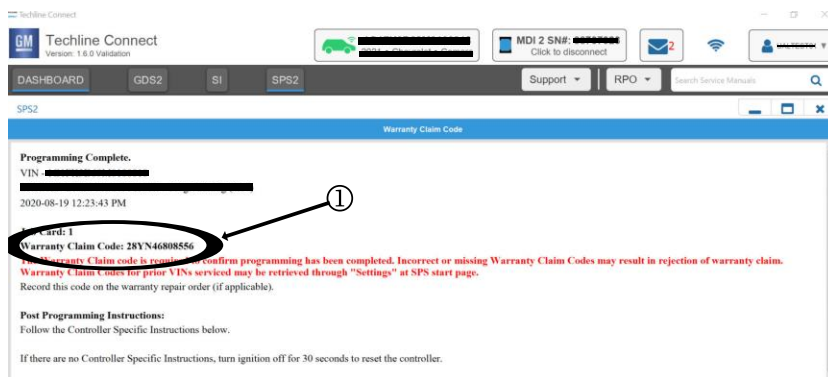
5644478

Note: The screenshot above is an example of module programming and may not be indicative of the specific module that is being programmed. Module selection and VIN information have been blacked out.

Important: To avoid warranty transaction rejections, you MUST record the warranty claim code provided on the Warranty Claim Code (WCC) screen shown above on the job card. Refer to callout 1 above for the location of the WCC on the screen.

5. Record SPS Warranty Claim Code on job card for warranty transaction submission.
6. Clear all DTCs.
Note: Depending upon vehicle RPO, it may be equipped with both front and rear parking assist or just rear park assist.
7. Verify proper operation of the parking assist system.

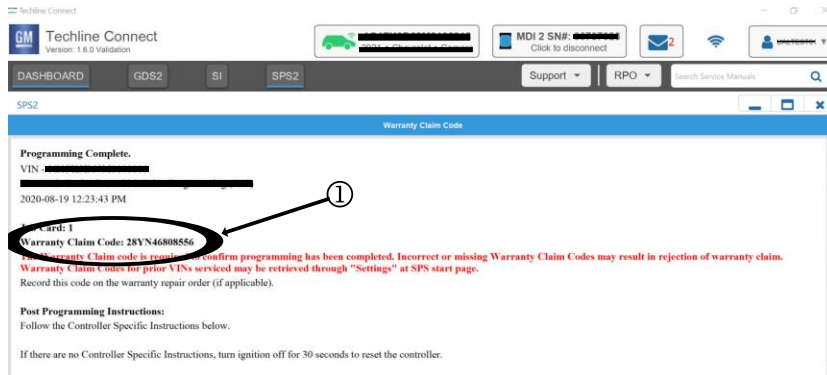
5644478

Note: The screenshot above is an example of module programming and may not be indicative of the specific module that is being programmed. Module selection and VIN information have been blacked out.

Important: To avoid warranty transaction rejections, you MUST record the warranty claim code provided on the Warranty Claim Code (WCC) screen shown above on the job card. Refer to callout 1 above for the location of the WCC on the screen.

6. Record SPS Warranty Claim Code on job card for warranty transaction submission.
7. Clear All DTCs
8. Verify proper operation of the parking assist system.
