Service Bulletin

Bulletin No.: 17-NA-357

Subject: Noise or Malfunction of Trim Door on Broken Quarter Upper Trim Panel, Possible Convertible Top Inoperative

Brand:	Model:	Model Year:		VIN:		Engine:	Transmission:
		from	to	from	to		
Chevrolet	Camaro Convertible	2016	2023	—	—	All	All

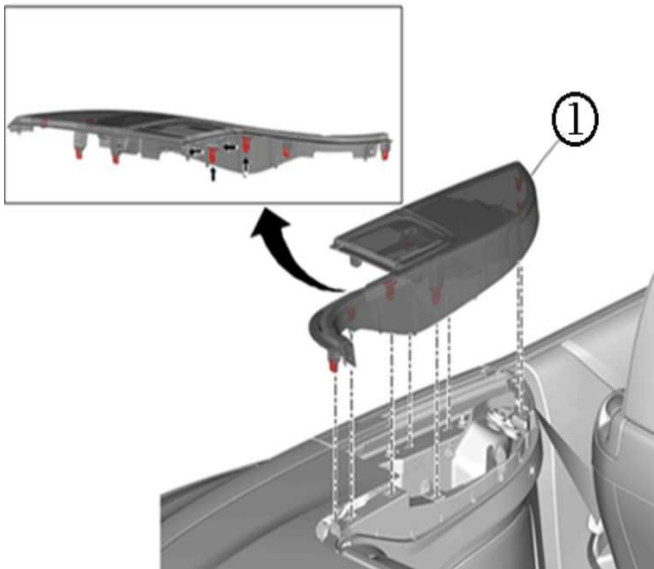
4889569

Involved Region or Country	North America, Europe, Russia, Middle East, Israel, Argentina, Brazil, Bolivia, Chile, Colombia, Ecuador, Paraguay, Peru, Uruguay, Japan, China, Taiwan, Philippines
Condition	Some customers may comment on a noise or malfunction of the trim door on a quarter upper trim panel. Upon inspection, the technician may find the quarter upper trim panel broken. Continued use, or an increased interference, may eventually render the convertible top inoperative.
Cause	The cause of the condition may be various reasons the quarter upper trim panel may break or fail.
Correction	<div style="text-align: center;"> </div> <p style="text-align: right; font-size: small;">4889567</p> <p>Note: As shown circled in the graphic above, the quarter upper trim panel design has been improved to include a 3rd retaining clip.</p> <p>Verify the condition, replace the affected quarter upper trim and possibly the quarter window regulator on that same side. Follow the vehicle build date breakpoint information noted in the Service Procedure below.</p>

- For vehicles built February 14, 2017 and after, replace the quarter upper trim panel (1). Refer to *Quarter Upper Trim Panel Replacement* in SI.

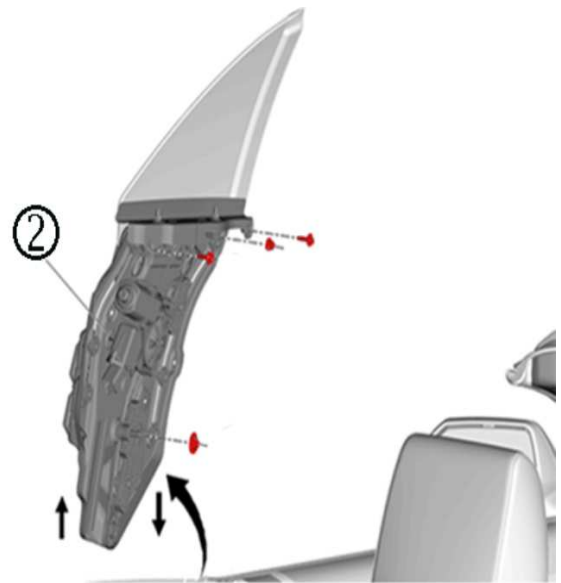
4889575

Note: For vehicles built prior to February 14, 2017, it will also be necessary to replace the window regulator in addition to the quarter upper trim panel to accommodate the added 3rd clip design.

- For vehicles built prior to February 14, 2017, replace the quarter upper trim panel AND the quarter window regulator (2). Refer to *Quarter Window Regulator Replacement* in SI.
