Service Bulletin

Bulletin No.: 22-NA-100

**Subject: Check Engine, Traction Control, Antilock Brake System Lamps Illuminated on DIC—
DTC C0582 Set**

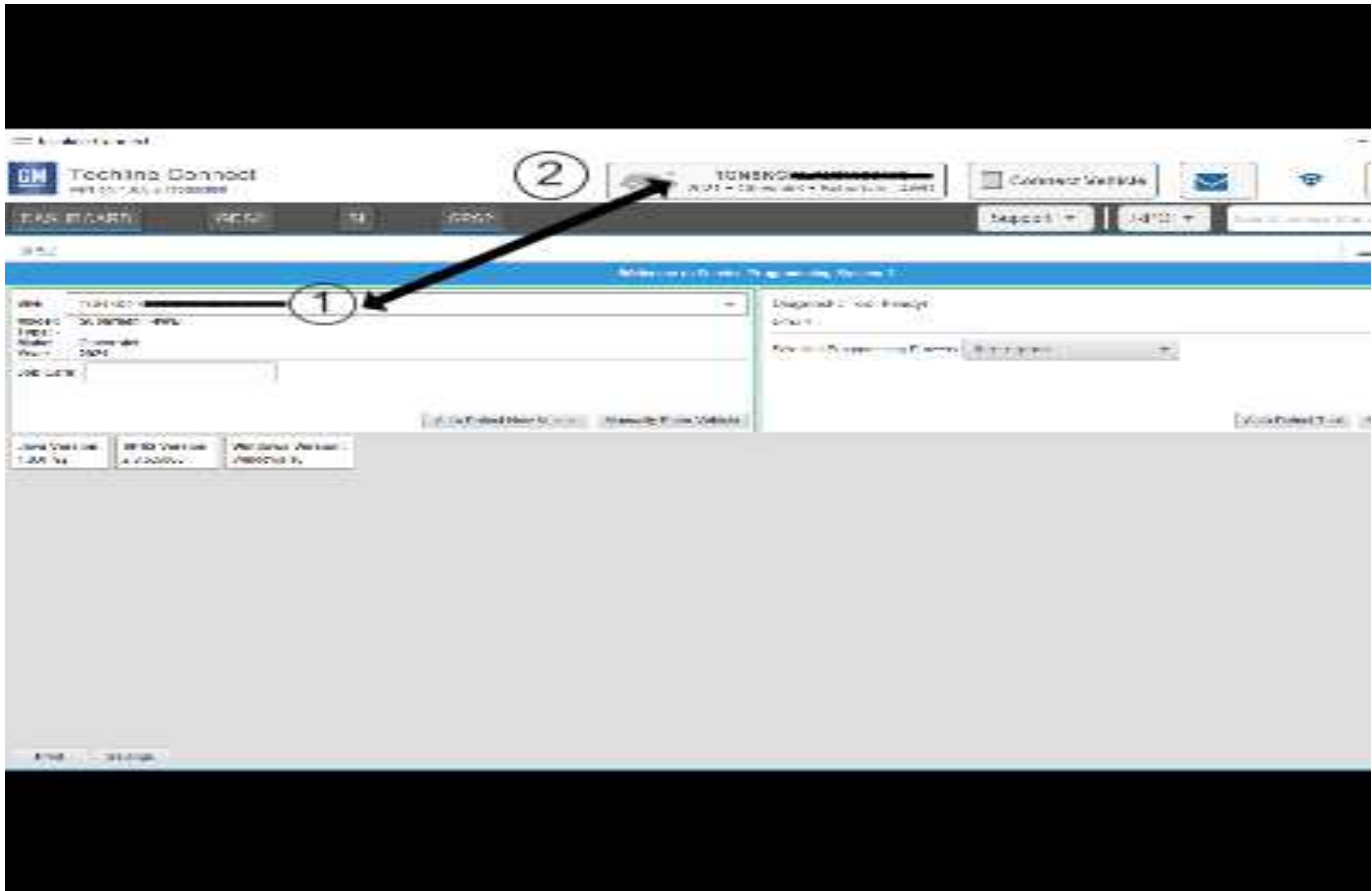
Caution: Be sure the VIN selected in the drop down menu (1) is the same as the vehicle connected (2) before beginning programming.

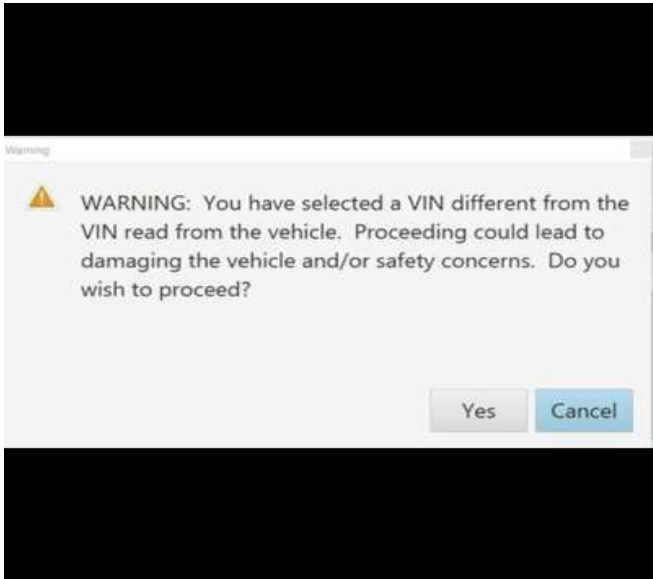
5877000

Important: If the vehicle VIN DOES NOT match, the message below will be shown
