Service Bulletin

Bulletin No.: 22-NA-137

Subject: Transmission Fluid Leak from Center of Vehicle

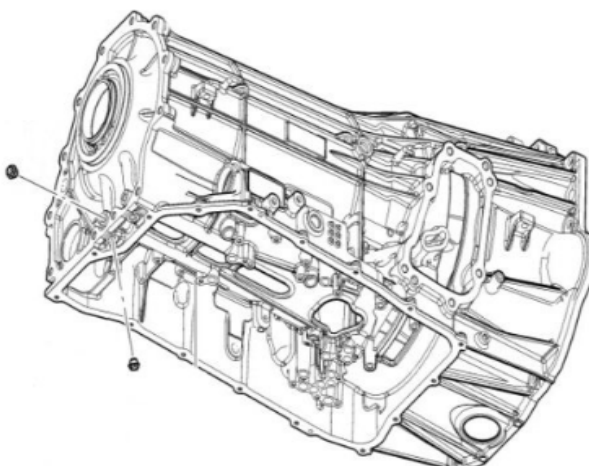
</div> <p style="text-align: right; font-size: small;">6105955</p> <p>Inspect the rear of the transmission for a possible leak at the case plugs for evidence of transmission fluid. The fluid leak may be visible from two locations:</p>

Involved Region or Country	North America, Middle East, Argentina (Mercosur), Chile (West), Colombia (West), Ecuador (West), Paraguay (West), Uruguay (West), Thailand (ASEAN), Australia, New Zealand
Condition	Some customers may comment that transmission fluid is leaking from the center of vehicle.
Cause	This condition may be caused by one or more of the transmission rear case plugs leaking.
Correction	<div style="text-align: center;">

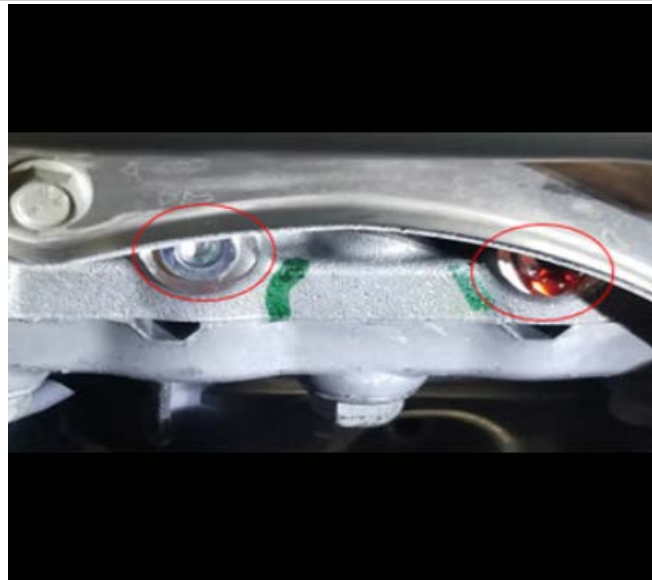
6106602

- The two transmission case plugs at the rear of the transmission oil pan rail.

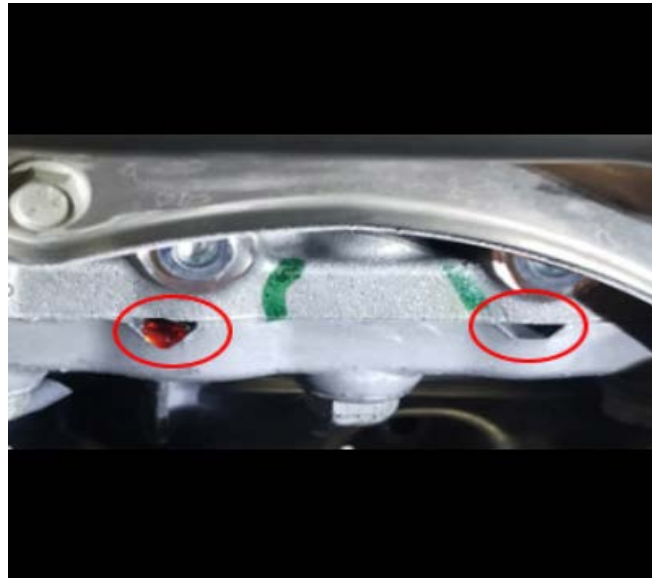
6106596

- The two transmission case plugs between the transmission and transfer case mating surfaces (4wd) or between the transmission case and extension housing (2wd), as the transmission rear case plugs are covered by the transfer case front case half or extension housing and may leak through weep holes.
- If a leak has been noticed from the case plug or the weep holes, replace only the case plugs that are leaking.
