Service Bulletin

Bulletin No.: 23-NA-101

Subject: Fuel Range Blank on Instrument Panel

Brand:	Model:	Model Year:		VIN:		Engine:	Transmission:
		from	to	from	to		
Chevrolet	Silverado 2500HD/3500HD	2022	2023				
GMC	Sierra 2500HD/3500HD	2022	2023

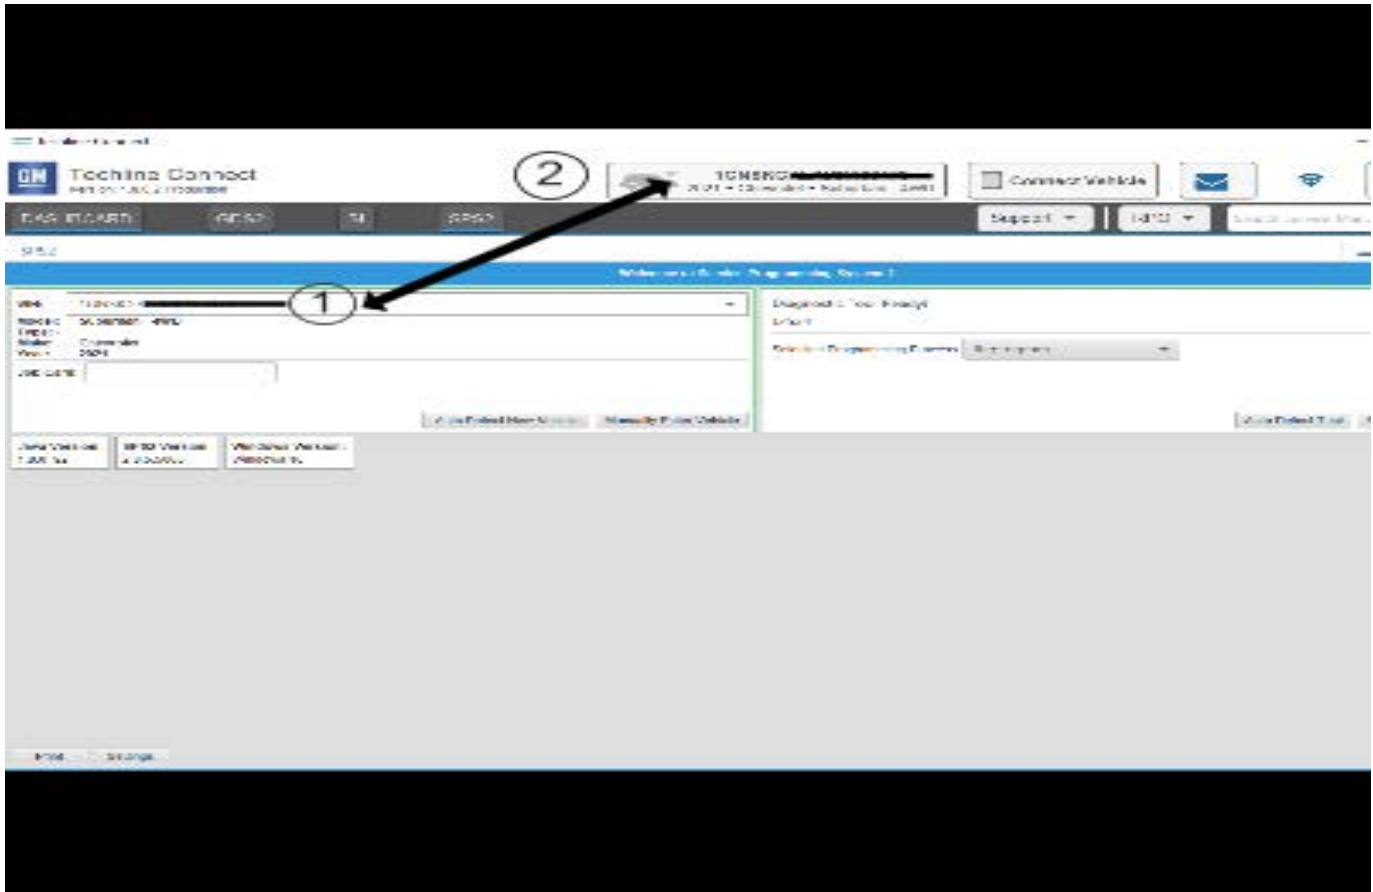
5877000

Caution: Be sure the VIN selected in the drop down menu (1) is the same as the vehicle connected (2) before beginning programming.
