REFERENCE:	Nova Bus Manuals
SECTION:	16: Electrical system
RS N°:	MQR 7621-2619
EFFECTIVE IN PROD.:	LF46 (2023JL)

SUBJECT:	Battery tray
JUSTIFICATION:	Battery tray may crack, new battery hold down required.

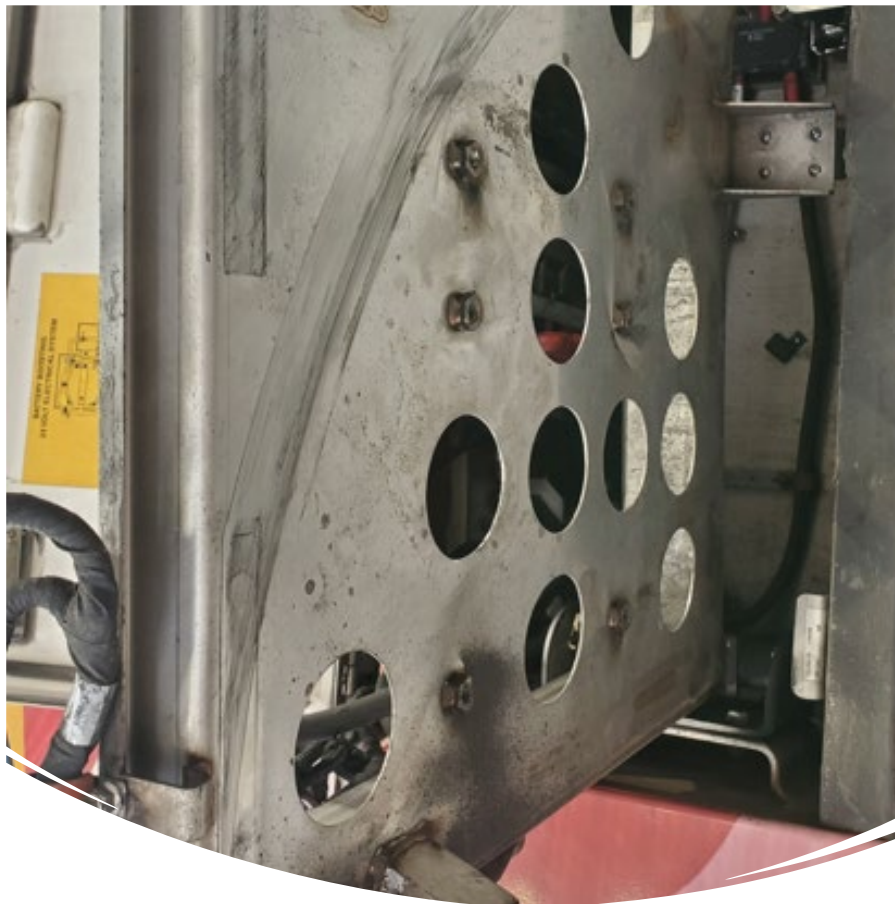
#1 Inspection

- Inspect bottom of battery tray for cracks
- If cracked, contact Nova rep
- If not cracked, continue procedure

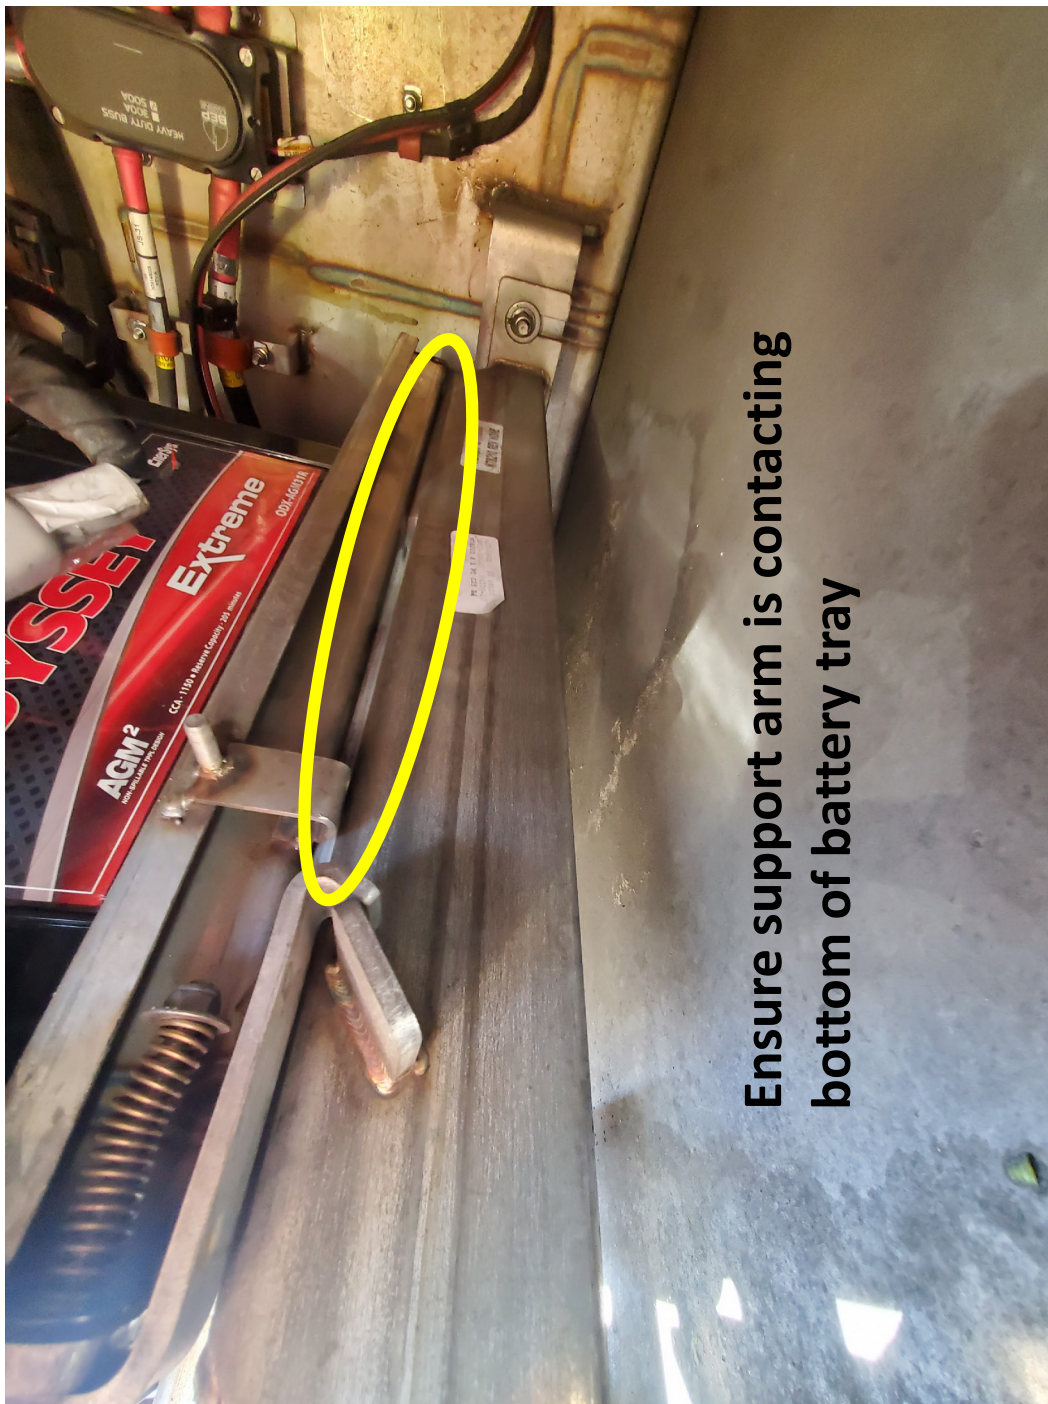
#3 Inspect Support Arm

**Ensure support arm is contacting
bottom of battery tray**

- Ensure support arm is contacting bottom of battery tray
- Adjust, if necessary
- Torque bolts to 33Nm
- Add torque seal to nuts
