TECHNICAL SERVICE BULLETIN

Whistle Noise At Lower Left Windshield Area - Built On Or Before 31-May-2023

23-2213

Ford 2021-2023 Bronco	Built on or before 31-May-2023
---------------------------------	--------------------------------

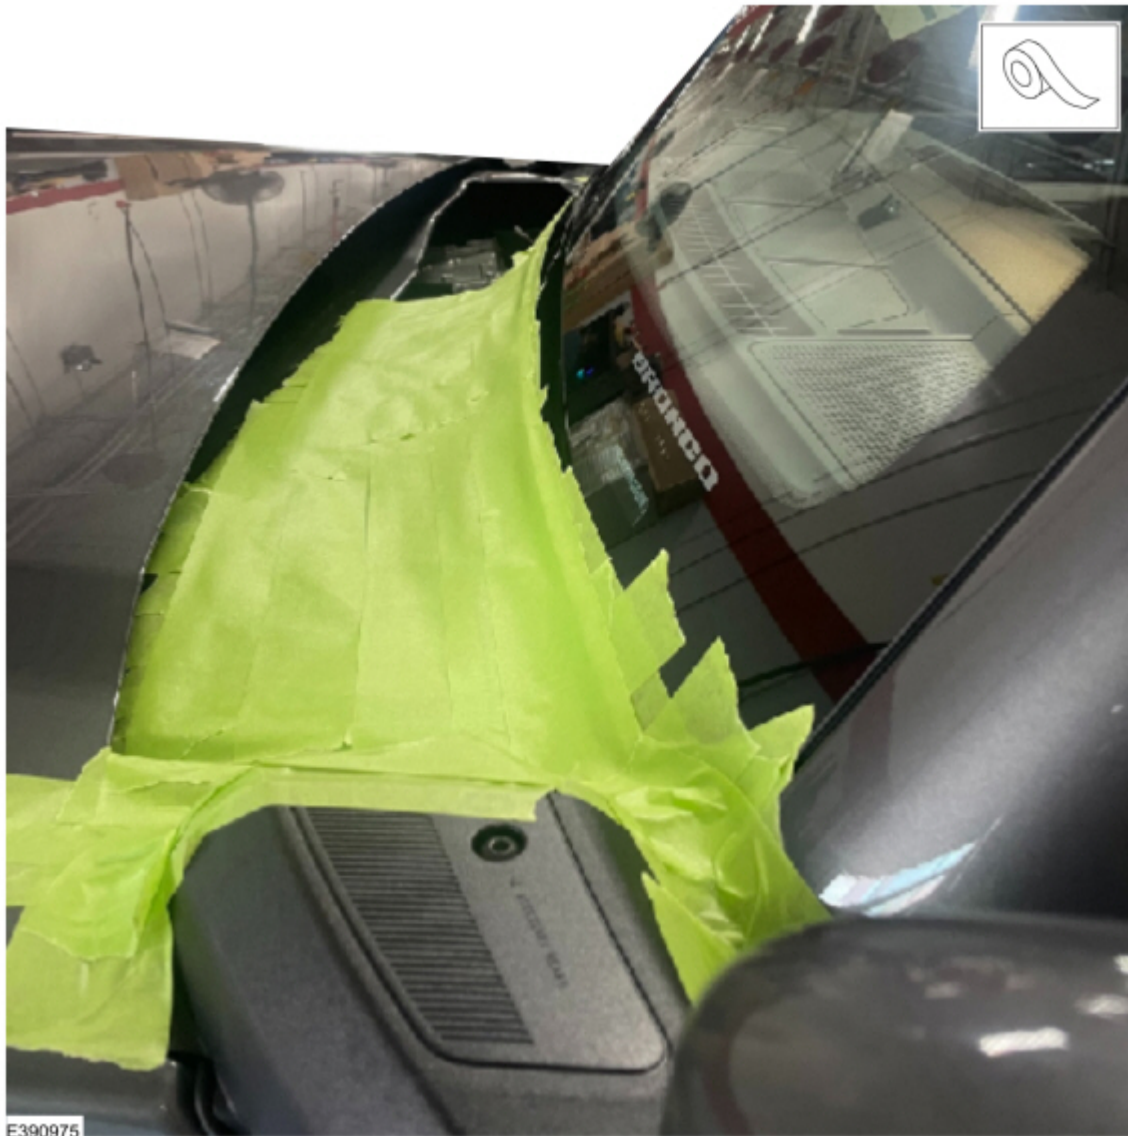
Figure 1

1. Tape off the left side of the cowl panel and drive the vehicle above 50 mph (80 km/h). Did taping off the cowl resolve the whistle noise? (Figure 1)

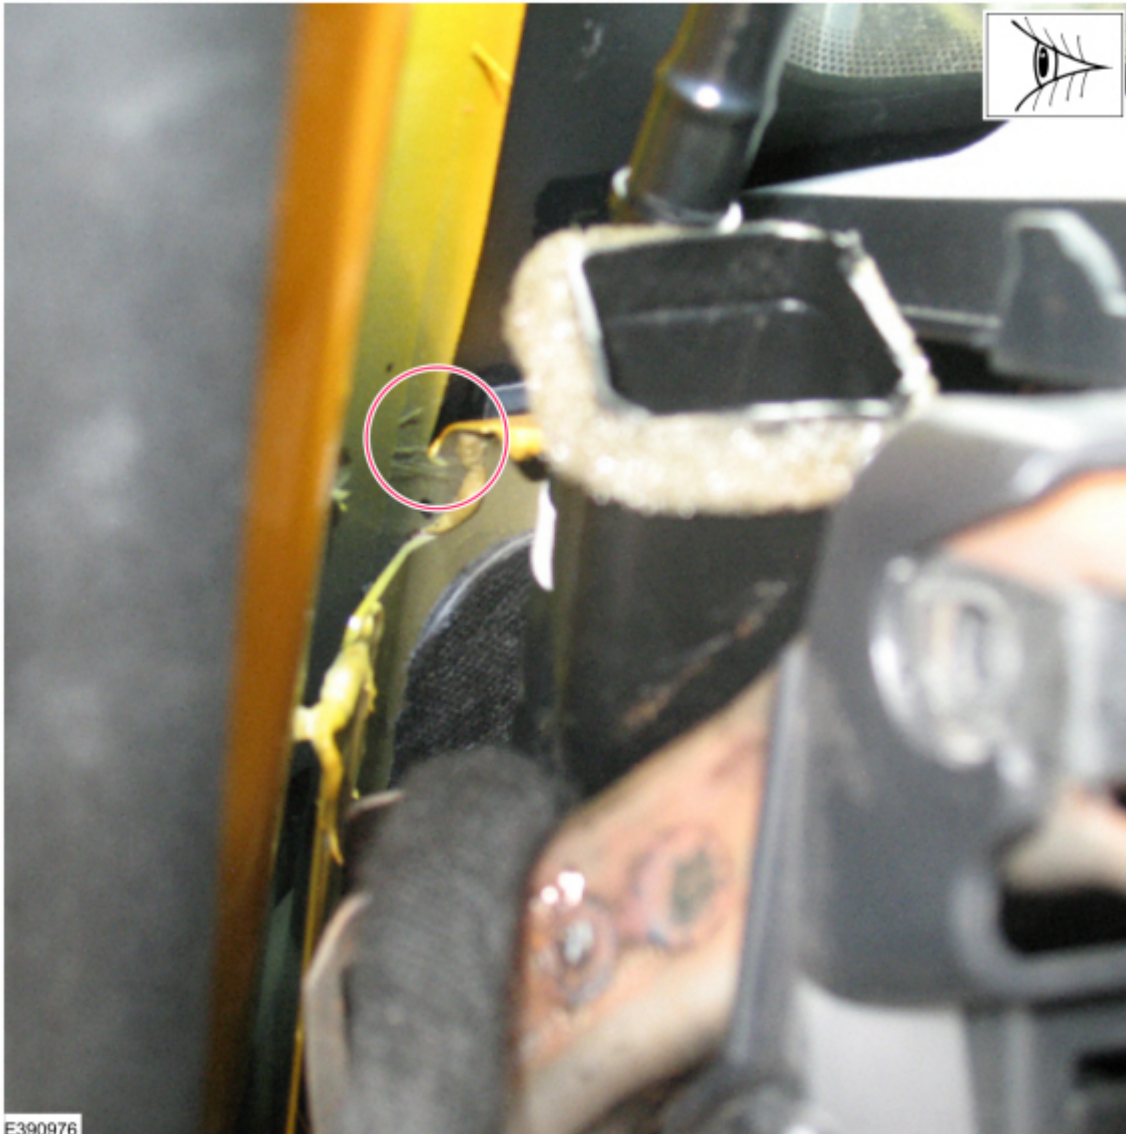
Figure 2

Issue: Some 2021-2023 Bronco vehicles built on or before 31-May-2023 may exhibit a whistle noise below the lower left windshield area at the bottom of the A-pillar. This may be due to a missed body sealer application at the factory. To correct this condition, follow the Service Procedure to reseal the affected body seam.

- (1). Yes - proceed to Step 2.
 - (2). No - this article does not apply. Refer to Workshop Manual (WSM), Section 100-04.
2. Remove the left A-pillar trim. Refer to WSM, Section 501-05.
 3. Visually inspect for a gap in the sheet metal at the bottom of the A-pillar where it joins the rear engine compartment wall. Is a gap present? (Figure 2)

- (1). Yes - proceed to Step 4.
 - (2). No - this article does not apply.
- 4.** Apply a liberal amount of butyl to fill the gap between the two metal panels and eliminate the air entry.
 - 5.** To assemble, reverse the removal procedure.
