Service Bulletin

Bulletin No.: 23-NA-042

Subject: Radio Software Version V164 Update

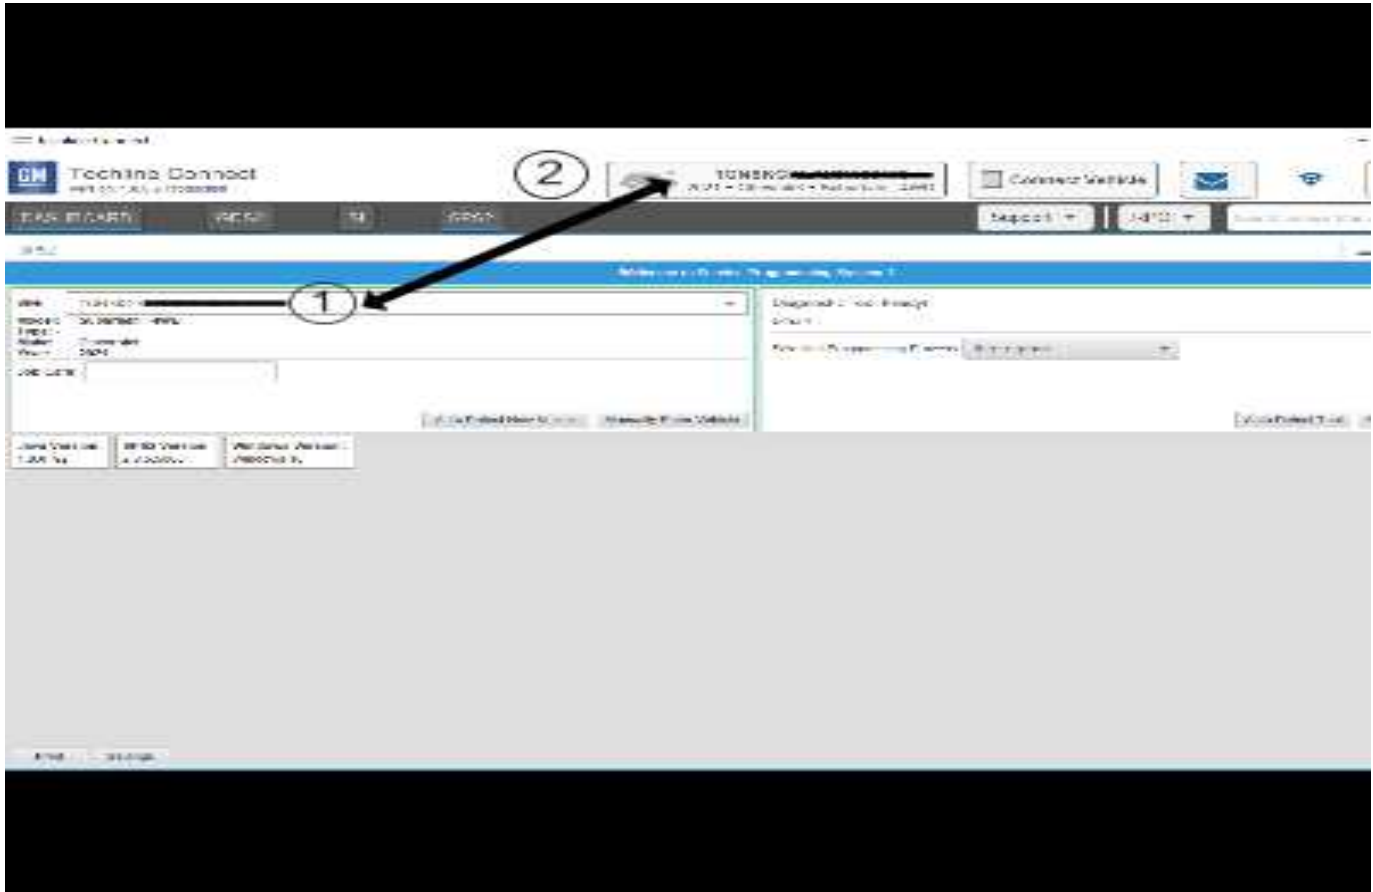
Caution: Be sure the VIN selected in the drop down menu (1) is the same as the vehicle connected (2) before beginning programming.

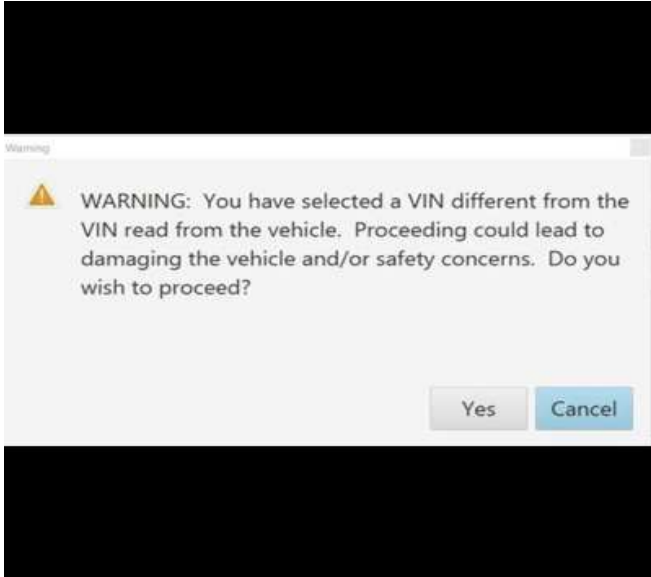
5877000

Important: If the vehicle VIN DOES NOT match, the message below will be shown.
