Service Bulletin

Bulletin No.: 23-NA-102

Subject: Drivability Concerns, Hesitation, Transmission Shifting Rough/Harsh, Malfunction Indicator Lamp (MIL) Illuminated - Multiple DTCs Set

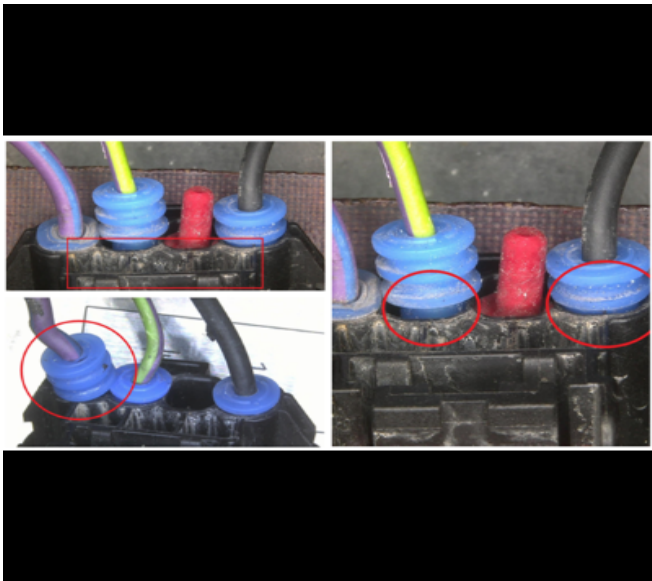
6219342

U02A9 might be set with or without U1345 (LIN BUS1 Failure).

An unsealed pump connector allowing water leakage into the (M10) charge air cooler pump electrical connector might be the root cause of the communication failure.

- Check the CAC Pump connector sealing and look for any corrosion at the pump due to water leakage.

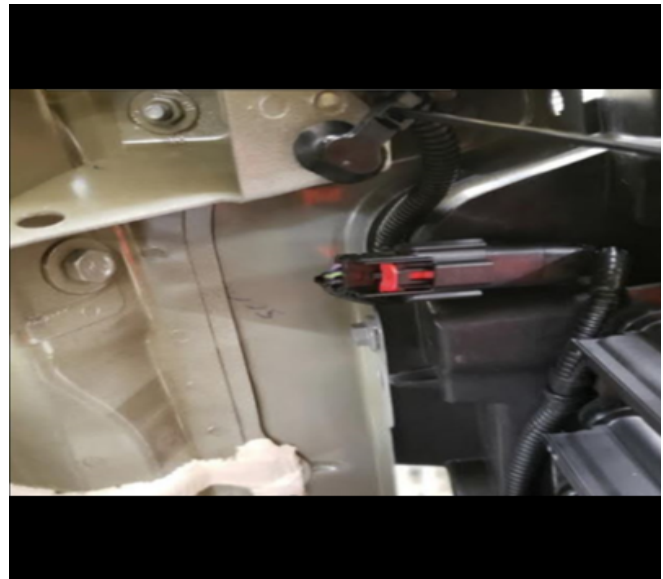
6219339

DTC U1345, U0284 and U0285 may be caused by the engine wiring harness to active grille air shutter actuator inline connector (X618 on the pickup and X604A On the SUV). Please check circuit 4621 which may be:

- Not properly connected
- Not properly hold by the rear clip
- Grounded on the radiator

The graphic above shows how the proper connection must be.

- Check the active grille air shutter actuator in-line connector for not being properly connected or grounded to the radiator.

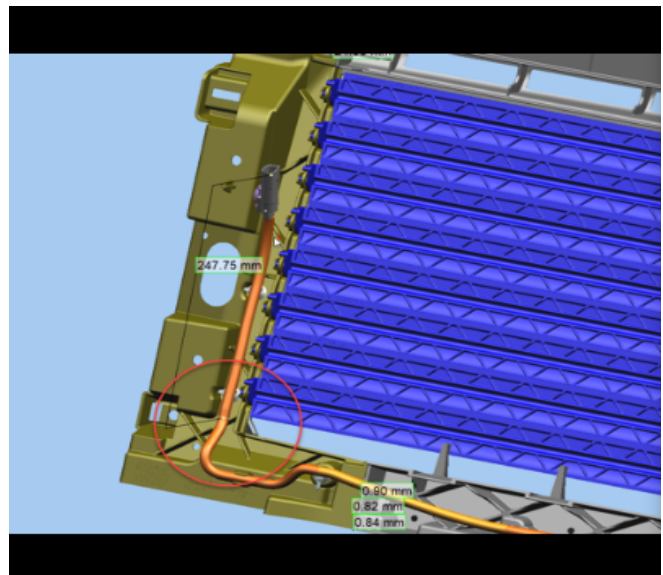
6219340

DTCs may be caused by the active grill air shutter wiring pinched at the radiator support.

The graphic above depicts where a pinching condition may be located.

- Check the active grill air shutter wiring route to identify possible damaged points in the wiring.

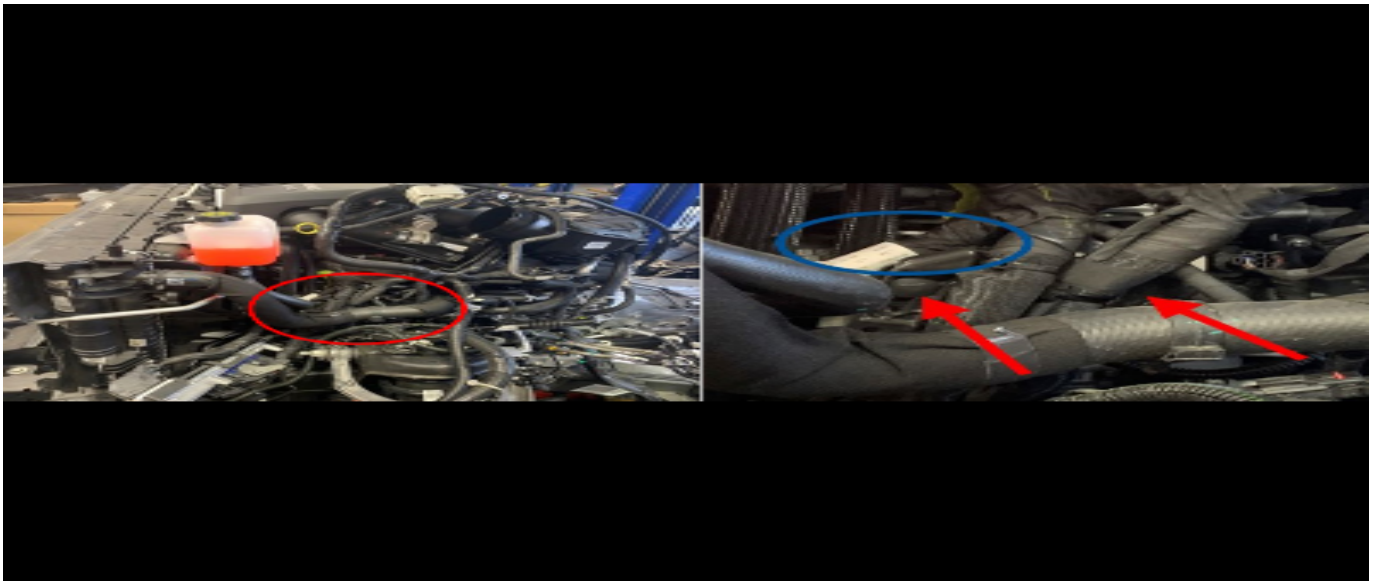
6357536

LM2/LZ0 – Area of Contact at Alternator Bracket.

- Arrows indicate location of retainer pins that were not properly installed.
- •Blue circle indicates where a chafe in the wiring has occurred. The mis installed bracket allowed the harness to lay on the alternator.

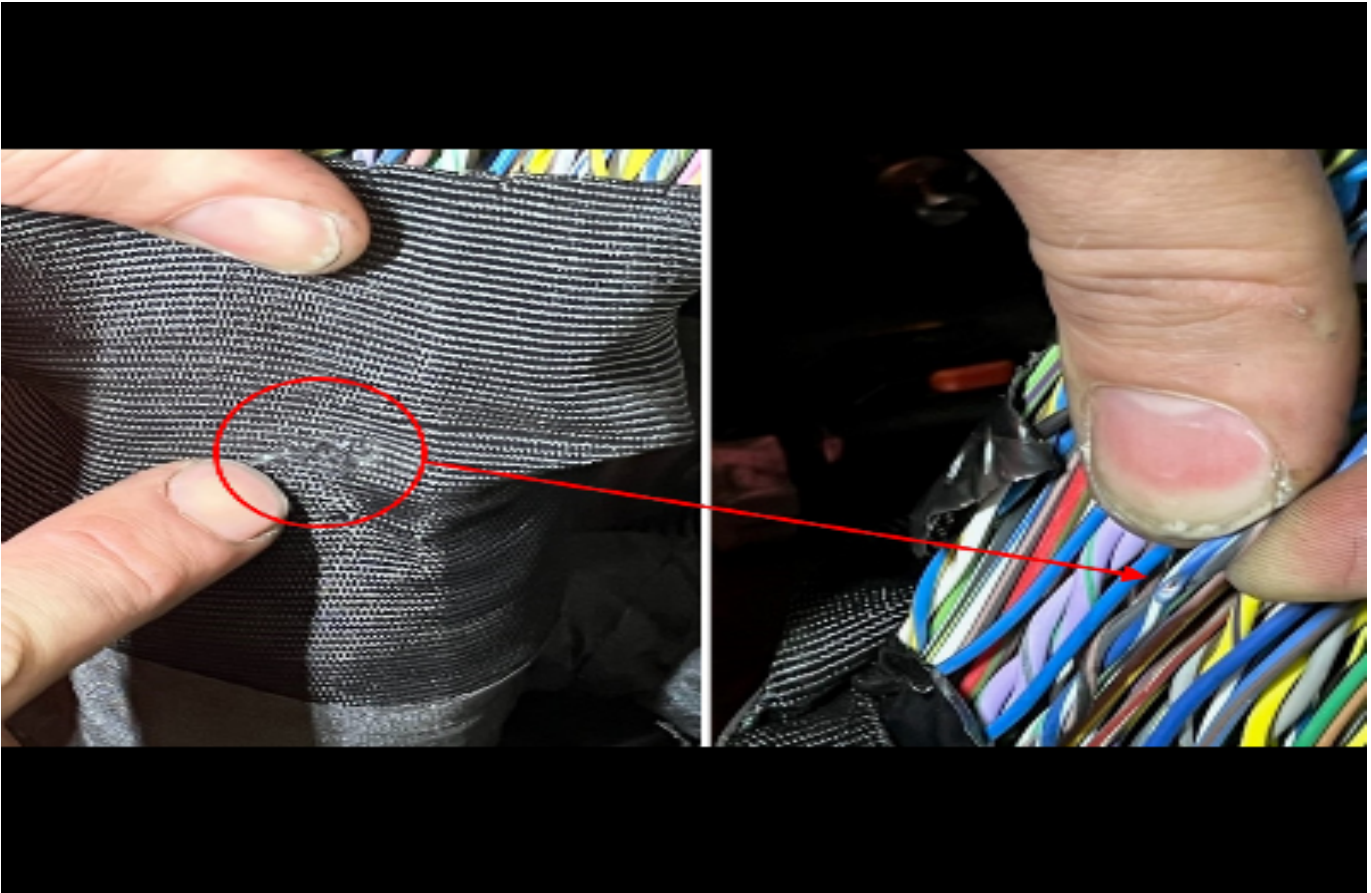
6357529

LM2 – Wiring Harness Contact at Alternator Bracket.

- The engine wire harness was chafed by a bracket next to the back of the alternator.

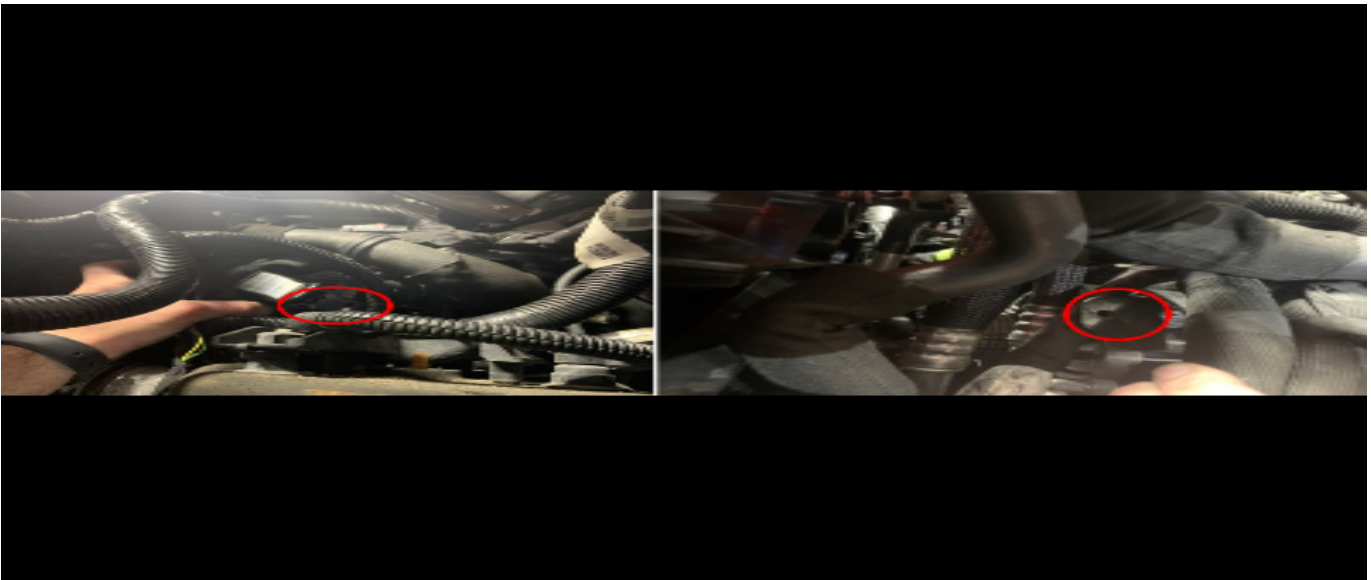
6357546

U0073 CAN BUS 2 off or U0074 CAN BUS 3 off

LM2 – TCCM Wiring Harness Contact at A/C Line and Bracket near Alternator.

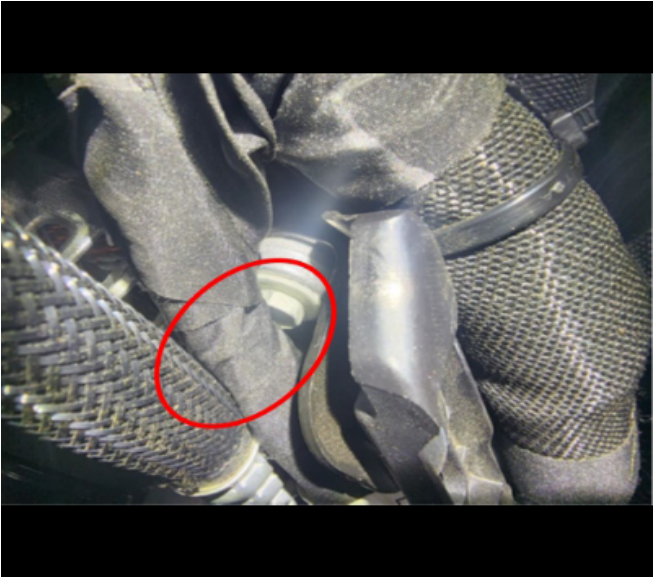
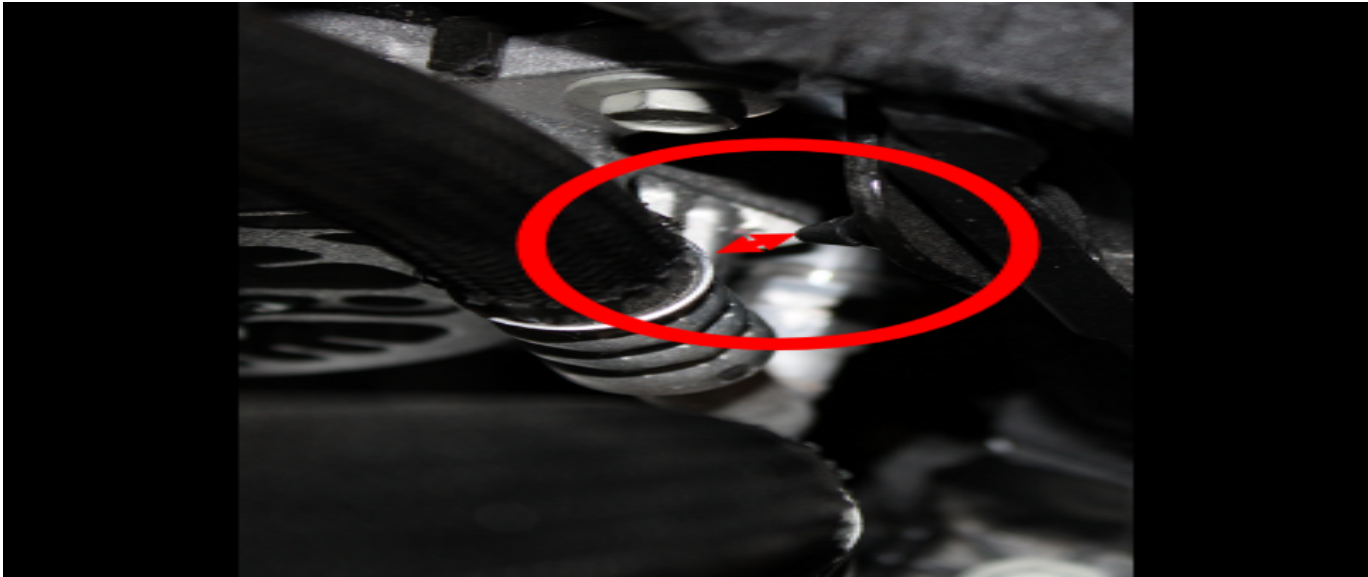
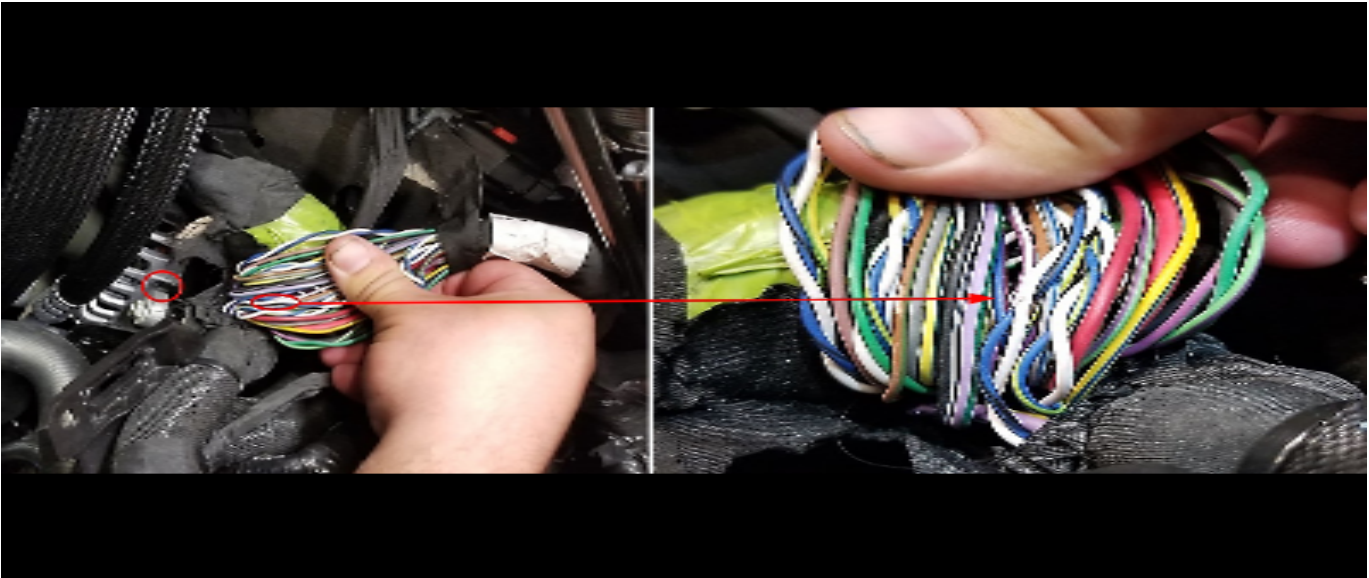
6357562

U0073 CAN BUS 2 off or U0074 CAN BUS 3 off.

LZ0 – The Wiring Harness Contacted the Alternator Bracket do to Routing of the Harness.

Note: During the repair. It was noted that a 5/8 ths diameter hose was used to prevent a reoccurring chafe condition.

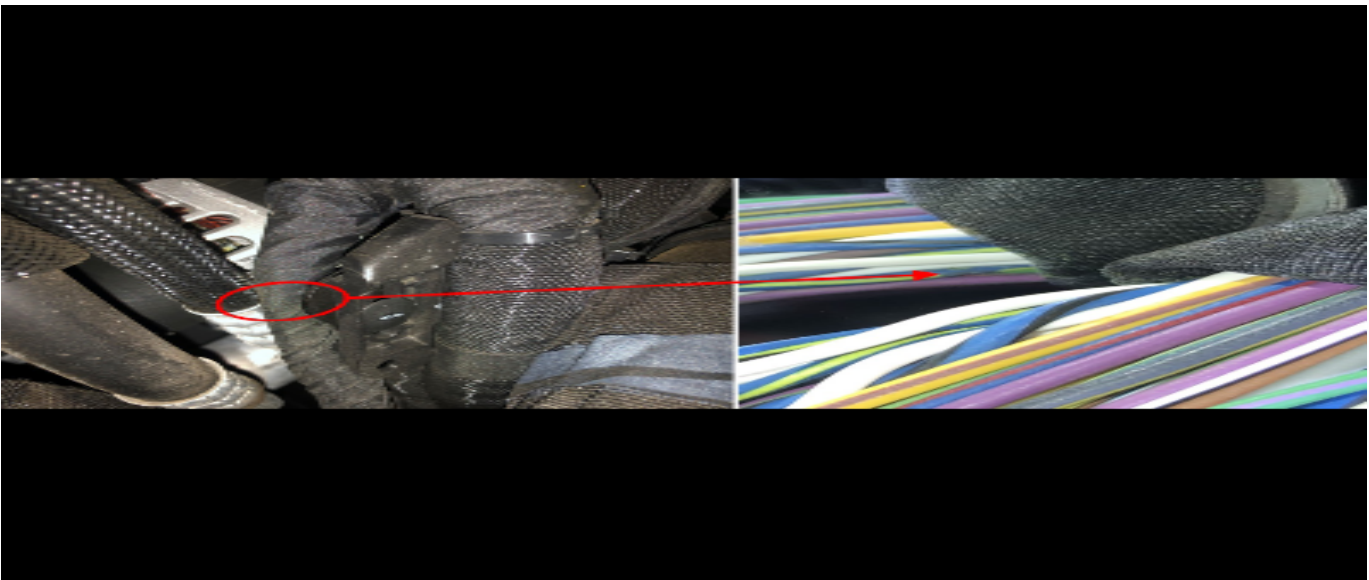
6357567

This is CAN 3 wire harness. Can 4 is also in this bundle only blue and yellow twisted with white.

LZ0 – Wiring Harness Contacting the A/C Line and Alternator Bracket.
