Bulletin No.: PIP5926

PIP5926 Transmission Fluid Leak Between the Transmission and Transfer Case

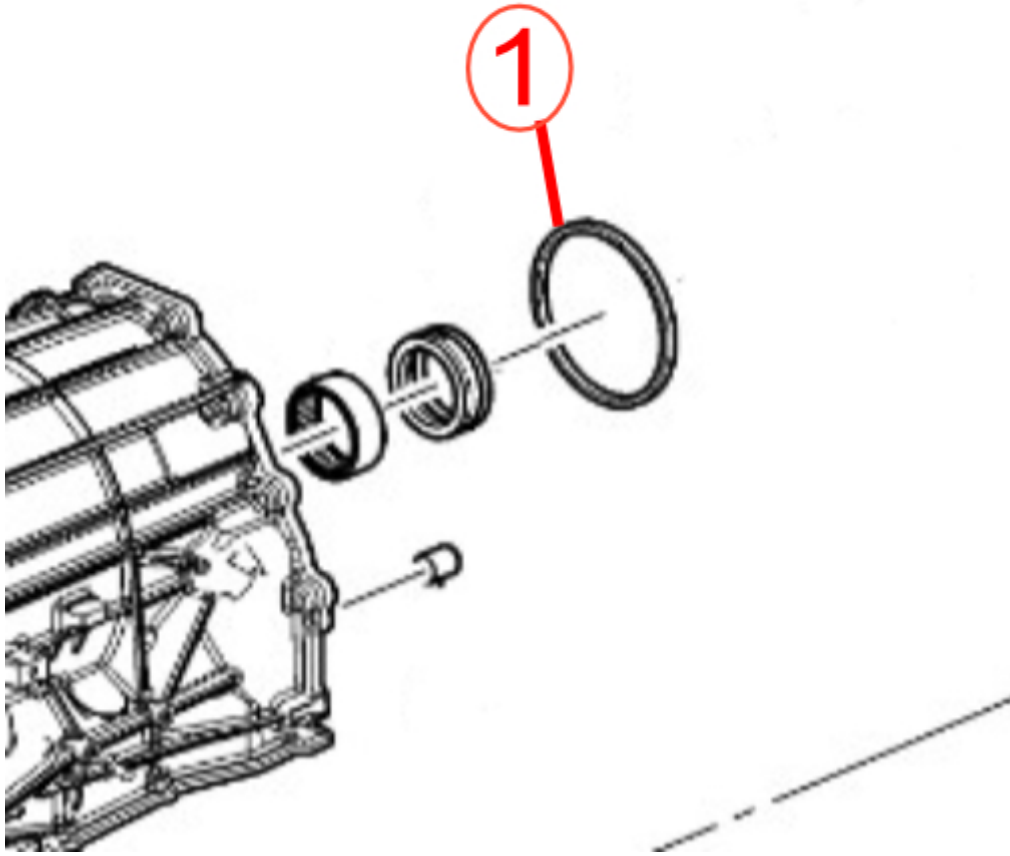
Involved Region or Country	North America, Middle East, Israel and Australia/New Zealand.
Additional RPO	NQF NQH
Condition	Some customers or technicians may comment of a transmission fluid leak between the transmission and transfer case.
Cause	The Transmission Case Extension Seal (call out 1 second pic below) is leaking or the Transfer Case Input Shaft Seal (call out 1 third pic below).

Replace the Transmission Case Extension Seal (call out 1 second pic below) and Transfer Case Input Shaft Seal (call out 1 third pic below).

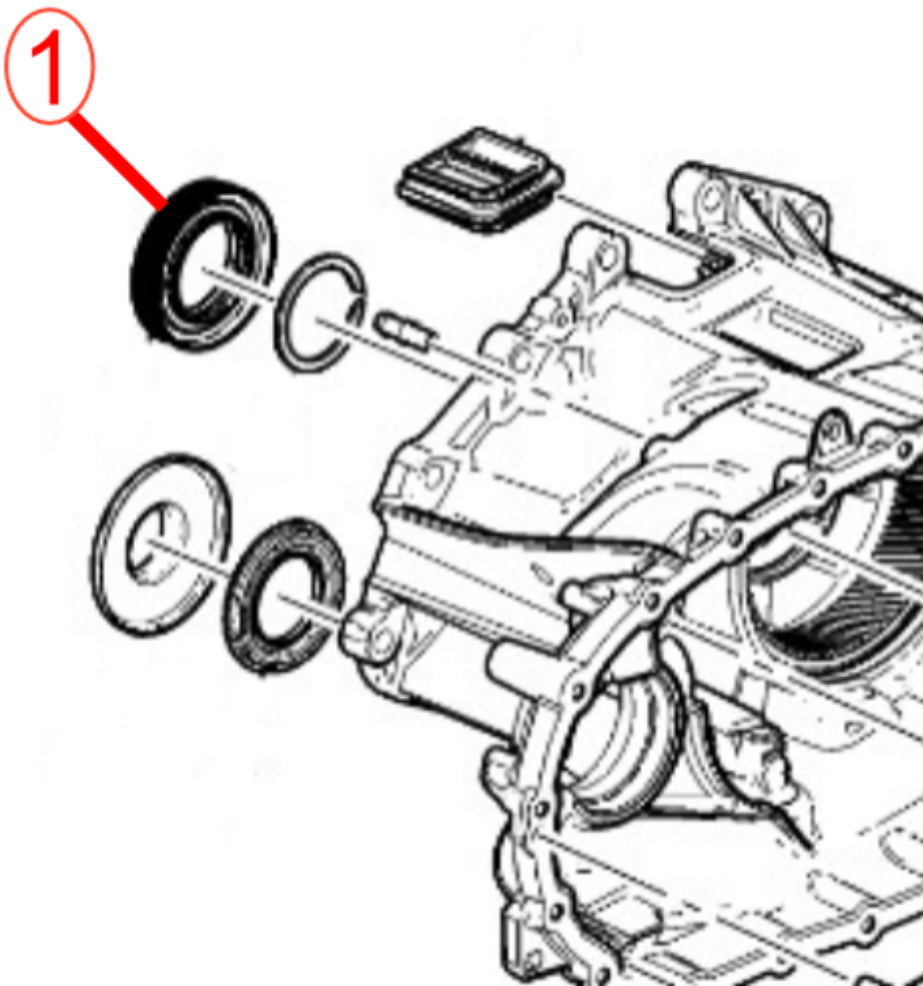
Note: The cavity between the Transmission and Transfer Case is a wet cavity by design. The Transfer Case Input Shaft Seal is a double seal to prevent fluid transmission and transfer case fluid from intermixing with each. If either side of the seal leaks fluid will leak from the weep holes between the Transmission and Transfer Case.

Adding dye to either the transfer case or transmission will help determine if the seal depth is incorrect.

If the seal is installed to deep the fluid leaking is transmission fluid.

If the seal is not installed deep enough the fluid leaking is transfer case fluid.

Either condition will cause fluid to leak out of the weep holes between the transmission and transfer case.

Note: Review PIP5810B for proper Transfer Case Input Shaft Seal Installation Instructions. Improper Transfer Case Extension Seal installation will result in repeat leaks.
