# Preliminary Information

## PIT5999A Intermittent Audio On IOK Radio: 1-2 Seconds Of Audio Cut Out

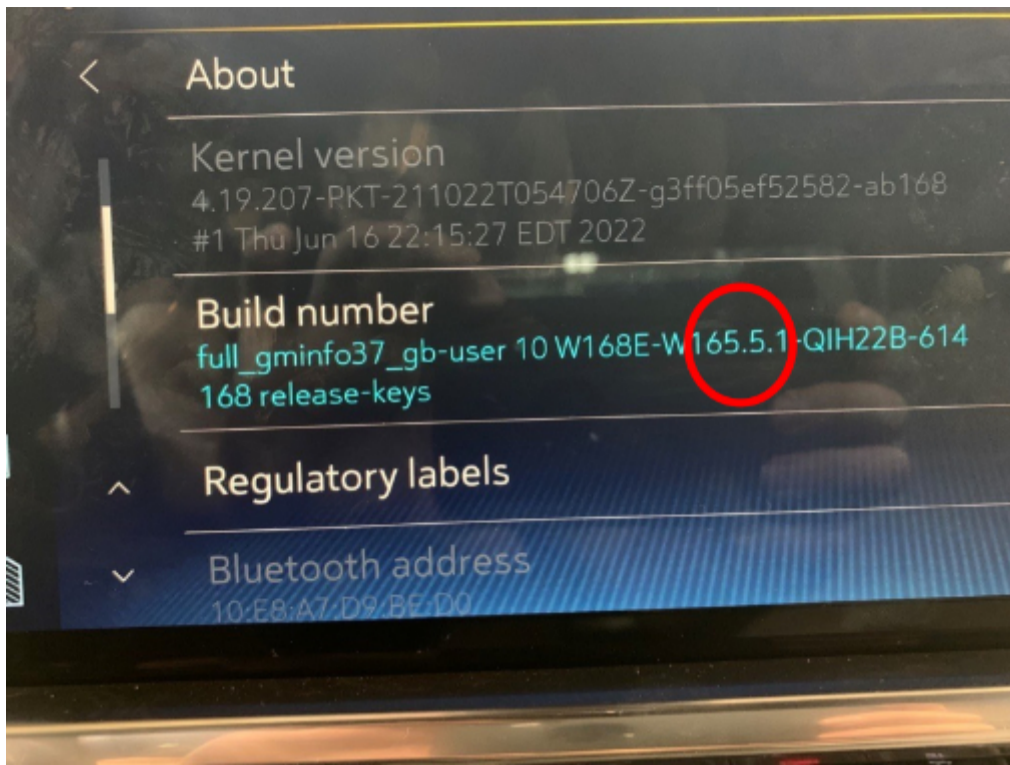
Inspect the current radio software version. Navigate to Settings -> About -> Build Number -> Information "i" to view and verify the software version.

If the build number is less than Y167, update the radio software.
