Bulletin No.: PIT4261J
Published date: 06/9/2023

PIT4261J Tire Sidewall Irregularities

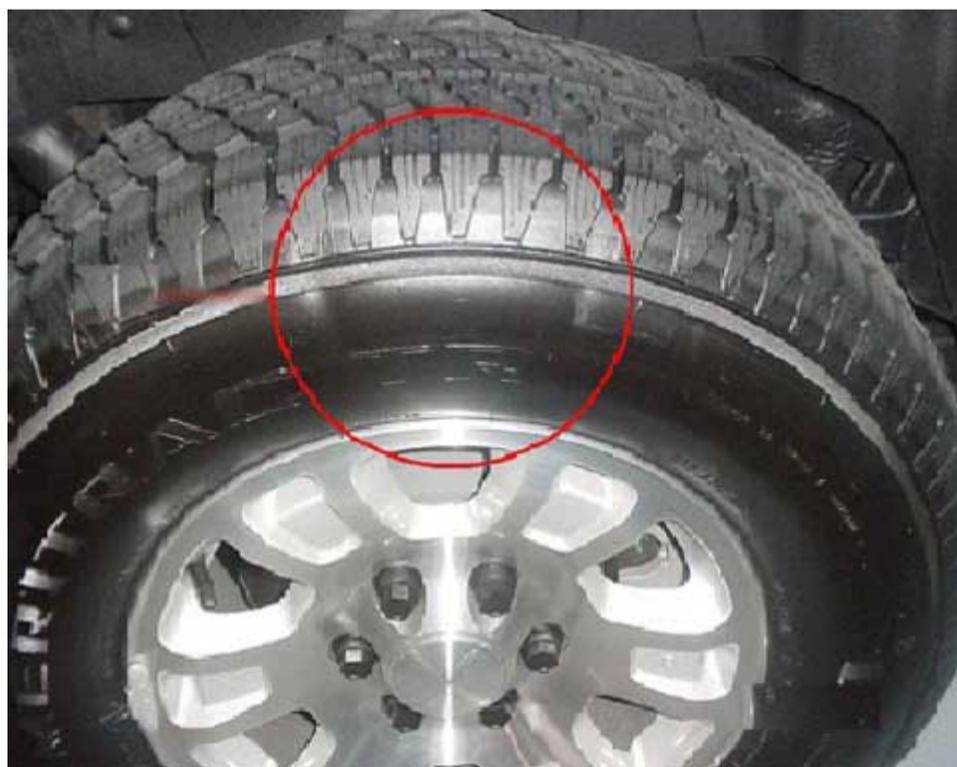
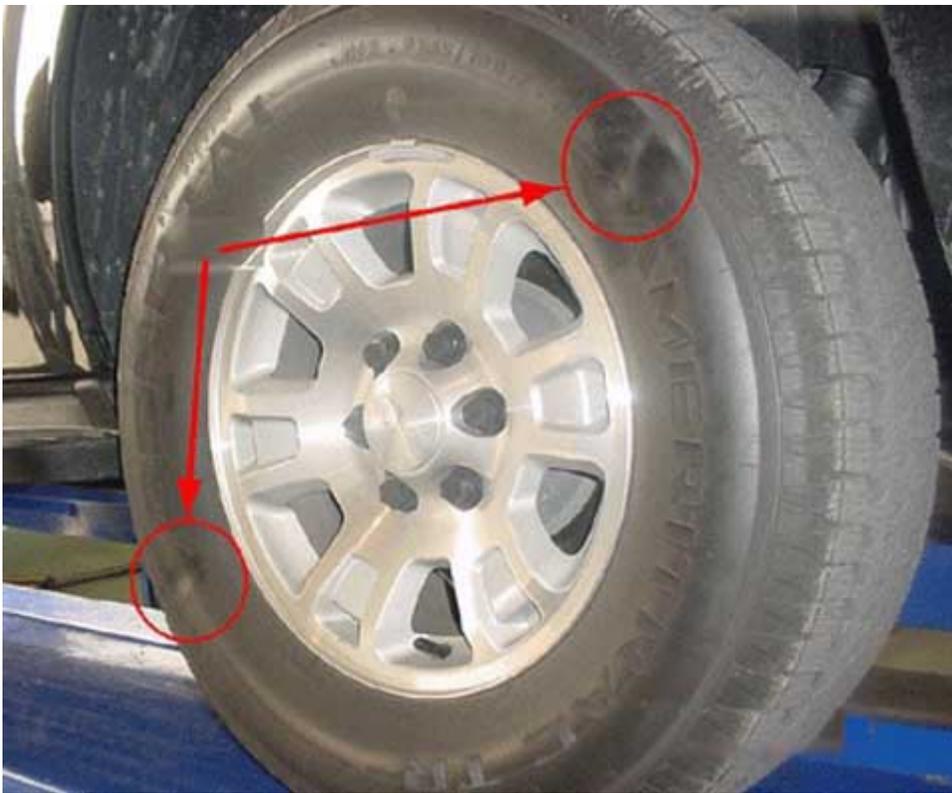
Slight sidewall indentations are a common characteristic of radial tire construction. These indentations are more noticeable on larger size tires having a larger side wall height. Radial tire body construction includes individual cords that run parallel to each other from bead to bead (down the sidewall, across the tread and up the other sidewall). These cords will overlap at points on the circumference of the tire. When the tire is mounted and inflated, it is free to naturally expand. The overlapped areas may create slight indentations, undulations, or protrusions since the stretching capacity of the overlapped area is slightly different than the rest of tire sidewall area.

The following two photos show examples of tires with a sidewall indentation.

This is a visual condition that will not affect durability, reliability or performance of the tires. Tire replacement to address this condition is not recommended and will lead to customer dissatisfaction as the replacement tires will likely have the same or similar condition.
