# Preliminary Information

## PIP5927 Diagnostic Tip: Possible DTC P0237 P0101 P1101 or p0299 Reduced Power Potential Damage To Charge Air Inlet Hose At Turbocharger

Brand:	Model:	Model Years:	VIN:		Engine:	Transmissions:
			from	to		
Chevrolet	Equinox	2023	All	All	1.5 LSD	All
GMC	Terrain	2023	All	All	1.5 LSD	All

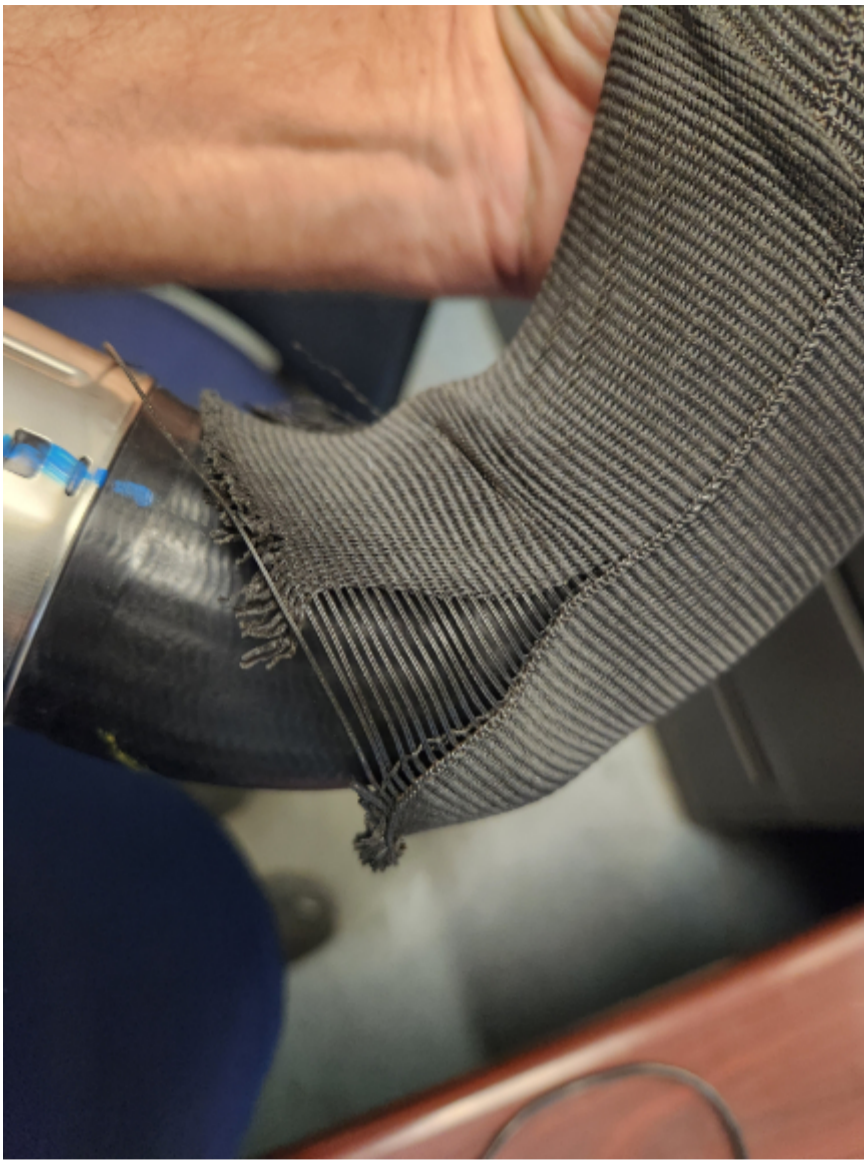
#1

Pictures below show damage to abrasion sleeve on Charge Air Inlet Hose.

**Replace Charge Air Inlet Pipe assembly using latest parts listed in EPC.**

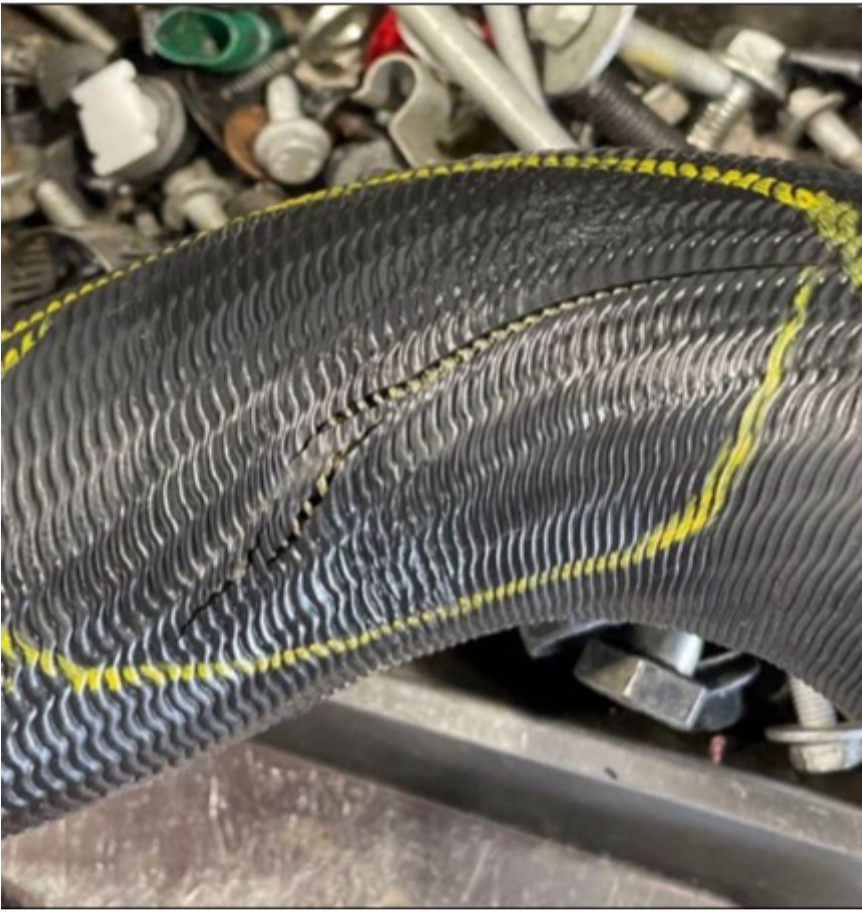
If this type of damage has been identified remove the Charge Air Inlet Hose assembly and inspect the Charge Air hose beneath the abrasion sleeve for signs of being split. This type of damage would allow the hose to swell under pressure damaging the abrasion sleeve and altering the readings within the boost control system or create a potential air leak.

#3 Picture below inside the circled area shows damage to inner hose beneath abrasion sleeve
