Preliminary Information

PIT5966B OTA Failure or Download Will Not Complete / No Crank / Dead Battery

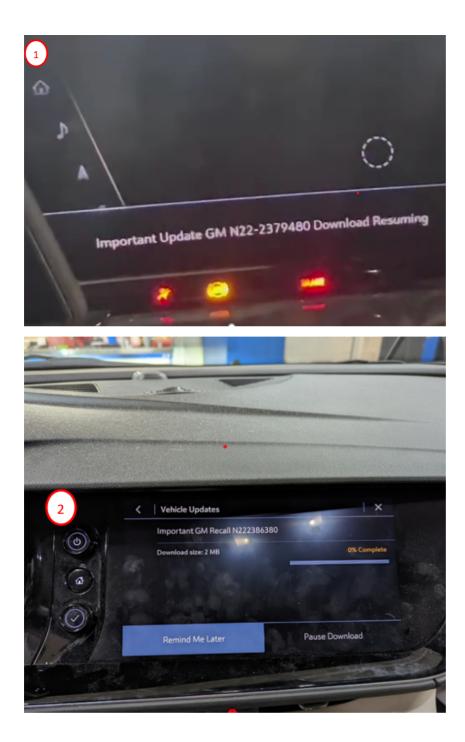
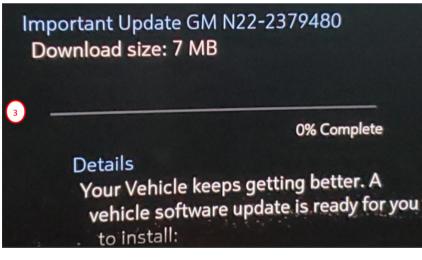
Brand:	Model:	Model Years:	VIN:		Engino	Transmissions:		
			from	to	Engine:	Transmissions.		
All	All	2021 - 2024	All	All	All	All		
Involved Region or Country		North America						
Involved Region or Country		The Air (OTA) update: - The radio will remain of - No Crank due to a dea charged. - Intermittently at start Update Download R - When checking the Ve OTA available that will r NOTE: These messages downloaded examples: N22236365, N22238222 Warranty under Require	Some customers may comment on any of the following complaints after an Over The Air (OTA) update: - The radio will remain on for up to 11 minutes after RAP is cancelled. - No Crank due to a dead battery. Vehicle will start and run after the battery is					
Cause		The cause of these concerns could be an OTA is stuck in a pending or download state.

If you have a vehicle that has these symptoms, please perform the following to reset the OTA and clear the messages:

1. Charge the vehicle battery and test for a good battery. Then confirm the vehicle will start and run. NOTE: When connecting the negative battery charger lead, use a solid engine ground or the ground stud in the engine compartment that is connected directly to the battery negative cable/terminal/post. Do NOT connect the battery charger lead directly to the negative battery post.

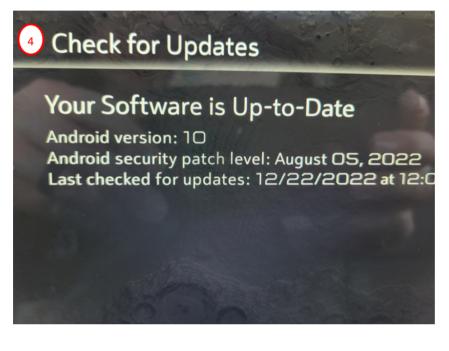
NOTE: This is only an example showing your software is up to date and the version or dates will vary.

7. After 2 hours, start the vehicle and verify no update messages are shown on the radio display, but more importantly, go back into vehicle settings and check the "Vehicle Update" screen to make sure there are no OTA's available, examples shown below (4). In some cases there will be an OTA to accept.
