Bulletin No.: PIT6033
Published date: 06/21/2023

PIT6033 Diagnostic Tip - Clunk / Rattle / Squeak / Pop / Click Noise When Turning

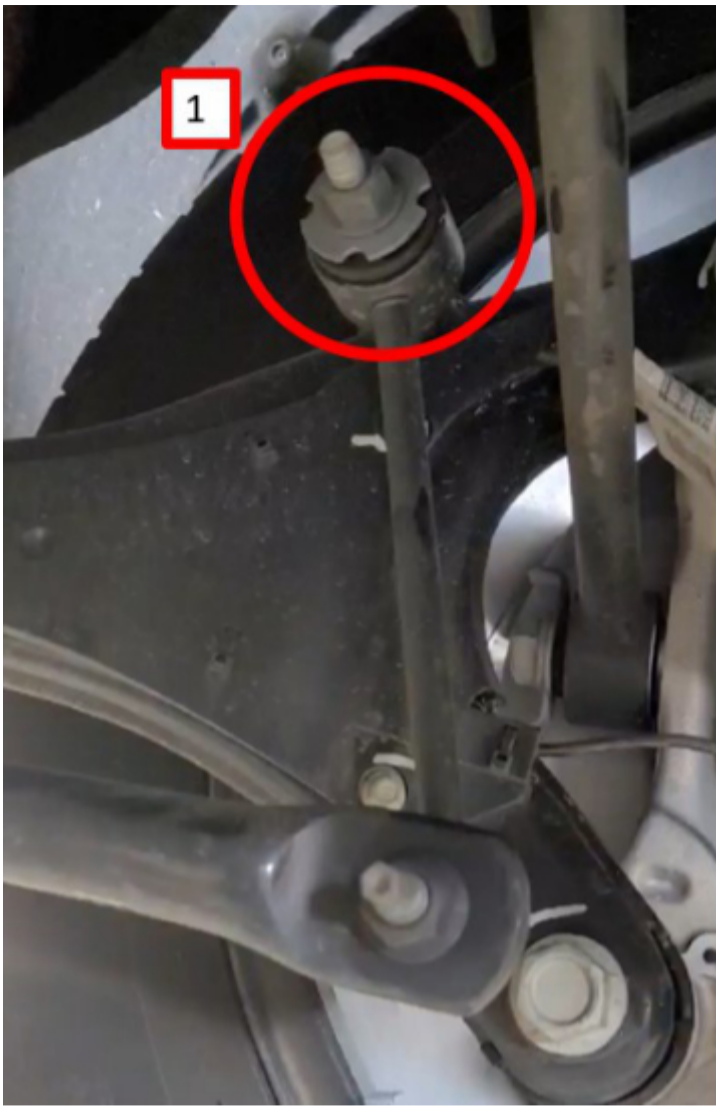
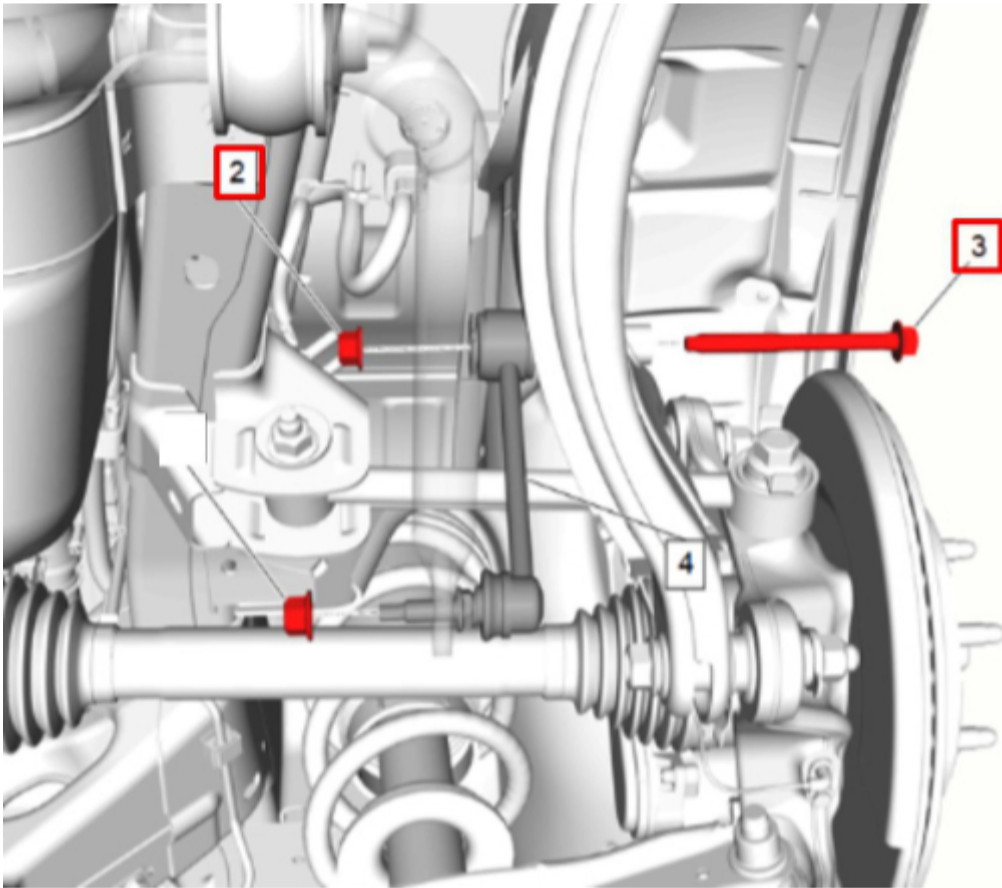
Involved Region or Country	North America
Condition	Some customers may comment on a clunk, pop, rattle, click, and/or squeak type noise from under the vehicle. In most cases, the noise can be duplicated when making full left and then full right turns, at slow speeds, in an open parking lot. This noise may sound like it is from the front of the vehicle, but it is coming from the rear.
Cause	The cause of this noise could be a loose rear sway bar link upper mounting bolt/nut, shown below.

Inspect the rear sway bar link upper mounting bolts/nuts for proper torque and if necessary torque to 74 lb. ft. (100 Nm).
