Preliminary Information

PIP5926B Transmission Fluid Leak Between the Transmission and Transfer Case

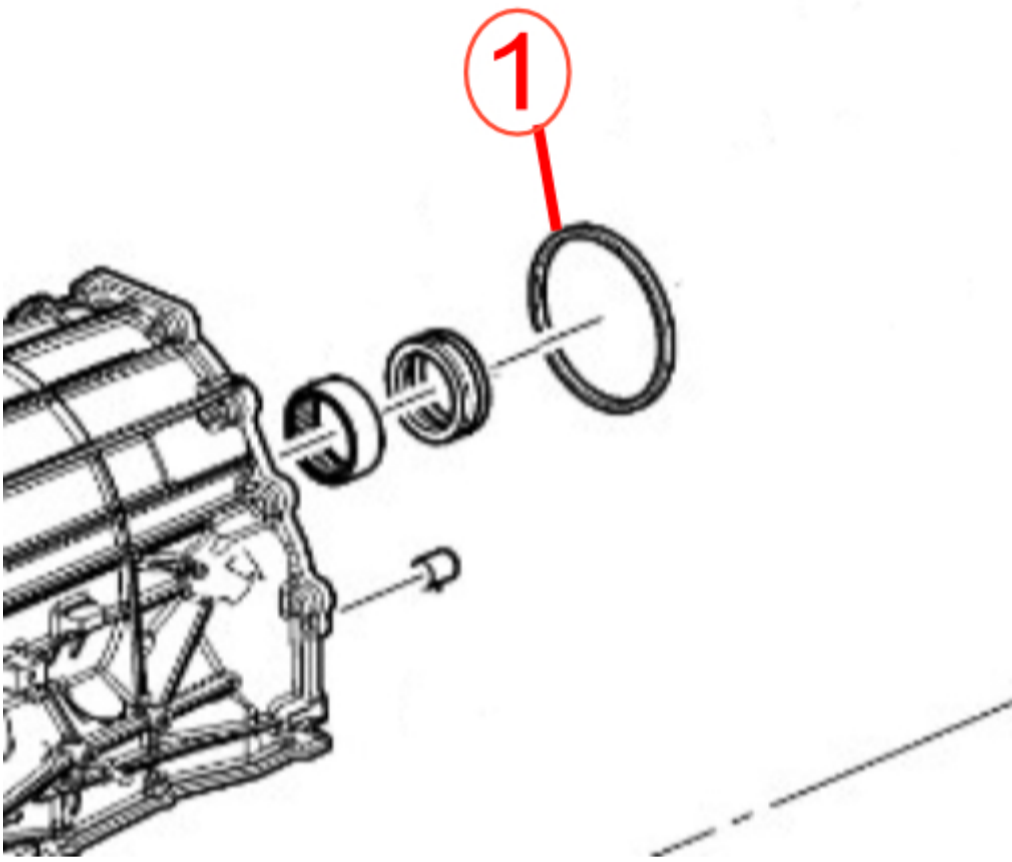
Involved Region or Country	North America, Middle East, Israel and Australia/New Zealand.
Additional RPO	NQF NQH
Condition	Some customers or technicians may comment of a transmission fluid leak between the transmission and transfer case.
Cause	The Transmission Case Extension Seal (call out 1 second pic below) is leaking or the Transfer Case Input Shaft Seal (call out 1 third pic below).

Replace the Transmission Case Extension Seal (call out 1 second pic below) and Transfer Case Input Shaft Seal (call out 1 third pic below).

Note: Review the latest version of PIP5810 for proper Transfer Case Input Shaft Seal Installation Instructions. Improper Transfer Case Extension Seal installation will result in repeat leaks.

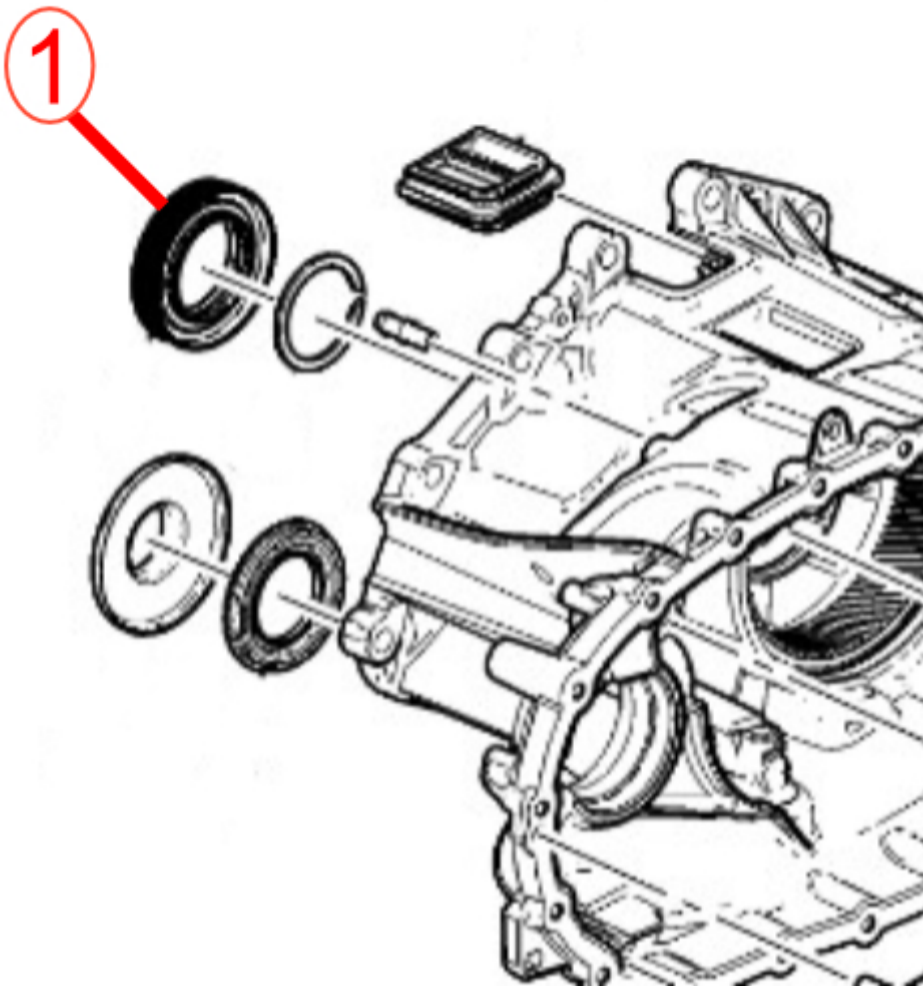
Note: The cavity between the Transmission and Transfer Case is a wet cavity by design. The Transfer Case Input Shaft Seal is a double seal to prevent fluid transmission and transfer case fluid from intermixing with each. If either side of the seal leaks fluid will leak from the weep holes between the Transmission and Transfer Case.

Note: It is being reported that the t-case input seal may be installed backwards, as a two piece seal back to back, and the replacement seal may also come as two seals to be installed. Correct orientation if two seals are received is metal clad together, which may be rubber coated, garner springs need to facing opposite of each other, one spring facing the t-case input gear, and one spring facing towards the trans output shaft, additionally, each seal may have three tabs, one seal protruding tabs, and the other inverted tabs, those tabs are to be aligned for proper installation.

If the seal is installed to deep the fluid leaking is transmission fluid.

If the seal is not installed deep enough the fluid leaking is transfer case fluid.
