PIP5932 Information on Malfunction Indicator Lamp (MIL) Illuminated with Any Combination of DTCs P0521, P06DD or P06DE Setting

Brand:	Model:	Model Years:	VIN:		Engine:	Transmissions:
			from	to		
Chevrolet	Trax	2024	All	All	1.2L LIH	All

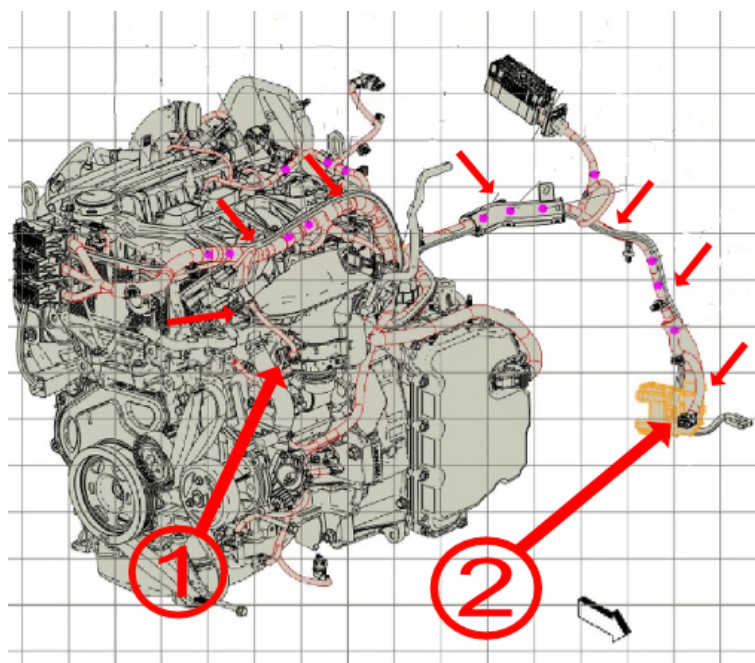
If the resistance is within range, tap and manipulate the engine wiring harness between the oil pressure sensor (1) and X125 (2) shown below, while monitoring for a change in the resistance reading.
