# Spartan Fire, LLC

## Technical Service Bulletin TSB23-520-001A

**APPLIES TO:** This service bulletin applies to 2021 through 2024 model year, Gladiator, Metro Star, FC-94, KME Panther, and KME Predator emergency response chassis cabs built between April 8, 2022 and March 20, 2023.

**CONDITION:** 120V box with dual breakers could be wired incorrectly.

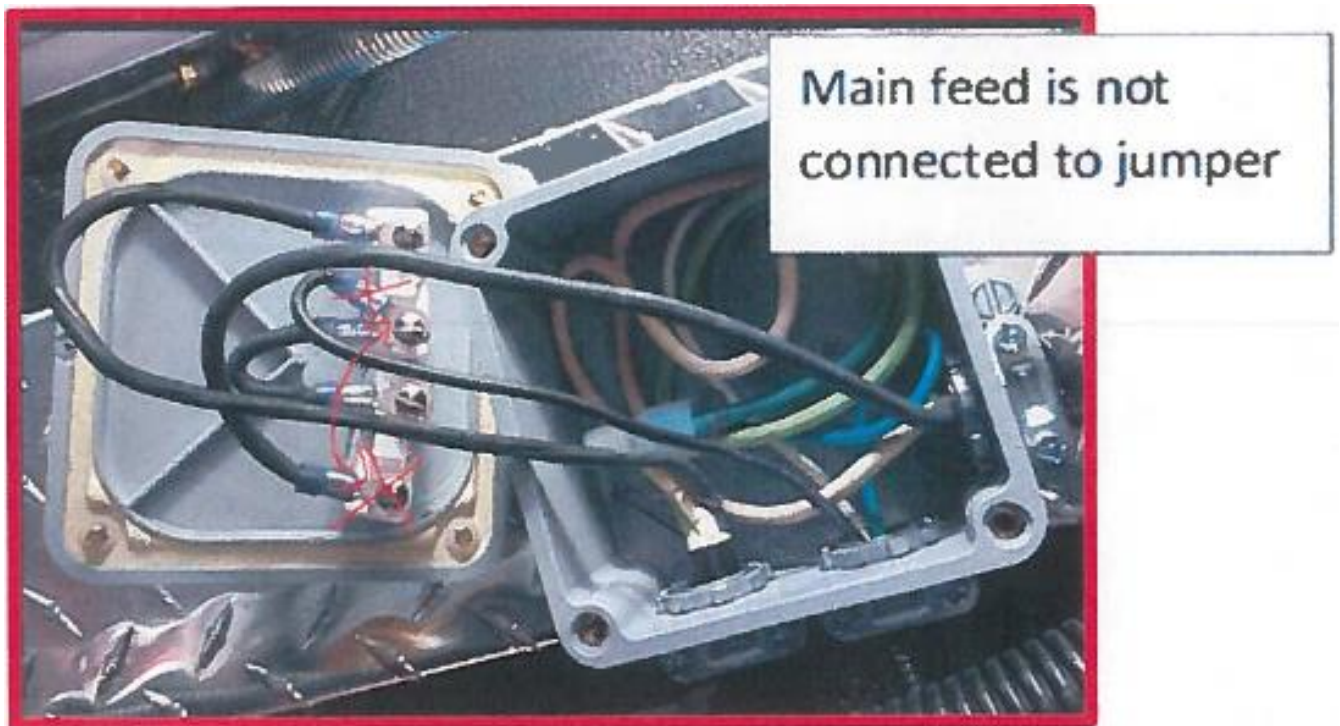
**Figure 2.1**

Main Feed Load Line (black wire) coming into box may not be wired correctly to the circuit breakers. If the black wire coming into the box is wired to the outside terminal of the circuit breaker and then the jumper between the circuit breakers is connected to the inner terminals, then the circuit breakers are wired in series, which is incorrect.
