Technical product information

Bentayga - Air suspension warning light within the DIP - DTC's P089200 - C104707 - C103B13 - Evident within Address 74

Air suspension warning light within the DIP

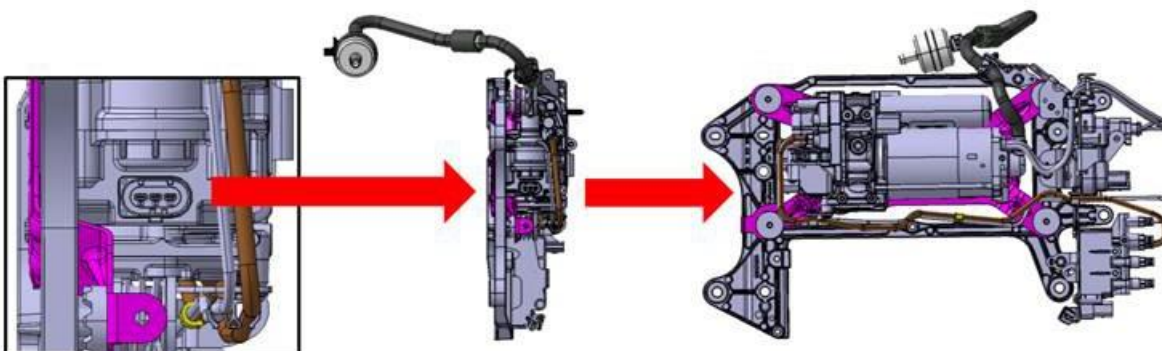
NOTE: NX7 is located as shown in Figure 1 (On the air supply unit/opposite side to the valve block)

1) Conduct a wiring integrity check between the valve block for adaptive suspension control unit (NX7) and the Running gear control unit (J775)

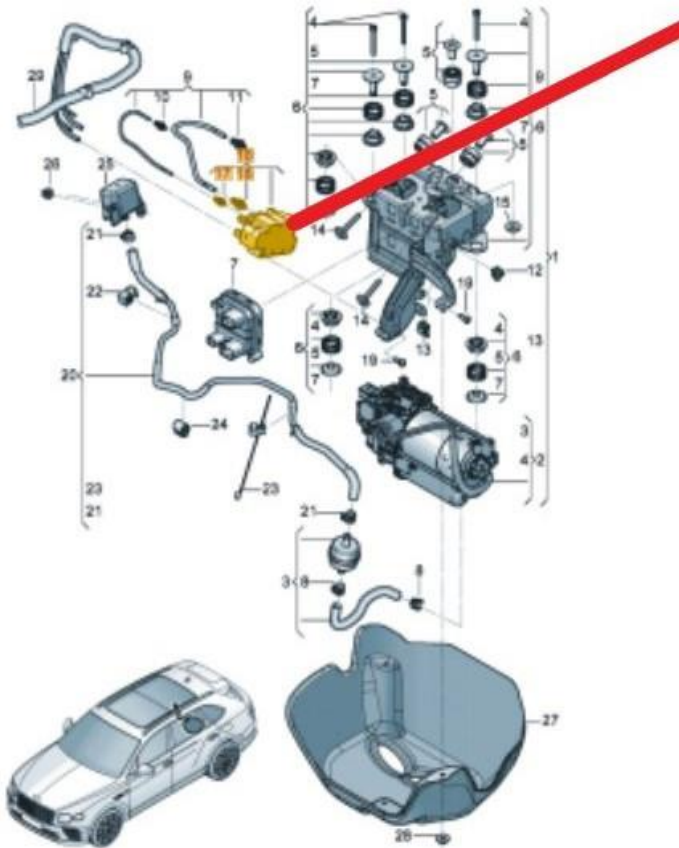
Figure 2

- Check for water ingress within the air supply unit/valve block
- Check for water ingress within the air supply hoses
- Check the air filter is not blocked
- Should none of the afore mentioned issues be evident - Replace the solenoid valve block (Figure 2)

Hint: The solenoid valve block can be replaced without the need to remove the air supply unit assembly from the vehicle

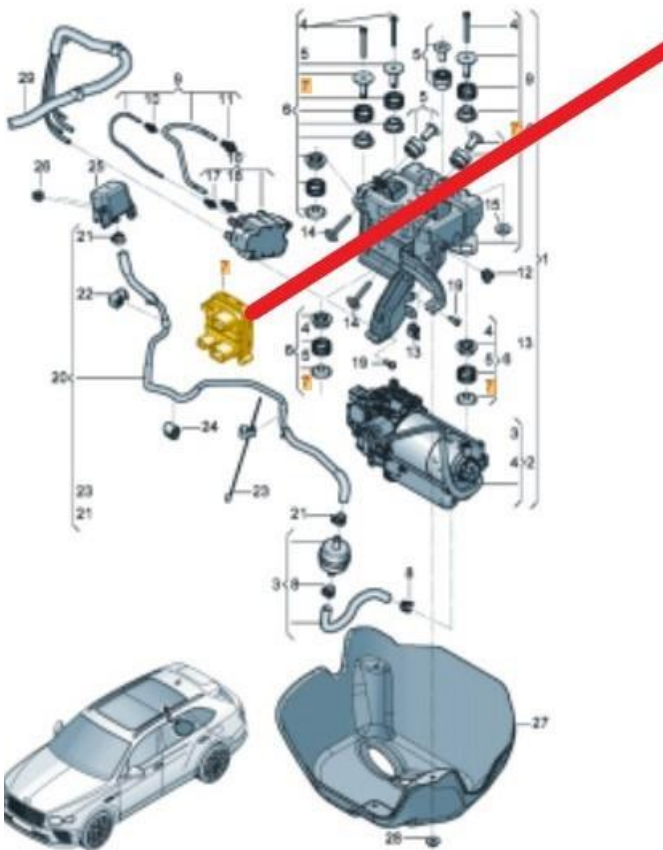
Should an electrical issue be evident issue and the wiring integrity checks were to specification, the operative should continue as follows:

- Replace the compressor control unit - Figure 3

Hint: The compressor control unit can be replaced without the need to remove the air supply assembly unit from the vehicle

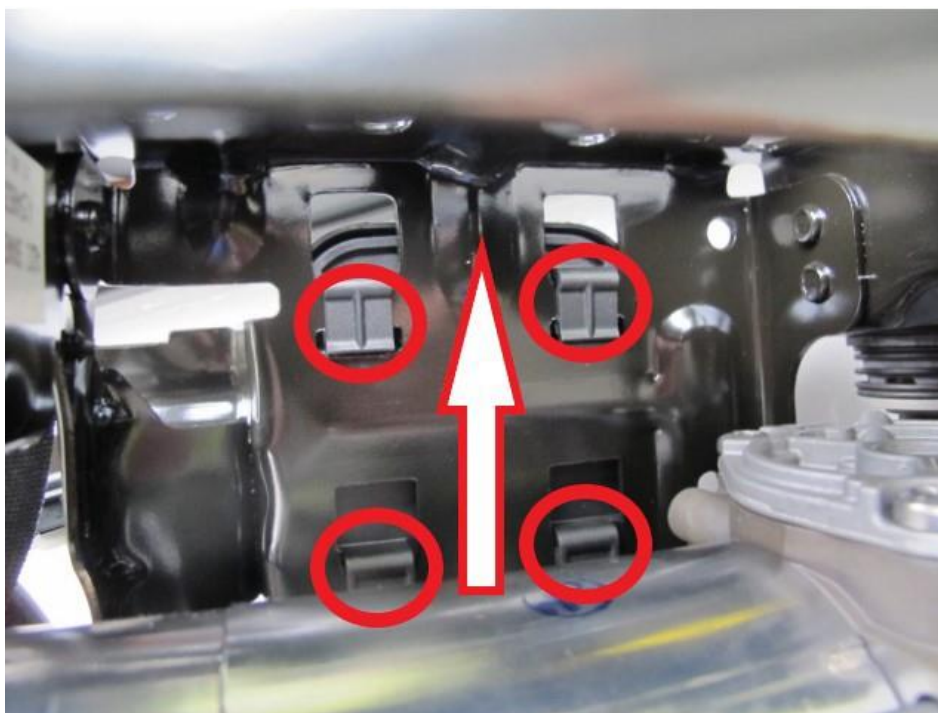
Figure 4

TIP: The clips can easily snap - Take care when refitting the new control unit

Hint: The control unit is secured to the air supply unit bracket using (x4) clips - To remove the control unit disengage the clips using a non metallic tool then slide/remove the control unit from the bracket (Figure 4)
