# Technical product information

<b>Topic</b>	New Continental GT and GTC - Window drop glass
<b>Market area</b>	Australia E04 Bentley rest Asia and Australia (6E04),China 796 VW Import Comp. Ltd (Vico), Beijing (6796),Germany E02 Bentley rest Europe (6E02),Japan E03 Bentley Japan (6E03),Korea, (South) E08 Bentley South Korea (6E08),United Arab Emirates E06 Bentley Middle East and Africa (6E06),United Kingdom E01 Bentley UK (6E01),United States E05 Bentley USA and rest America (6E05)
<b>Brand</b>	Bentley
<b>Transaction No.</b>	2070497/2
<b>Level</b>	EH
<b>Status</b>	Approval
<b>Release date</b>

## TPI 2070497/2

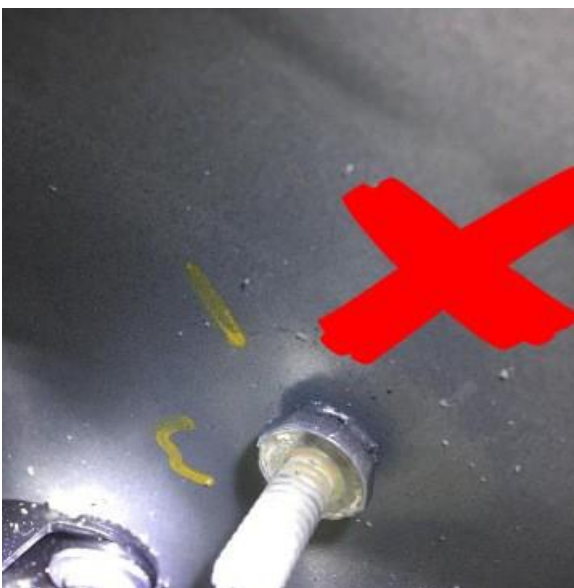
- Earth point 736 RHR and Earth point 738 LHR
- Check for cleanliness and security of both earth points Figure 5 shows an example of a contaminated earth point (dirt/paint/debris)

- Remove any dirt/paint/debris from the earth points using suitable abrasives/wire brush ensuring no damage is caused to the earth stud threads as shown in Figure 6

- Secure the earth point fixings (9Nm)
- 9) Conduct a thorough check of all Window/door seals for the following:
- Damage
  - Splits
  - Tears
  - Misalignment
  - Incorrectly fitted/located
  - Drop glass seal deformation (see Figures 7 and 8 as examples)

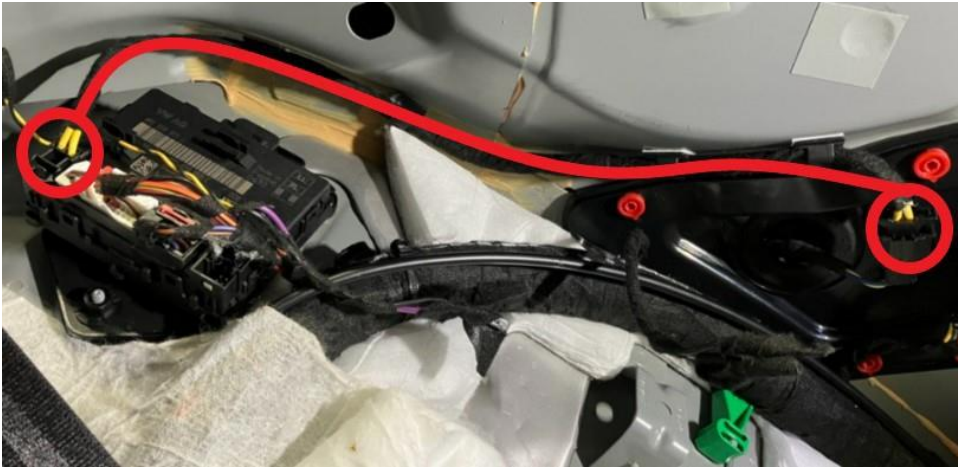
**B148729: Window regulator motor Range/Performance**

- Disconnect the original terminals from T6aq Pins 3 and 6 to T2jp Pins 1 and 2 respectively
- Once disconnected the terminals should be insulated with harness tape and suitably secured
- Referring to Figure 9 - Using 000 979 225E repair wires and (x2) 000 979 242E fit the new wires into T6aq Pins 3 and 6 to T2jp Pins 1 and 2 respectively
- Ensure the newly fitted wires are suitably insulated and secured away from the harness as shown in Figure 9
