Technical product information

Topic	New Continental GT/C & New Flying Spur - Air suspension warning light in the DIP
Market area	Australia E04 Bentley rest Asia and Australia (6E04),China 796 VW Import Comp. Ltd (Vico), Beijing (6796),Germany E02 Bentley rest Europe (6E02),Japan E03 Bentley Japan (6E03),Korea, (South) E08 Bentley South Korea (6E08),United Arab Emirates E06 Bentley Middle East and Africa (6E06),United Kingdom E01 Bentley UK (6E01),United States E05 Bentley USA and rest America (6E05)
Brand	Bentley
Transaction No.	2070768/1
Level	EH
Status	Approval
Release date

New Continental GT/C and New Flying Spur

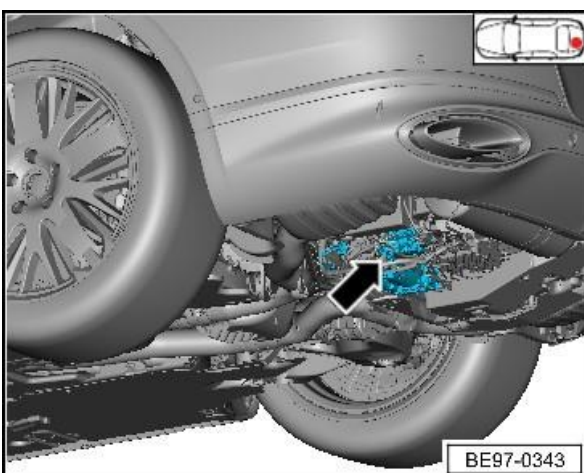
NOTE: NX7 is located as shown in Figure 1

- Perform visual inspections of the connectors/pins, checking for damage and water ingress

- Broken wires
- Kinked wiring
- Pin/s missing
- Pin's broken
- Pin's loose

2) Repair any broken or damaged wires as per Rep.Gr 97

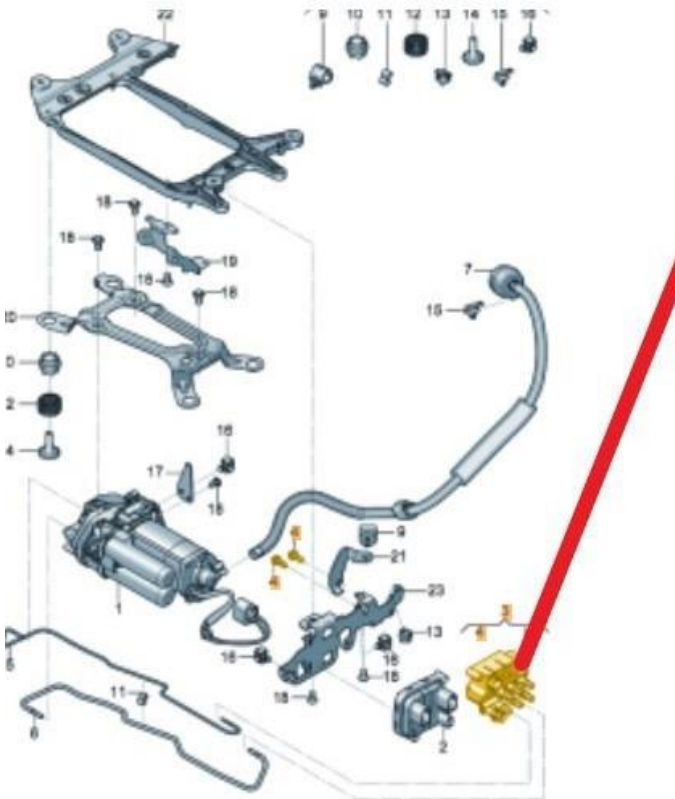
Figure 2

- Check for water ingress within the air supply unit/valve block
- Check for water ingress within the air supply hoses
- Check the air filter is not blocked
- Should none of the afore mentioned issues be evident - Replace the solenoid valve block (Figure 2) as detailed within Rep.Gr 43

Hint: The solenoid valve block can be replaced without the need to remove the air supply unit from the vehicle

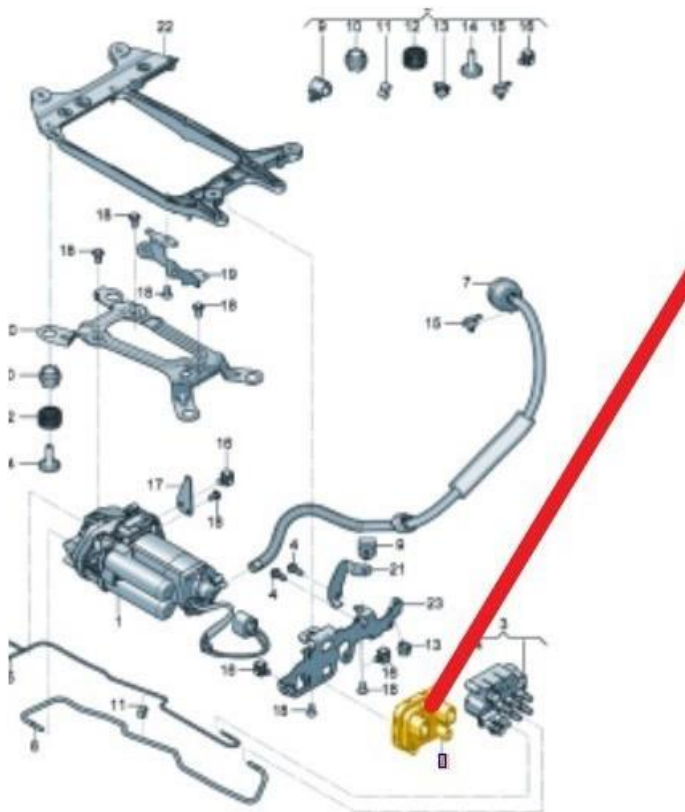
Figure 3

- Referring to Rep.Gr43 (Air suspension compressor to remove and fit) - Replace the compressor control unit (Figure 3)

The control unit is secured to the air supply unit bracket using (x4) clips - To remove the control unit disengage the clips using a non metallic tool then slide/remove the control unit from the bracket

TIP: The clips can easily snap - Take care when refitting the new control unit
