SIB 01 12 19

## FRONT GRILLE UPPER/LOWER ACTIVE AIR FLAPS: LTD WTY EXT TO 15 YEARS/150,000 MILES

This Service Information bulletin (Revision 07) supersedes SI B01 12 19 **dated August 2022**

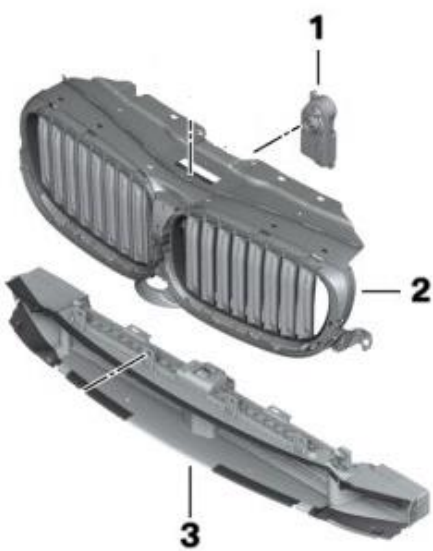
1. Air flap control (link) active, upper (G12, G30 and G32)
2. Air flap control (drive), active, upper
3. Air flaps, upper (assembly)
4. Air flaps, lower (assembly)

A check control message or MIL (Malfunction Indicator Lamp) may be illuminated with faults stored related to the upper and/or lower active air flap(s).

- Faulty upper air flap link (G12, G30, G32)
- Faulty upper air flap actuator (G01, G02, G12, G30, G32)
- Faulty upper flap assembly (G01, G02, G12, G30, G32)
- Faulty lower air flap assembly (G01, G02, G12, G30, G32)
- Software update (As instructed by ISTA diagnosis test plan)

Upon visual inspection, the passenger side upper active air flaps are either stuck open or closed, and they will not move and there are no faults stored for the active air flaps (With no check control message or check engine light or displaying)

Depending on the root cause, vehicle model, and the location of flap (upper or lower) at issue, as determined and/or as instructed, the vehicle may require one or more of the following correction repairs:

- Upper air flap link (G12, G30, G32)
- Upper air flap actuator
- Upper air flap assembly
- Lower air flap assembly
- Software update (As instructed by ISTA diagnosis test plan)
-
