SIB 51 11 23

CRACKING SOUND IN THE D-PILLAR TRIM PANEL

E-Series	Model Description
i20	iX Sports Activity Vehicle

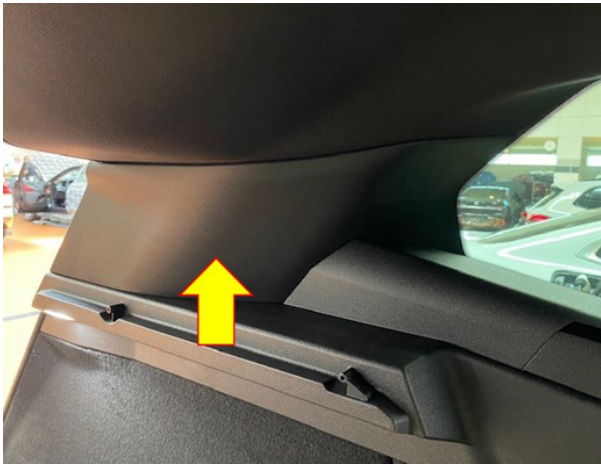
When driving on rough roads, a “cracking” sound can be heard coming from the D-pillar trim panel. The noise can occur on both left and right-side panels.

Unfavorable friction between the D-pillar trim panel and the headliner.

Apply felt tape to the top of the D-pillar trim panel.
