SIB 61 28 22

2023-06-26

G20 PHEV OCCASIONAL USE CHARGING (OUC) CABLE IS MISSING FROM THE FACTORY

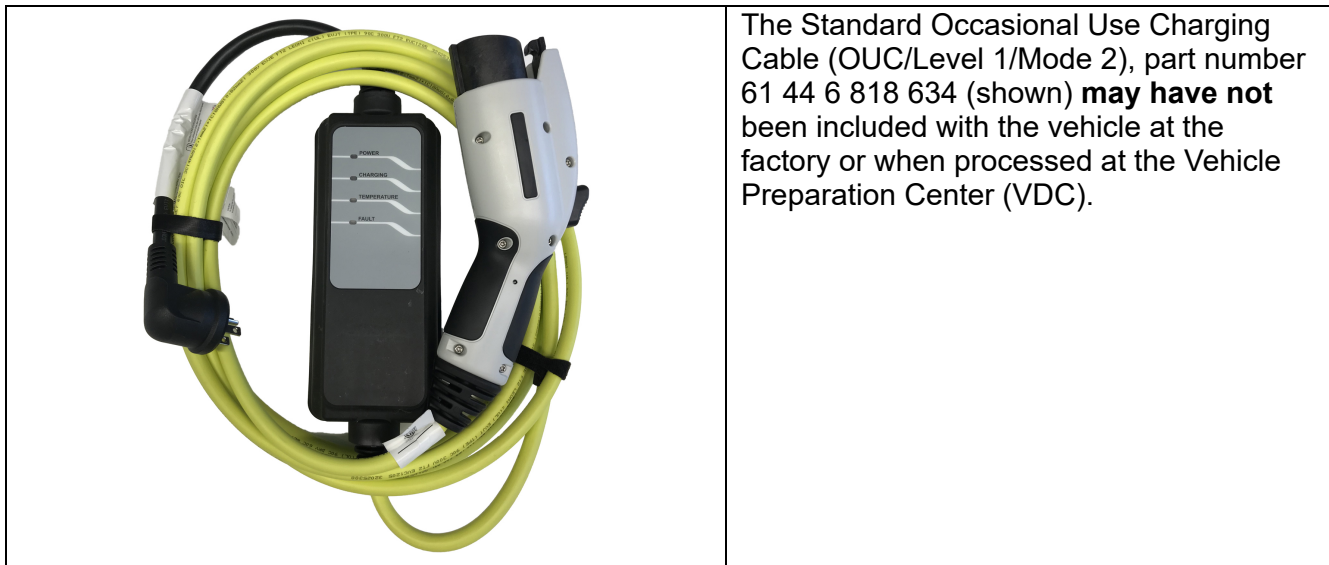
The Standard Occasional Use Charging Cable (OUC/Level 1/Mode 2), part number 61 44 6 818 634 (shown) **may have not** been included with the vehicle at the factory or when processed at the Vehicle Preparation Center (VDC).

Provide (insert/put in the vehicle) the OUC at a quantity one (1) per affected vehicle.
