# SIB 63 03 21 CONDENSATION IN TAILLIGHT

G05 (X5 Sports Activity Vehicle)	G06 (X6 Sports Activity Coupe)	G07 (Sports Activity Vehicle)	G14 (8 Series Convertible)
G15 (8 Series Coupe)	G16 (8 Series Gran Coupe)	G20 (3 Series Sedan)	G22 (4 Series Coupe)
G23 (4 Series Convertible)	G26 (4 Series Gran Coupe)	G29 (Z4 Roadster)	G80 (M3 Sedan)
G82 (M4 Coupe)	G83 (M4 Convertible)

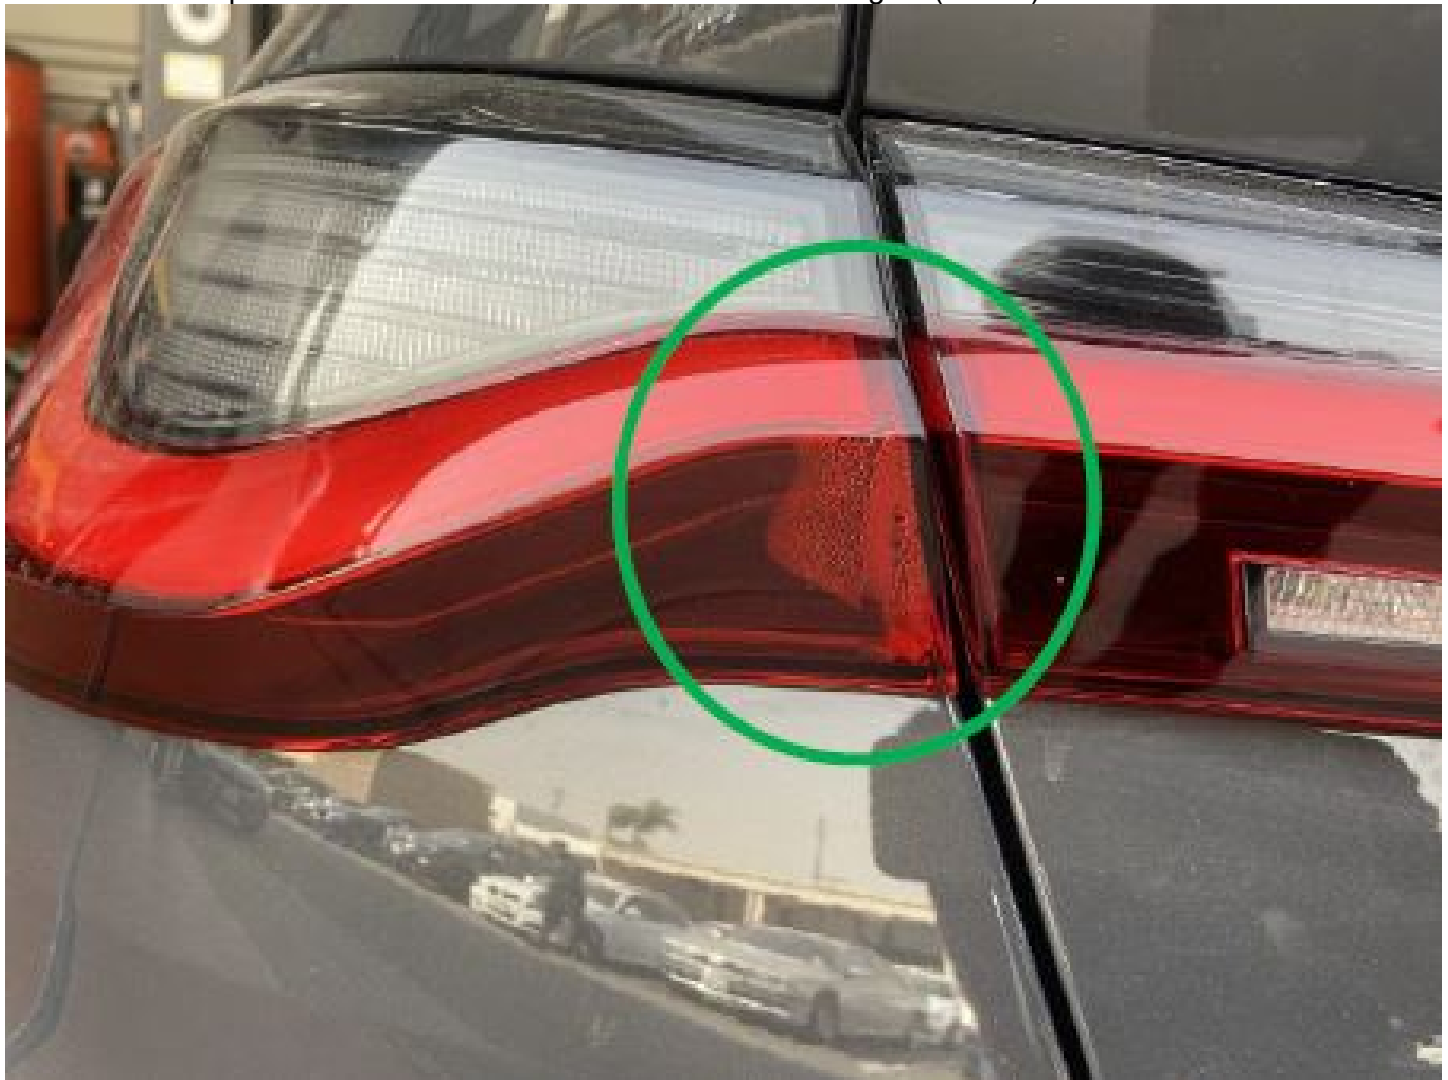
Condensation is present on the inner surfaces in one or both taillights (circled).

Modern BMW vehicles utilize waterproof membrane technology which allows for naturally occurring condensation and air to escape, without allowing excess water or dirt entry. Vehicles which utilize this

membrane technology will dry normal condensation at a slower rate than open concept taillights used on previous models. This is a normal condition and requires no correction.

The condensation shown will typically form along the geometrical edges or corners of the taillight lenses. This is a normal characteristic of modern taillights and requires no correction, as this is not a defect.

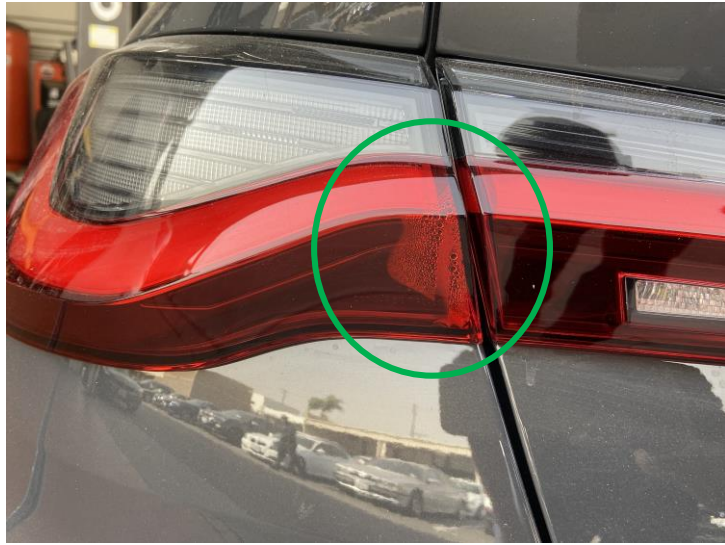
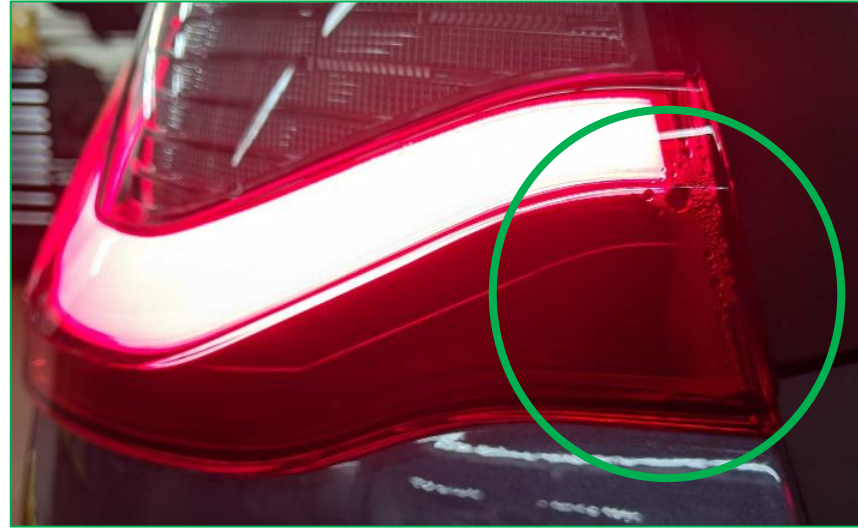
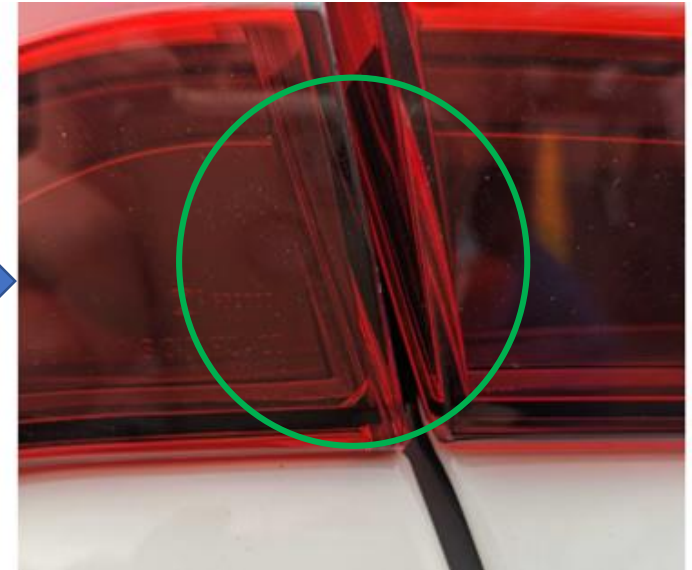
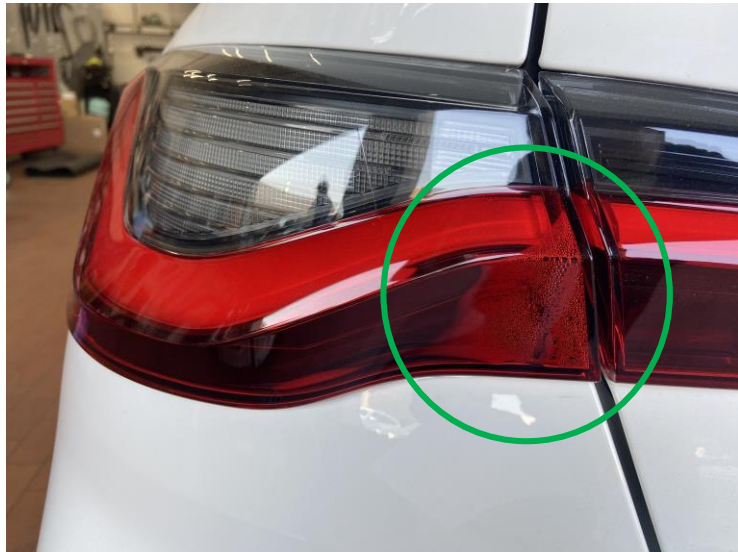
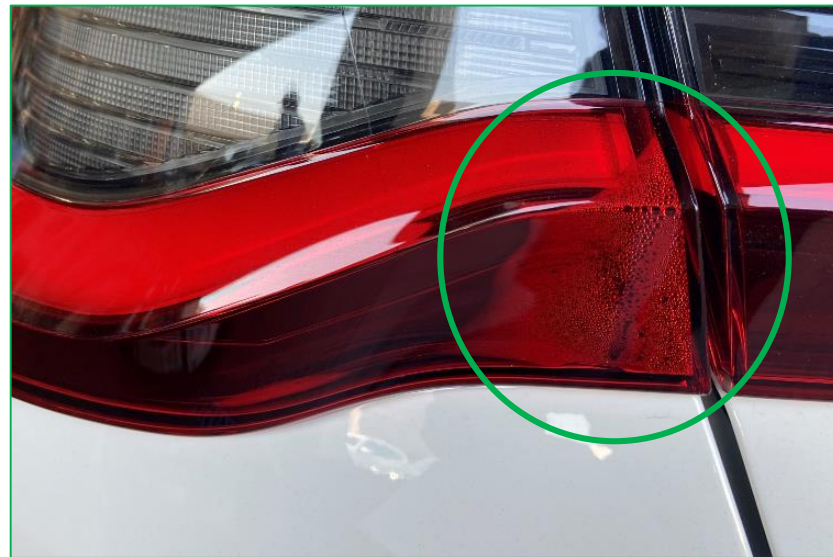
Examples below are showing NORMAL condensation. The vehicles below require no correction. Condensation is a characteristic of this style of taillight.

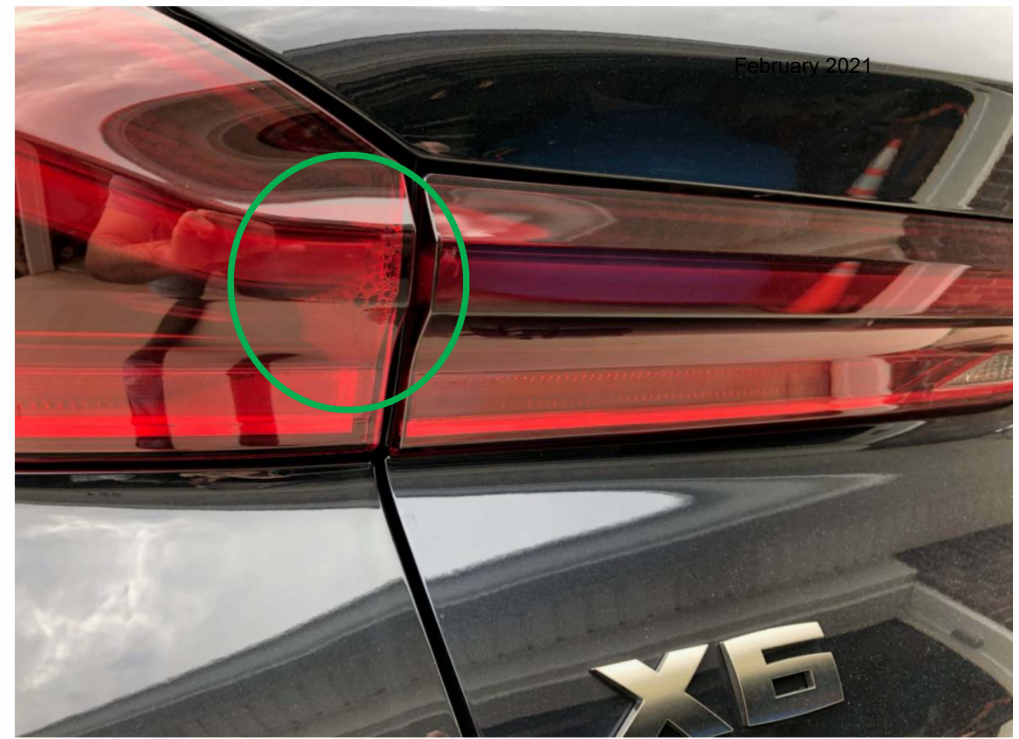
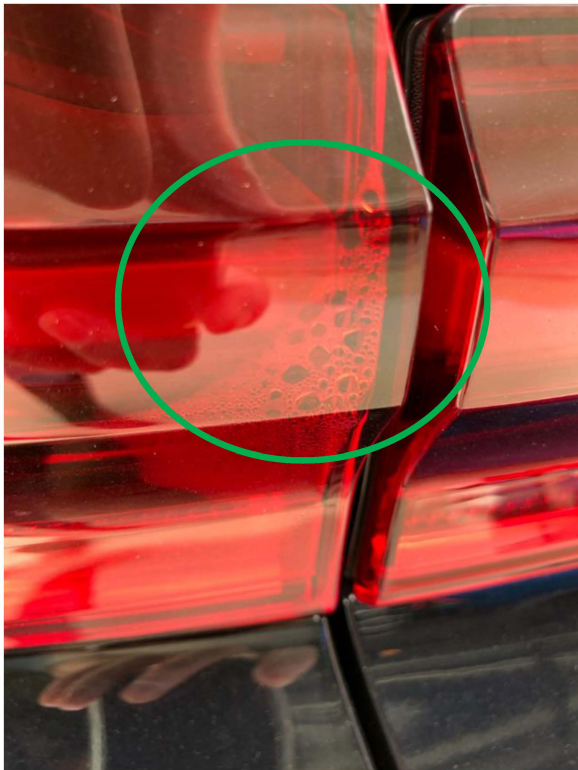
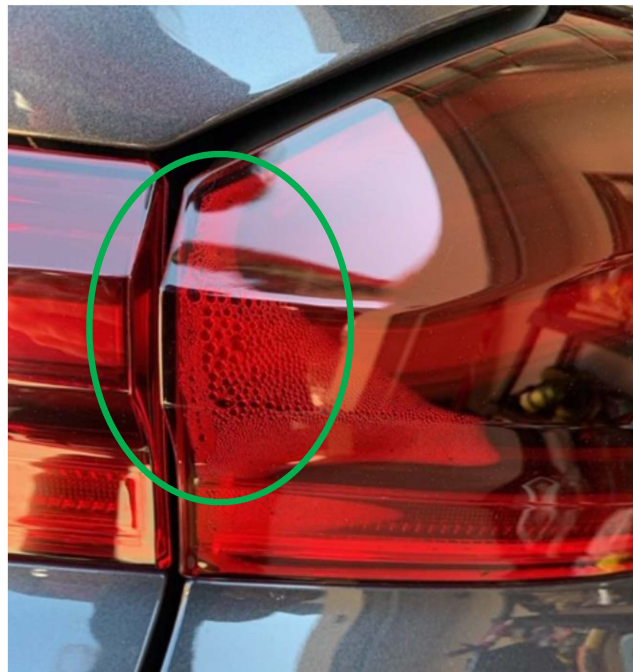
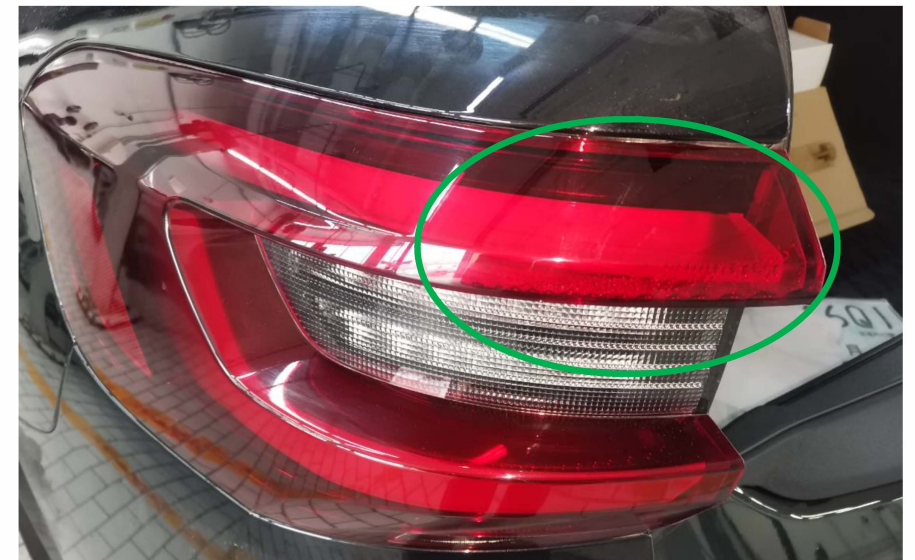
Examples below are showing NORMAL condensation. The vehicles below require no correction. Condensation is a characteristic of this style of taillight.

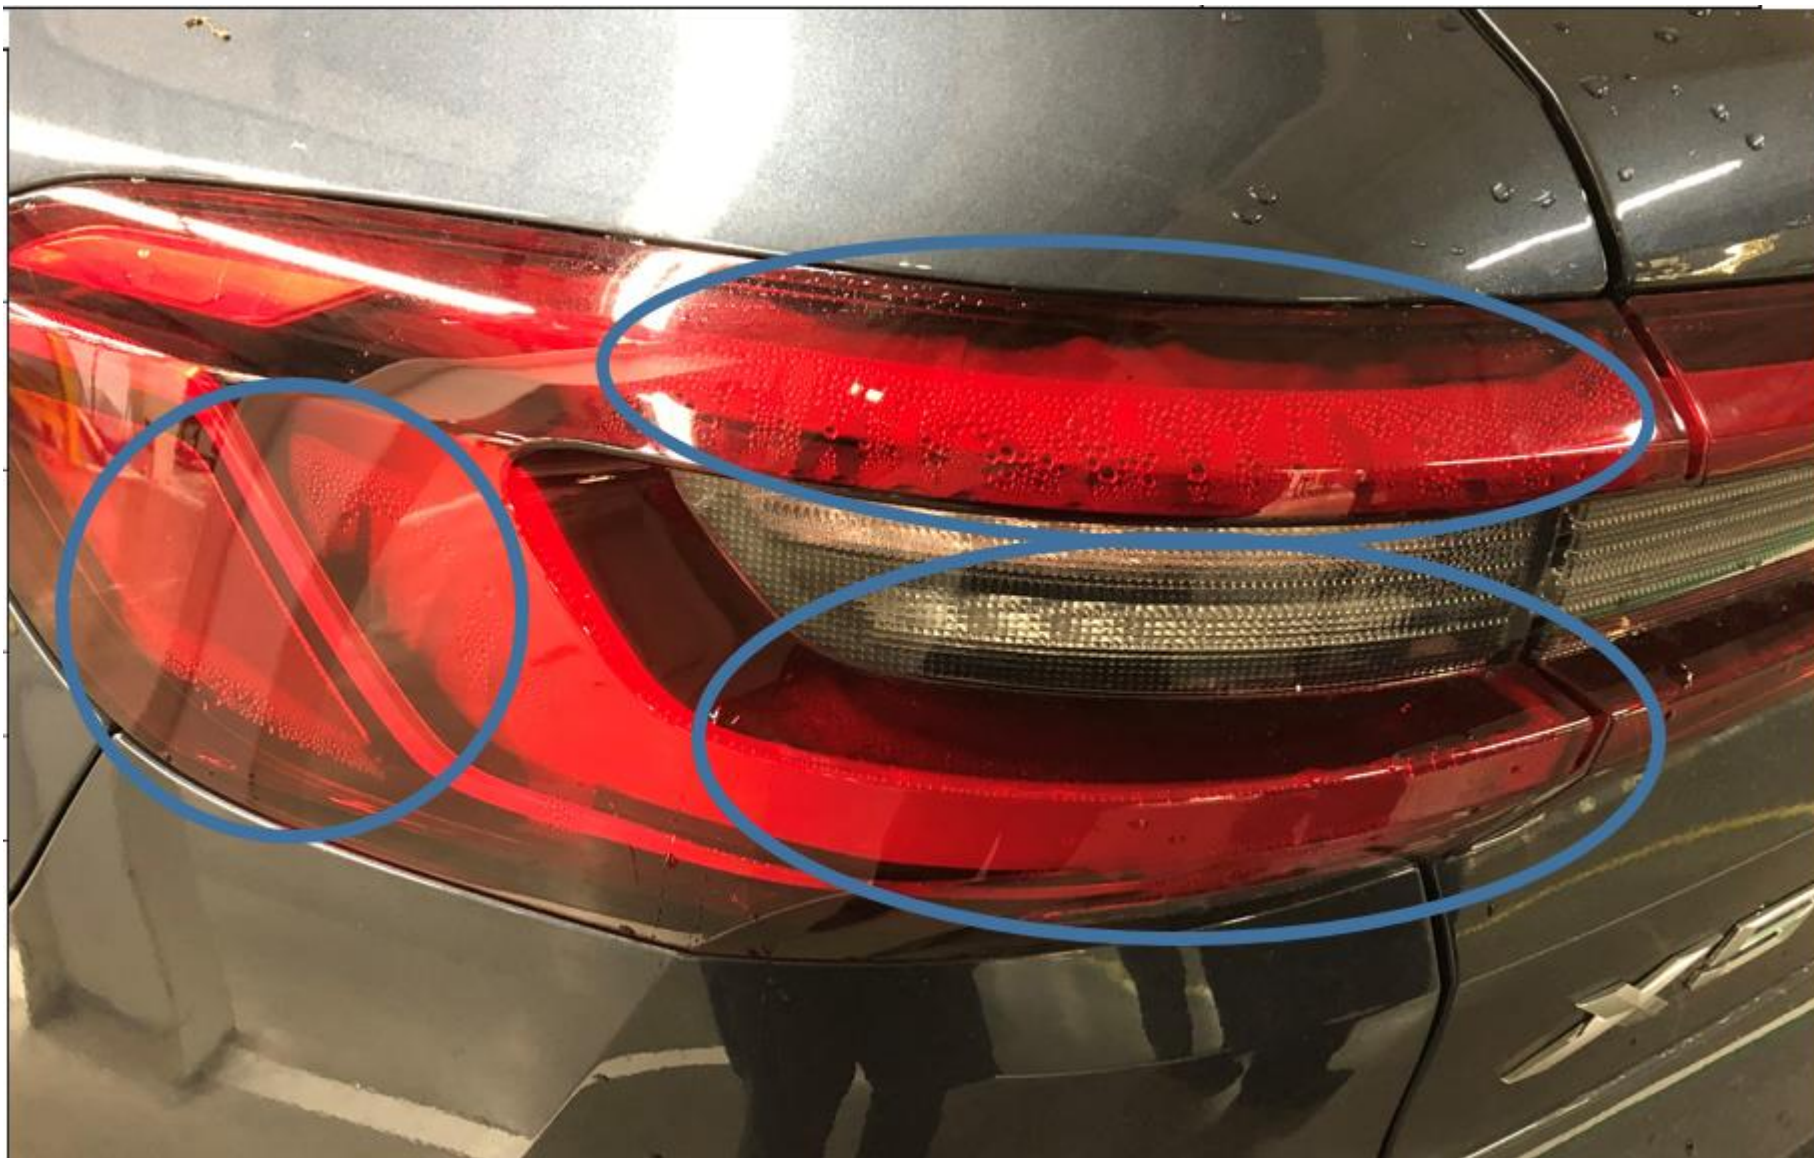
The example shown below is demonstrating a taillight which has excess water entry, beyond normal condensation. Note water across entire lens of the taillight, rather than along the edges alone. This taillight would require correction. This SIB does not apply to taillights which are defective.
