SIB 84 03 23

2023-06-02

SERVICE ACTION: PROGRAMMING CONTROL UNITS AND PROVIDING DIGITAL KEY CARD

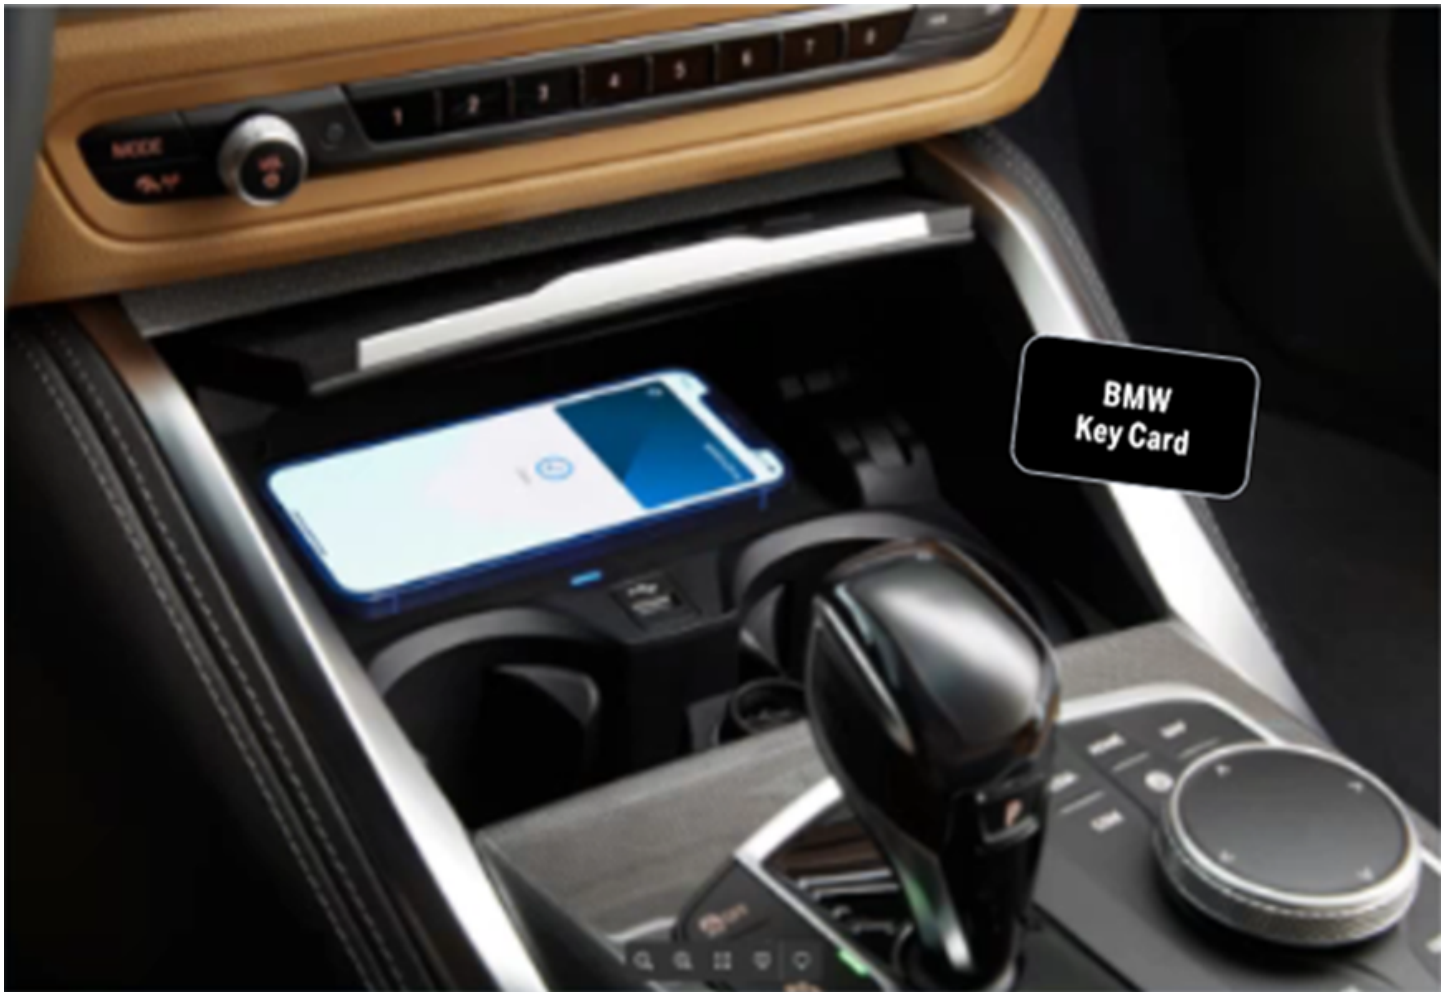
Unfavorable software causes the vehicle to not detect when the digital key (mobile phone/BMW Key Card) is removed from the wireless charging station (WCA). It is still possible to operate the window regulators,

sunroof and convertible top for a certain period of time until the vehicle is locked, despite the digital key being removed from the WCA.

Example below: Wireless Charging Tray with either the BMW Key Card or a telephone with the Digital Key activated.

Order a replacement Digital Key Card for the vehicle and program the complete vehicle with ISTA 4.41.1x (release date of May 2, 2023).
