GLOBAL SAFETY FIELD INVESTIGATIONS
DCS6626
URGENT - DISTRIBUTE IMMEDIATELY

Subject: N222383020 - Service Update
ECM Does Not Properly Report CVN to Service Tools

Models: 2022 Chevrolet Silverado 1500 New
2022 GMC Sierra 1500 New

N222383020 ECM Does Not Properly Report CVN to Service Tools

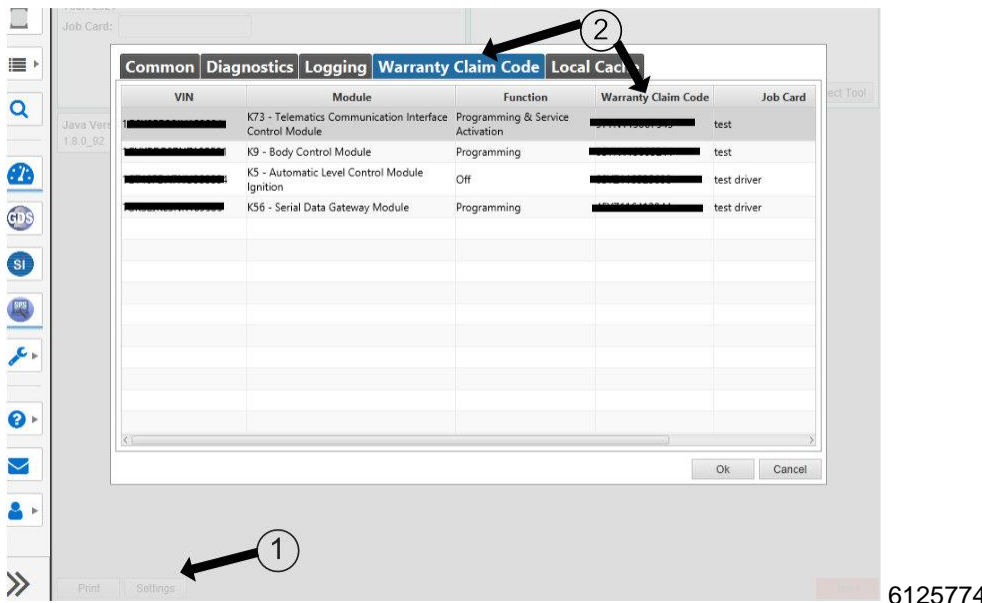
If the Warranty Claim Code was not recorded on the Job Card, the code can be retrieved in the SPS2 system as follows:

1. Open TLC on the computer used to program the vehicle.
2. Select and start SPS2.
3. Select Settings (1).
4. Select the Warranty Claim Code tab (2).

The VIN, Warranty Claim Code and Date/Time will be listed on a roster of recent programming events. If the code is retrievable, dealers should resubmit the transaction making sure to include the code in the SPS Warranty Claim Code field.

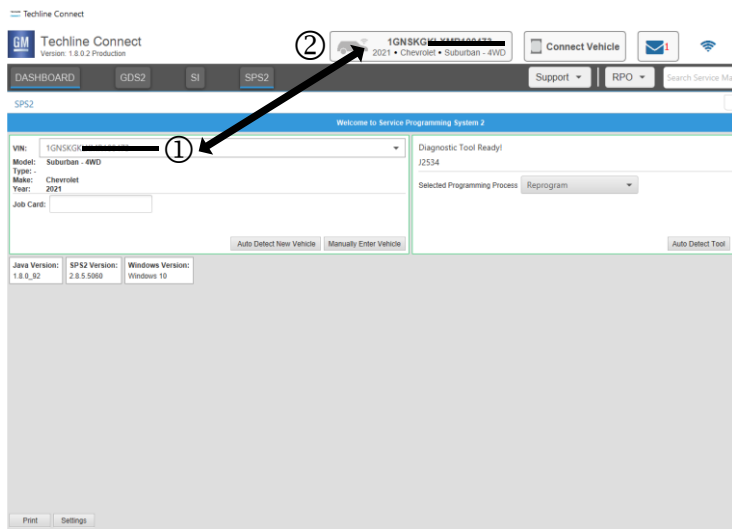
5743643

Caution: Be sure the VIN selected in the drop down menu (1) is the same as the vehicle connected (2) before beginning programming.

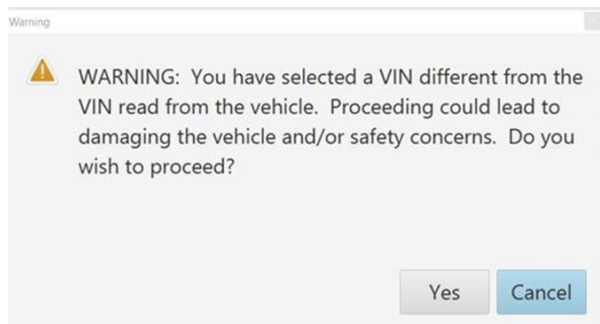
5877000

Important: If the vehicle VIN DOES NOT match, the message below will be shown.

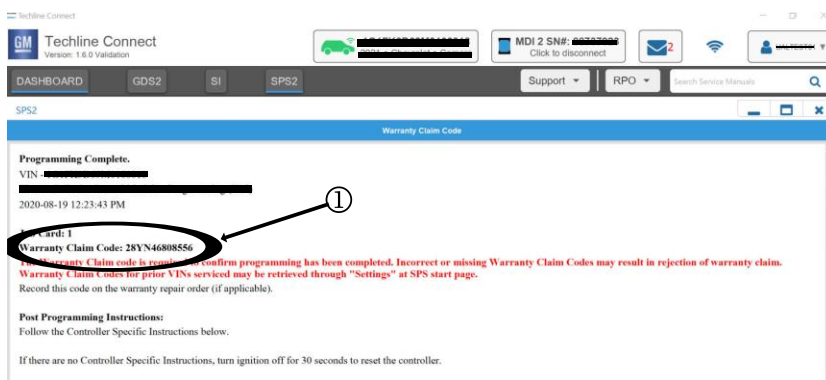
5644478

Important: To avoid warranty transaction rejections, you **MUST** record the warranty claim code provided on the Warranty Claim Code (WCC) screen shown above on the job card. Refer to callout 1 above for the location of the WCC on the screen.

1. Reprogram the Engine Control Module. Refer to *K20 Engine Control Module: Programming and Setup* in SI.

2. Record SPS Warranty Claim Code on job card for warranty transaction submission.
