GLOBAL SAFETY FIELD INVESTIGATIONS  
DCS6625  
URGENT - DISTRIBUTE IMMEDIATELY

Subject: N232402000 - Service Update  
Rear Inner Wheelhouse Metal Split

Models: 2023 Buick Enclave  
2023 Chevrolet Traverse

## N232402000 Rear Inner Wheelhouse Metal Split

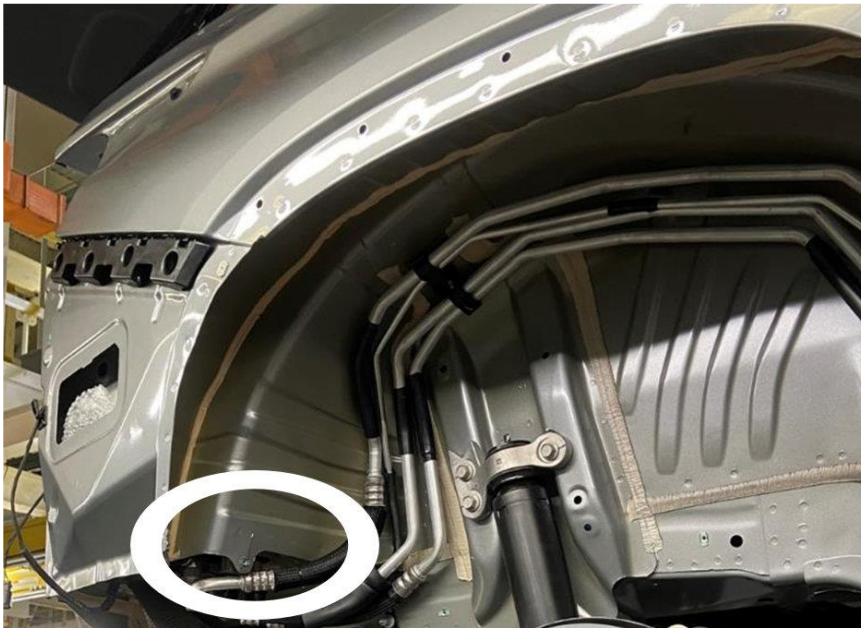
6388263

2. Locate the rear section of the Right Rear Wheelhouse, shown above.

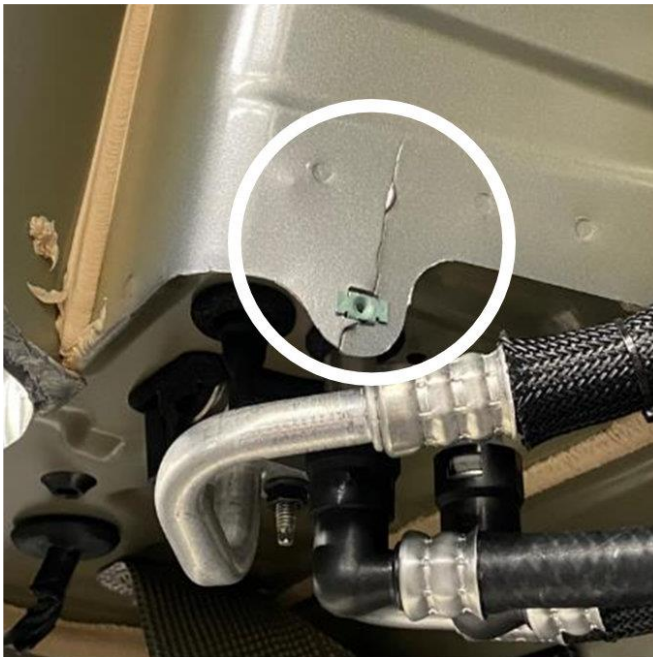
6388266

**Note:** Cracks may vary in both location and length, ANY crack requires repair.

**Note:** If crack is through the screw retainer hole, as shown above, remove the screw retainer and reinstall in the patch panel that will be installed later in this procedure.

3. Inspect the area for cracking, as shown above.
  - If cracking is found, no further action is required. Proceed to step 14.
  - If cracking found, proceed to step 4. These steps will involve mitigating the spread of the crack and installing a metal overlay to seal and reinforce the area.
