# Service Bulletin

Bulletin No.: 22-NA-080

**Subject: Diagnostic Tips for Engine Related Shudder Concerns**

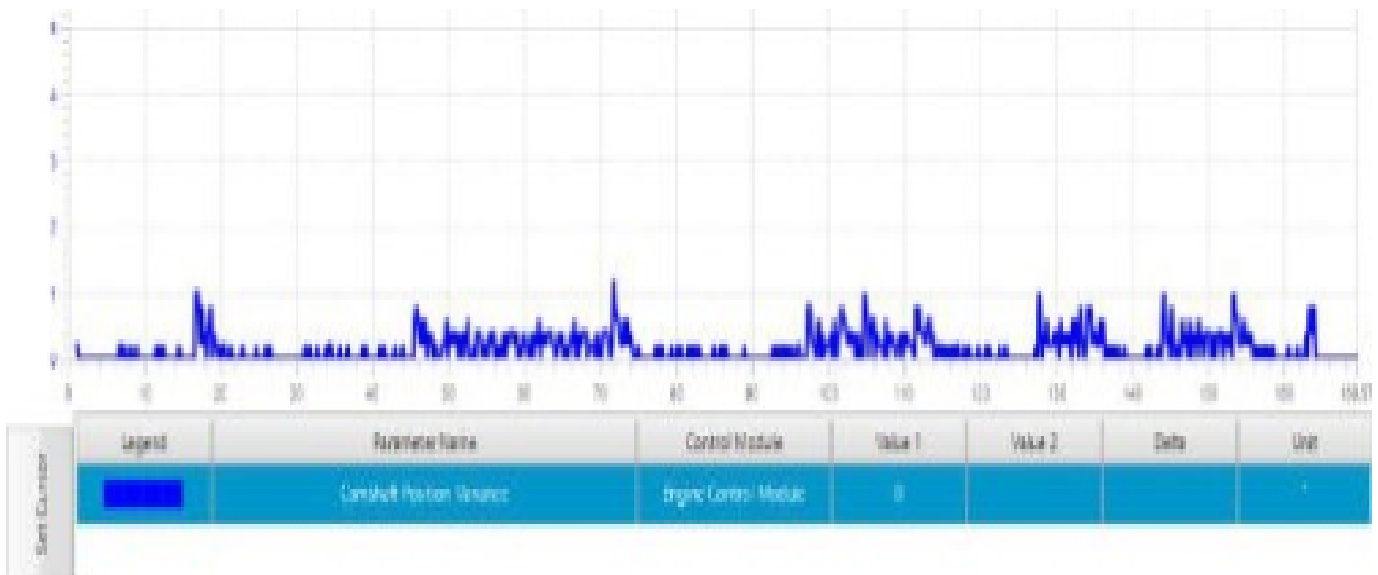
Normal operation (variance under 4 degrees)

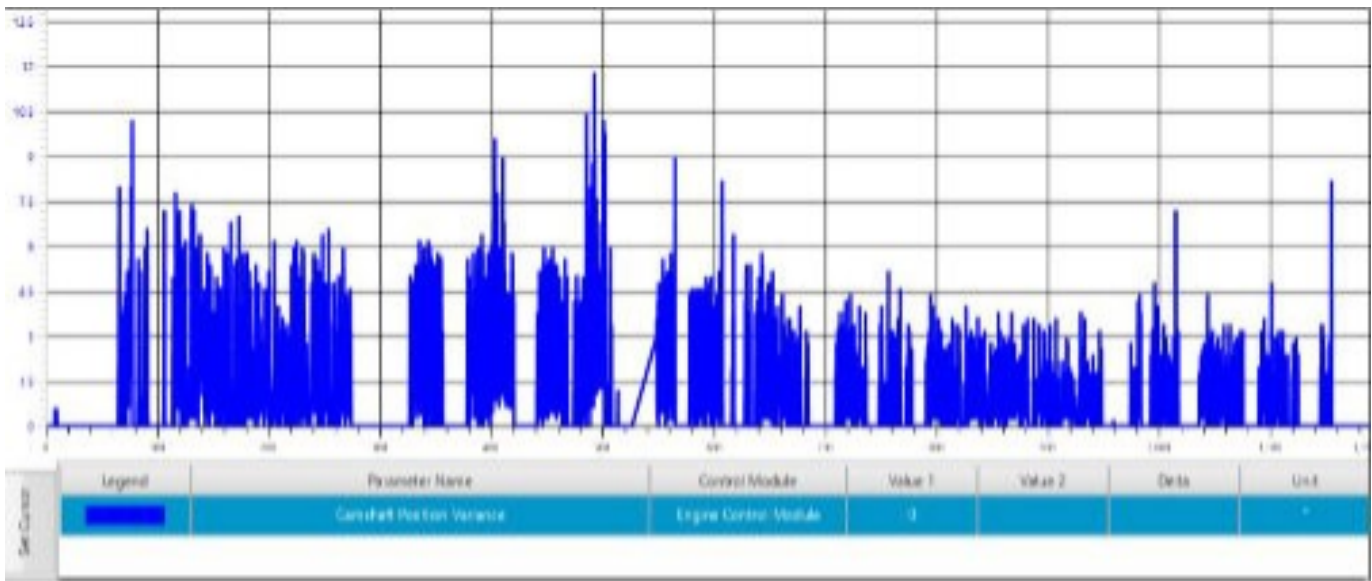
6029096

Suspect fault in camshaft actuator system (variance over 4 degrees)
