Deck Non-Skid Coating Inspection

Units Affected: Certain AH, LS, AT-P, AN, DC, DH-E/H, and AT-M Series aerial devices built from March 2022 to March 2023. Verify your unit is affected by reviewing the attached list or accessing Altec Connect.

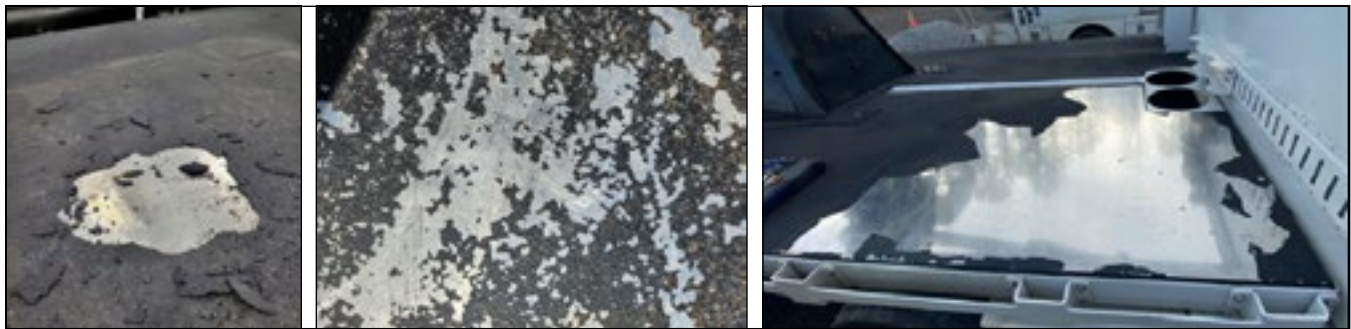
Figure 1 — Examples of Delamination

Background: Altec has learned that the affected units have non-skid coating on the deck that could delaminate and flake off over time. This causes the deck surface to lose its texture and is cosmetically unappealing.

1. Position the unit on a level surface, apply the parking brake, and turn off the engine. Remove the key from the ignition, and secure it following your employer’s vehicle lockout/tagout procedure. Chock the wheels.
2. Inspect the non-skid coating on the deck. Remove any items from the deck that may block the deck from view. Look for areas where the non-skid coating has completely separated from the deck.
3. Determine the cause of separation (refer to Figures 1 and 2).
 - If the underlying surface is gouged, this separation is due to damage. It is not covered by this SIL. Proceed to step 7.
 - If the underlying surface has black or grey residue on the surface, this separation is due to normal use. It is not covered by this SIL. Proceed to step 7.
 - If the underlying surface is undamaged parent material (refer to Figure 1), this decking requires repair. Proceed to the next step.

4. Schedule repair with a local body shop that is qualified to meet the requirements under the Repair Instructions list on page 3.
5. Prior to taking the vehicle to the body shop, remove all equipment.
6. Once the repair is complete, proceed to step 7.

1. Use Lanning LE-1050 or an equivalent product for application of new non-skid coating.
2. Remove all non-skid coating from the entire deck without removing bolt-on components. Do not use sand or other blasting techniques to remove the non-skid coating or prep the surface.
3. Prepare the surface according to the manufacturer's recommendation.
4. Apply a single layer of Lanning LE-1050 or equivalent product and allow it to dry according to the manufacturer's recommendation.
