Service Bulletin

Bulletin No.: 18-NA-069

Subject: Poor Engine Performance in Extremely Cold Weather Conditions for LFV Engines, Charge Air Cooler Icing - Malfunction Indicator Lamp (MIL) Illuminated - DTC P0299, P0234, P2227 and/or P00C7 Set

Brand:	Model:	Model Year:		VIN:		Engine:	Transmission:
		from	to	from	to		
Chevrolet	Malibu	2016	2023	—	—	1.5L (LFV)	—

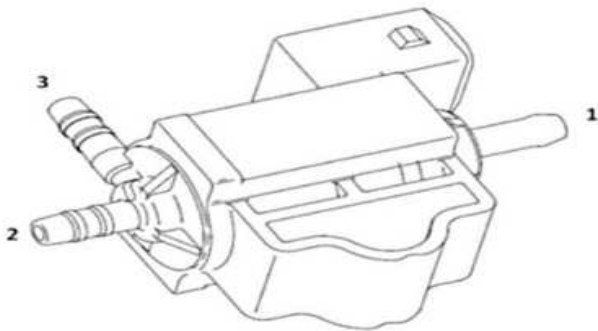
6055068

Note: Check port #2 to assure the spring gets lifted off the seat. This will be determined by the compressed air not dead heading when applied to port #2. When applying air to this port, a small amount of air should be observed at port #3 and even less air will be noticed at port #1. If this does not happen, the TCV plunger may have hardened deposits from hot operating conditions which will impede TCV plunger movement, and the TCV should be replaced.

4. Using clean shop air regulated to 80-100 PSI, blow through all three ports (1, 2 & 3) for 5 seconds each.
⇒ Repeat step 4 twice.

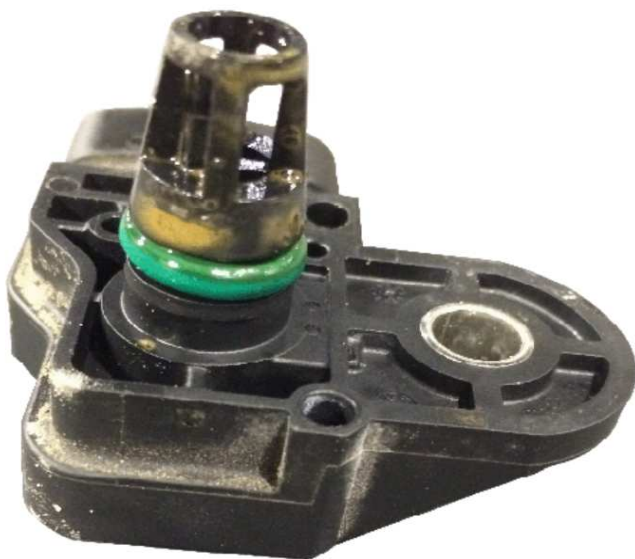
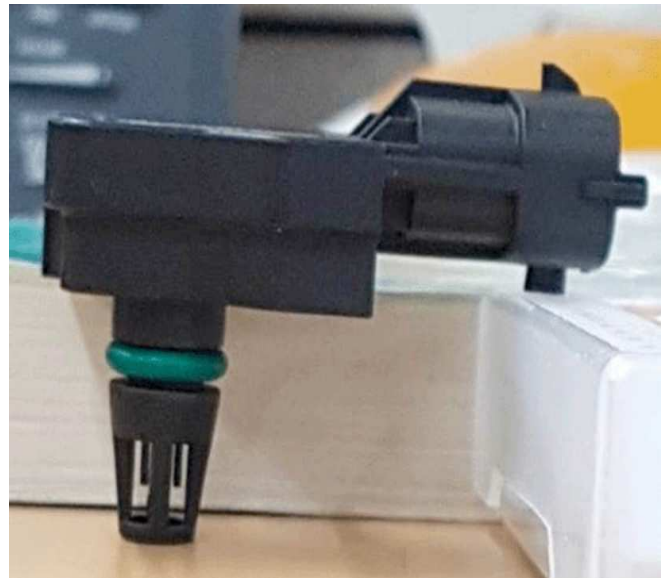
2. Inspect the sensor of any contaminates.

3. Allow time for any ice build-up to melt by placing the sensor port down.
4. Clean the sensor with a clean towel.
5. Install the sensor.
