# **Service Bulletin**

## Subject: Information on Spark EV (BEV) High Voltage Battery Exchange Process

# This bulletin replaces PIP5112S to reflect the revised TAC approval and battery pack ordering process. Please discard PIP5112S.

Brand:	Model:	Model Year:		VIN:		Engine	Electric
		from	to	from	to	Engine:	Drive Unit:
Chevrolet	Spark EV	2014	2016	All	All	EN0	1ET35 (RPO MME)

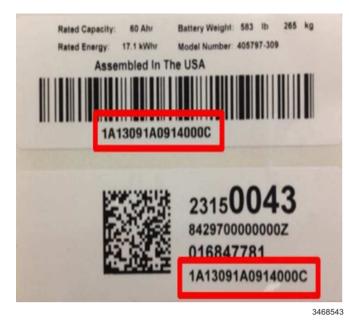
2. Record the 16-digit BIN (Hybrid/EV Battery Pack Identification Number), which is located on the right side of the battery and can be seen without removing the battery.

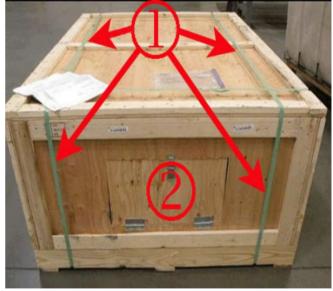
3943204

- 1. Banding Straps
- 2. Access Door

It is important to package the Drive Motor Battery upon return exactly as the service Drive Motor Battery was received. Zinc-Plated Steel Lag Screws for Wood, 5/16" Diameter, 2-1/2" Length are used to secure the battery pack to the crate base. The dealership must also use banding straps to secure the battery to the container base. The container top or "bonnet" must also be banded to the container base as pictured below:

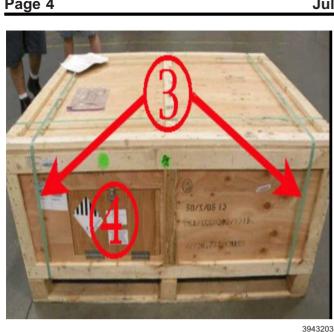
- 3. Banding Straps
- Access Door

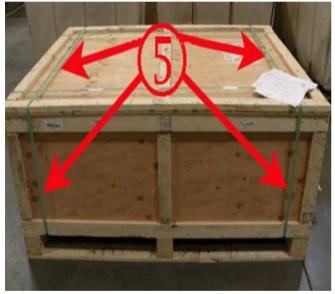
3943205

5. Banding Straps
